Submarine A1 Licensee report 2015

Overview

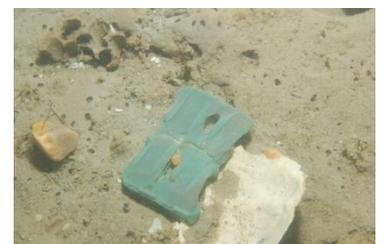
what this part is or even whether it is part of the site, I would assume that it is and therefore has been left in situ and recorded. If the material has come from inside the wreck then it is evidence of interference from divers though I would suggest that it is not a recent occurrence. The bronze pipe clamps surprisingly are still on the seabed that were exposed last year and have not been taken from the site yet.

site after the winter storms, and the wreck was seen in nothing had radically changed wildlife was in the usual see that there was no damage A small piece of material was observed at the bow and and photographed, it is not clear

Figure 2 none ferrous metal part near bow

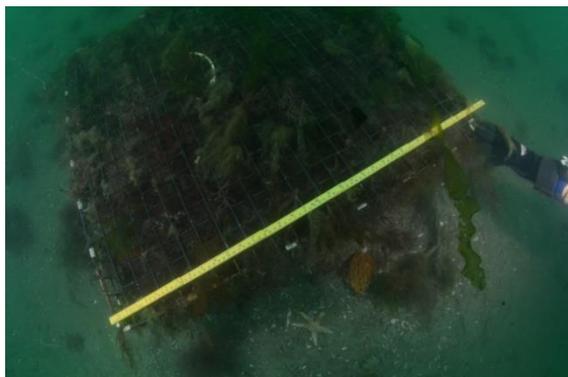
This dive I took the opportunity to record a large metal fishing pot possibly used for cuttle fishing that has appeared on the site and is near the stern area of the boat, measurements and pictures were taken and the details sent to Historic England. The rope on the pot was short and it is unclear as to whether it had been cut or abraded. Nothing was seen in the pot apart from sea weed and the door was open. The dimensions are 1mx1m and 450mm tall.

Figure 3 Cuttlefish pot

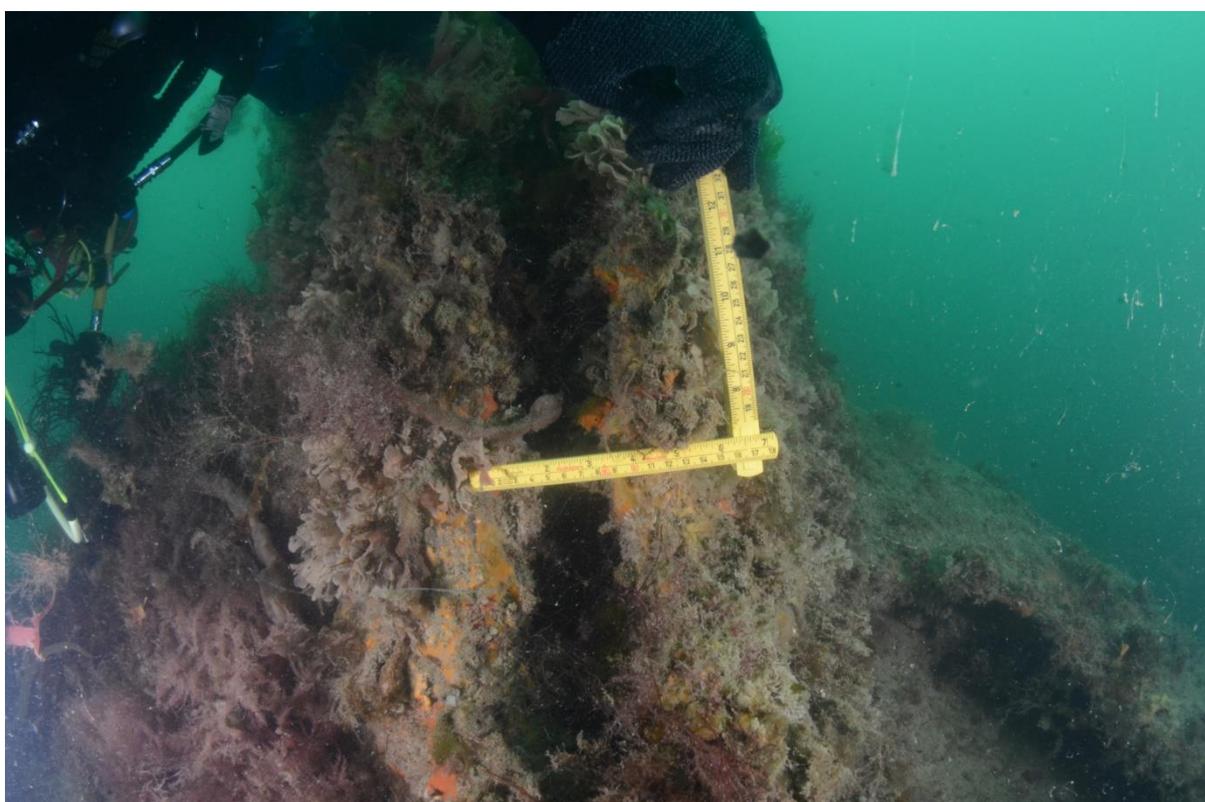
Figure 4 The crack in the conning tower

Seen in the image above the conning tower crack remains constant at present and there has not been any significant opening of it over the previous year, this is however a concern and will be monitored on an ongoing basis.

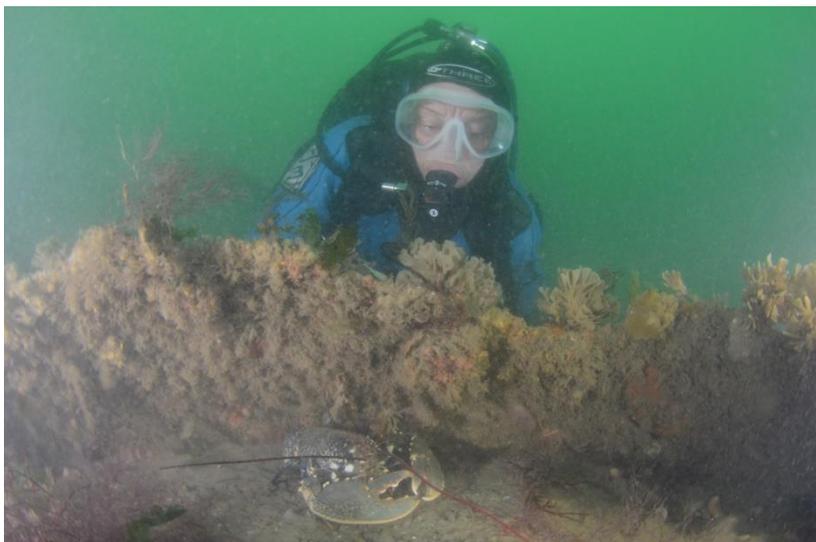
A sea Lemon was observed at the stern, this is the largest nudibranch that we get in the UK and always good to see one. We also visited the area 8m beyond the stern to see the remains of what is thought to be a large navigation buoy; this appears to be a bit more exposed at the moment and is home to a lobster. The presence of the buoy will remain a mystery and while it could have been

Figure 7 Remains of Navigation buoy?

connected to the wreck site in some way many years ago, perhaps as a marker of the site or was actually used to mark the position of the boat on its last journey and was dragged under. It is well buried and now corroded badly on the top so has been down there for a long time. Members of Portsmouth University dive club joined Southsea Sub-Aqua Club for
