HM Submarine A1 Licensee Report 2012

by Martin Davies

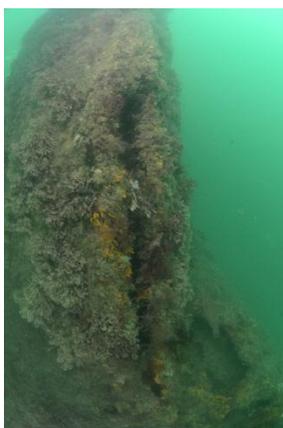
Figure 1 - Conning tower general view

The wreck of the A1 Submarine remains a stable and robust site for visiting divers to see, while she is showing signs of deterioration in many areas, the cracks in the conning tower being the most visible.

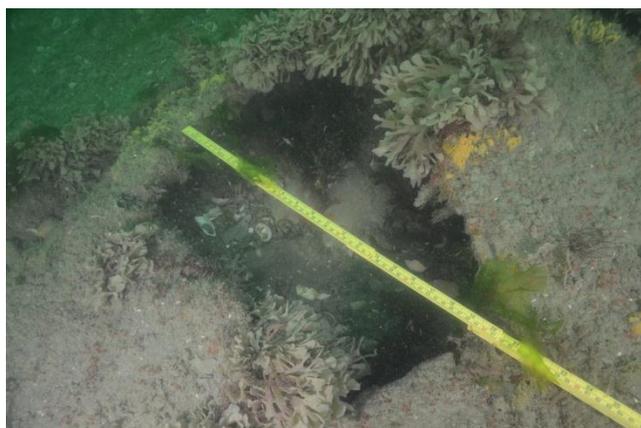
Figure 2 - Hole in rear casing 49cm long

Numerous holes can be seen in the rear casing one of the largest is 49cm across. The submarine is still very much intact. The build up of sediment inside the wreck remains a concern in the forward

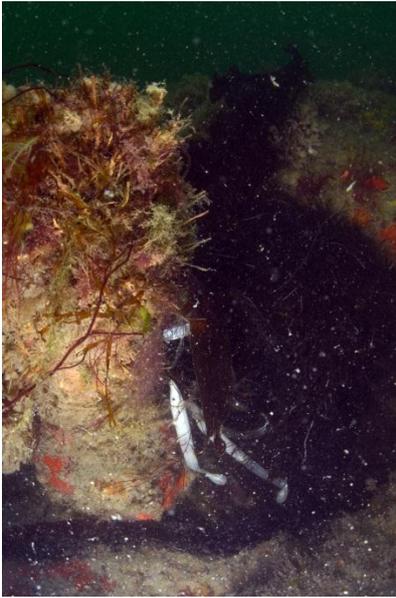
I dived the wreck for the first time and reported that the condition of the wreck was as previous visits. Some fishing line was seen around the stern area of the submarine from rod line fishing which

has subsequently been removed (see Figure 3). A large amount of sediment resides in the forward area of the bow and can be observed from the forward hatches that are open; a large amount of weed has also collected in the hatch area.

Figure 3 – Rod fishing gear

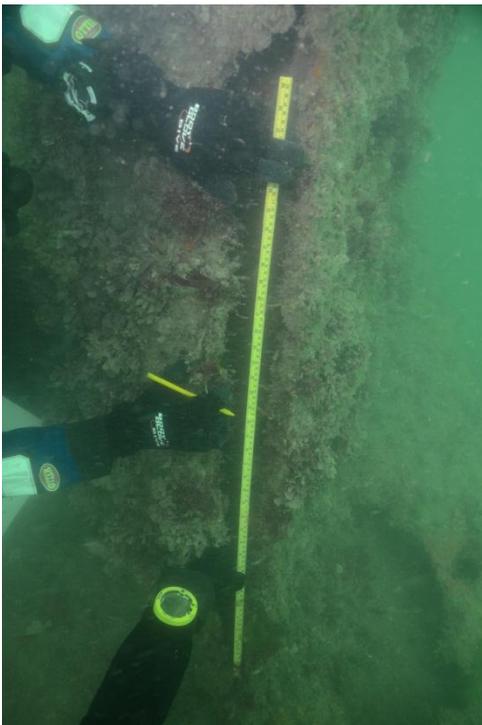
I visited the site again with members of Southsea BSAC, many thanks to Edward Rollins and Doug Carter for their assistance in taking some of the measurements while I was taking photographs. The measurements were of the crack in the conning tower which does appear to be growing from personal memory. From this date onward I intend to measure and monitoring the crack in the front of the conning tower and also a smaller one in the rear more carefully. See figures 4 to 6 for details.

Figure 4 - Length of crack is 1.1mrts

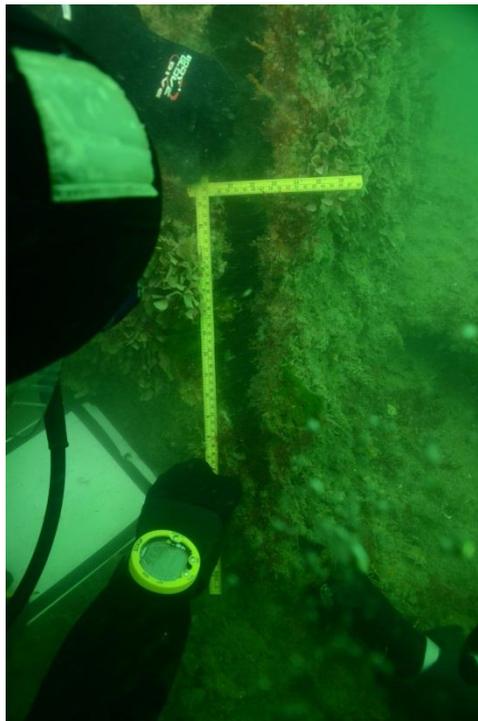
Figure 5 Width of crack is 8cm to 11cm

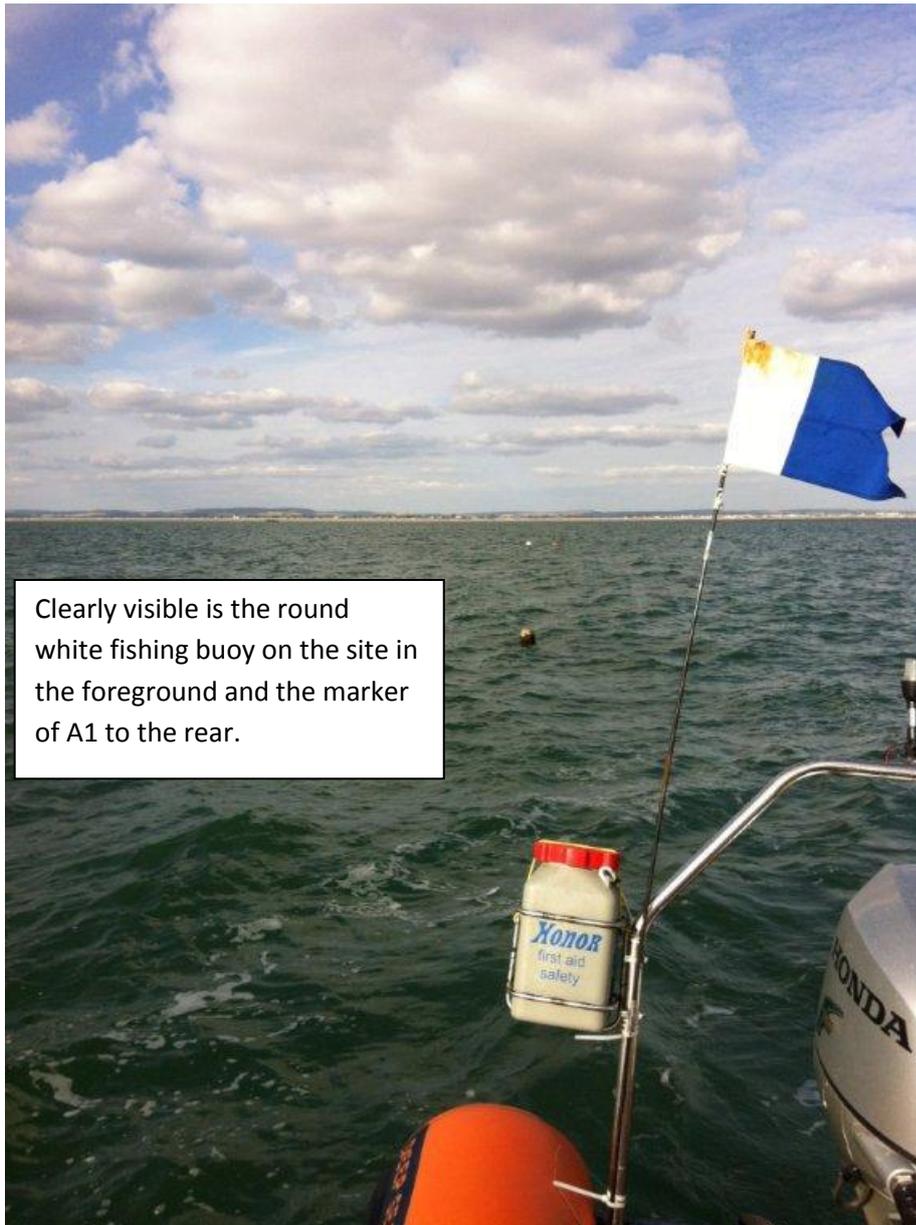
The wreck this year has not seen any direct major threats. There is a string of commercial fishing pots placed within the 300 metre exclusion zone, but these pots appear to have no owner. They are marked with a small round white buoy which is covered in growth and has been there for two seasons now. Whilst not directly a threat they appear to be illegally placed. WA commented on them in their report and said they were a hazard while that were manoeuvring their boat on site. See figure 5.

Clearly visible is the round white fishing buoy on the site in the foreground and the marker of A1 to the rear.

Figure 7 - Illegal potting with 300m of site – Picture by Mark Beattie Edwards
