TWO TUGS

Report of the investigation of WW2 wrecks reported to be HMRT SESAME
and USS PARTRIDGE, Baie de Seine, Normandy, France

Southsea Sub-Aqua Club | BSAC Branch 0009
December 2019

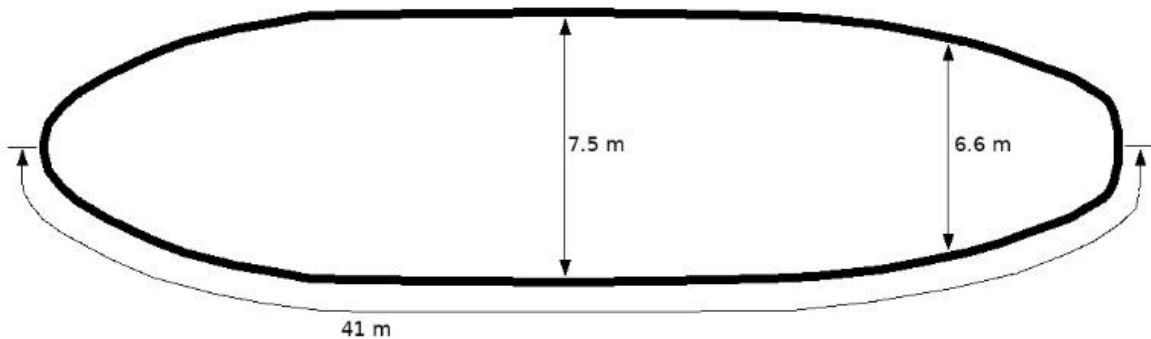
A direct measurement from bow to stern was not practicable due to the towing stanchion and forward winch assembly, which obstructed the ability to measure accurately. In order to overcome this two divers measured from bow to stern on the outer edge of the deck or gunwale. The length measurement was **41m** (134 feet 6 inches). In addition, the beam of the wreck, close to the towing stanchion and estimated to be the widest part of the wreck was measured. The beam measurement was **7.5m** (24 feet 7 inches).

Figure 16 EA4630 Wreck hull measurements (© Jim Fuller)

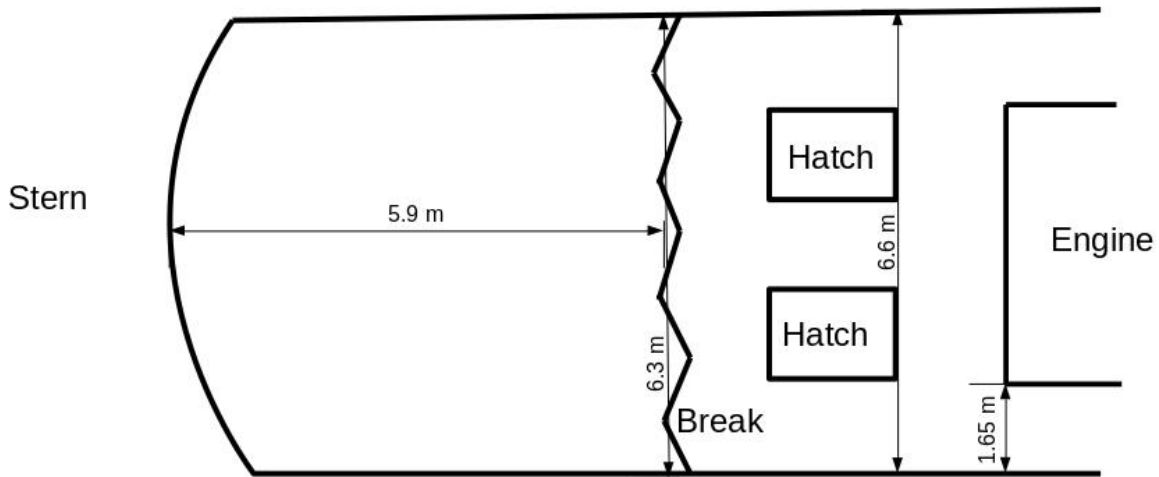
Further measurements and observations were recorded from the engine bay to the stern. It was noted that the wreck had a break in the structure, which was approximately 6m from the stern extending across the width of the deck (6.3m) and partially down the starboard side of the ship.

The width of the wreck across the deck behind the engine bay was **6.6m** (21 feet 8 inches) indicating a tapering stern.

Figure 17 EA4630 Survey data from the stern area. (© Jim Fuller)

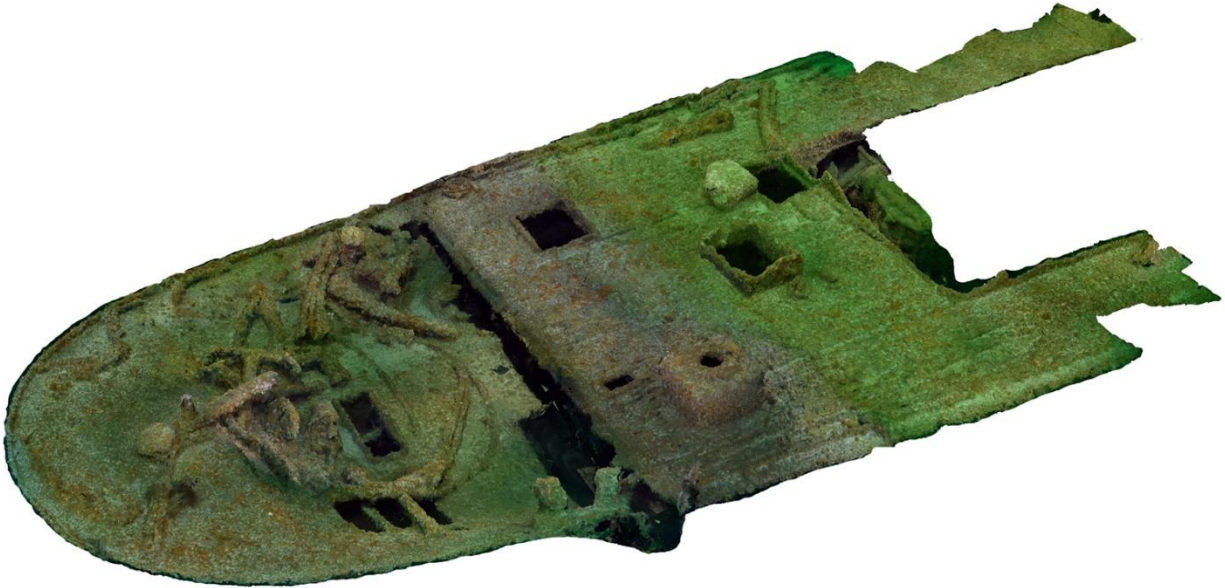
Figure 20 EA4360 Image created from photogrammetry model -Stern from the starboard side showing the collapse of the deck area. (© Martin Davies)

The top of the rudder post and steering quadrant were observed together with an anchor and rope. The damage to the starboard side at the top of the hull was significant, but we could not determine whether this had occurred at the time of the sinking or afterwards. However, given the intact condition of the wreck elsewhere, and this being the only evidence of a breach in the hull's integrity, it may be that the damage was a contributory factor to the sinking.

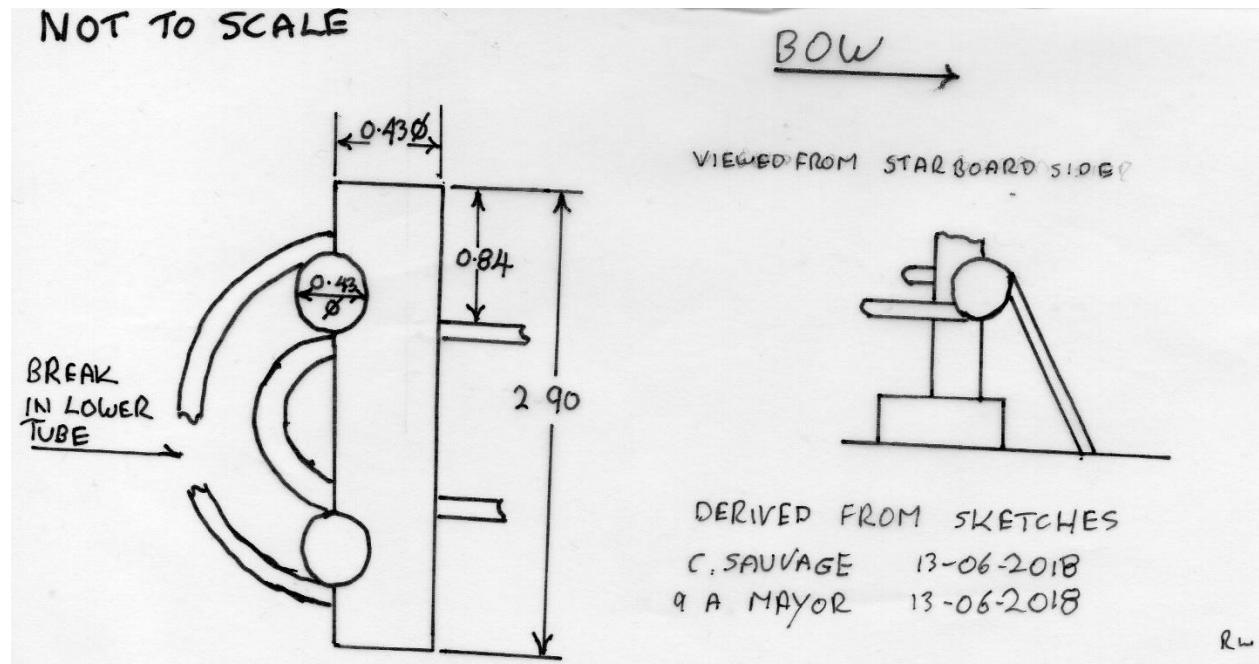
Measurements of the stanchion were taken, which aligned with the data from the previous DRASSM survey data. Part of the rope guide has broken, but otherwise the stanchion remains intact.

Figure 22 EA4360 Drawing of the towing stanchion with measurements taken by DRASSM survey 2018. (© Rob Watkins)

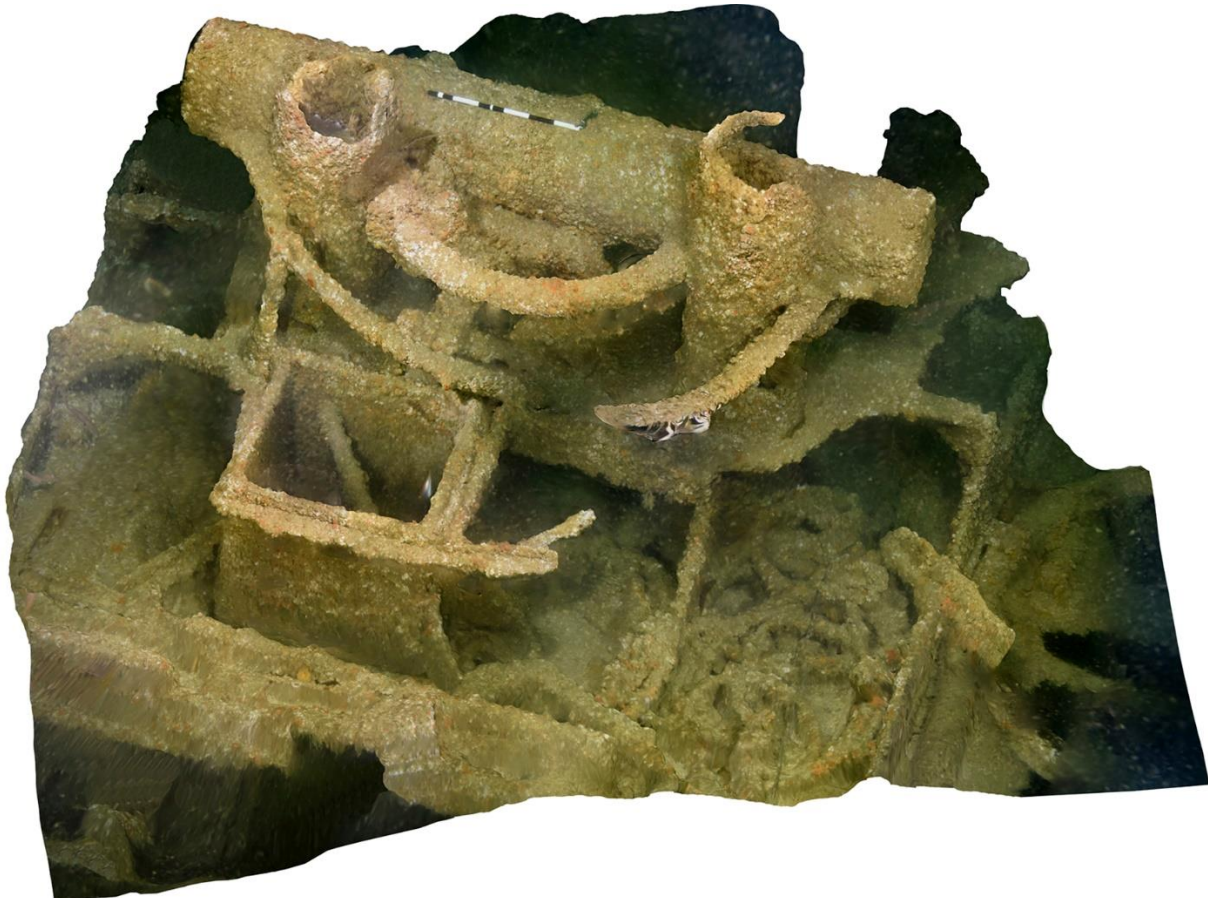
Figure 23 EA4360 Image from photogrammetry model. Towing stanchion from port looking forward. (© Martin Davies)

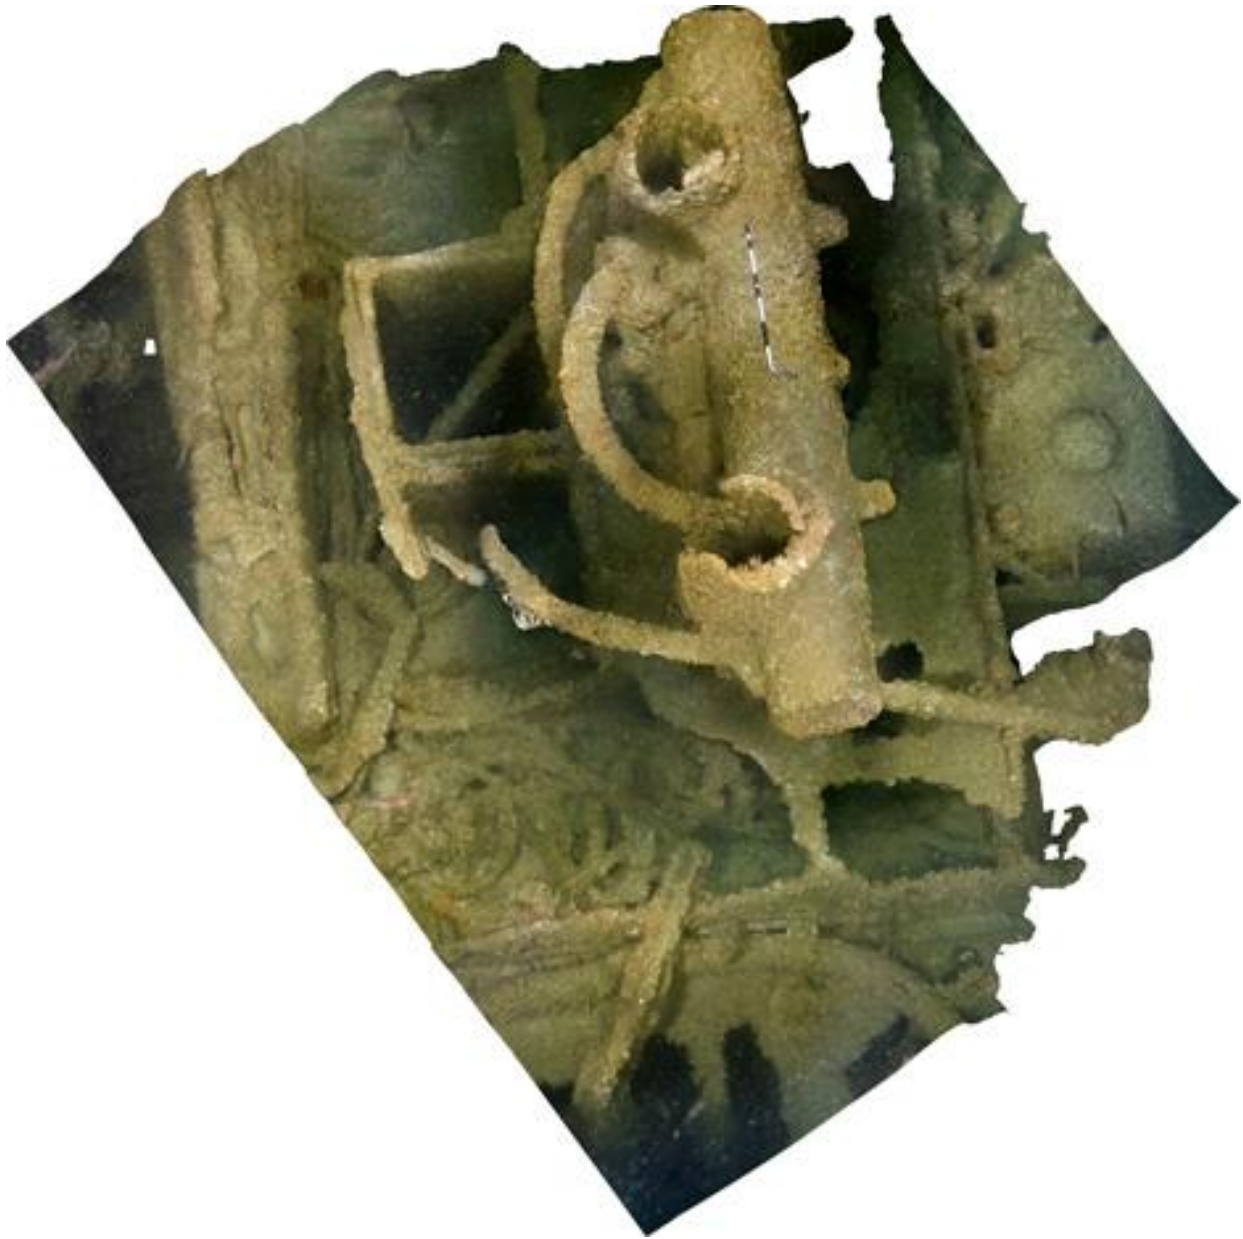
Figure 24 EA4360 Image from photogrammetry model. View looking down at the towing stanchion. (© Martin Davies).

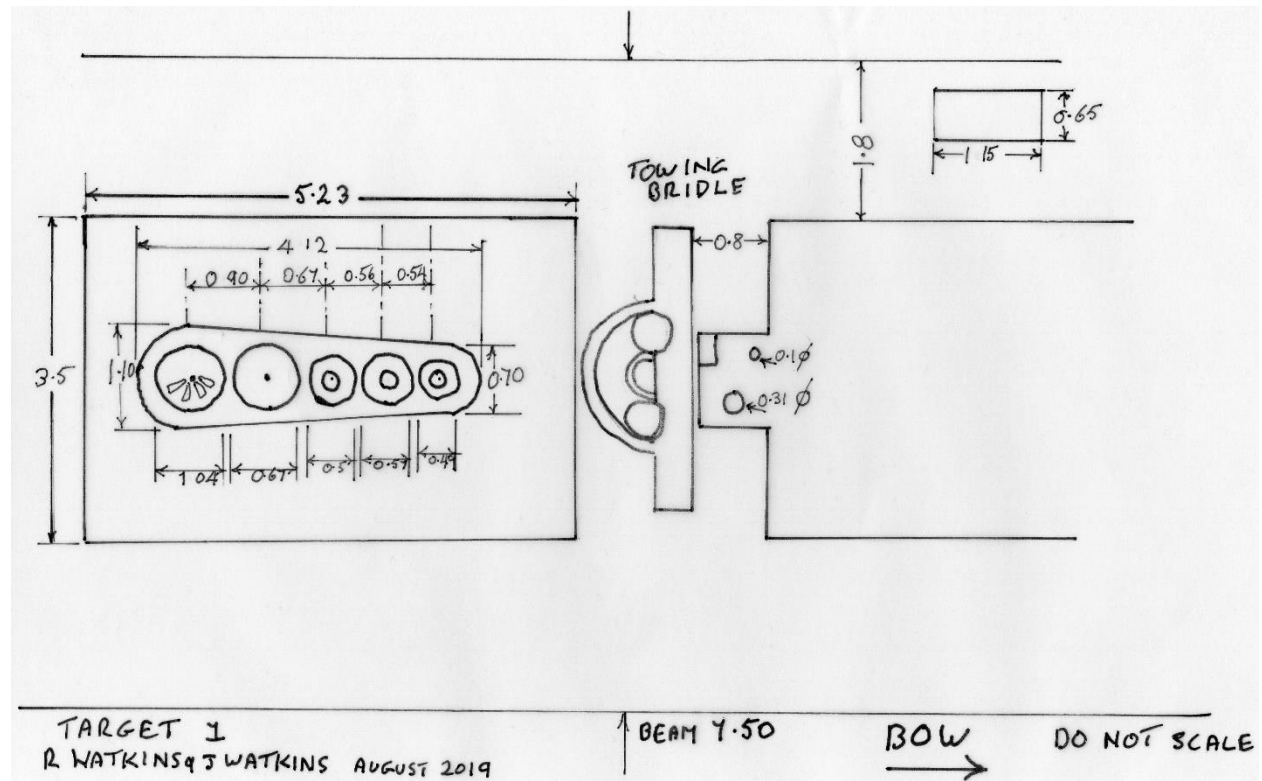
It is believed that the measurements 1 and 3 are of the steam expansion chambers. Measurement for 2, 4 and 5 represent the piston cylinder heads. Whilst the measurements of the largest cylinders are very similar, it is noted that there are some differences in the smaller measurements.

Figure 27 Measurements of engine and other wreck features (© Rob Watkins)

Observation 7 - It is noted that the measurements for cylinders 1, 2 and 3 align with those recorded for Atlantic / DUNDAS. (As taken by Cecile Sauvage 0.46m : 0.65m :1.04m)

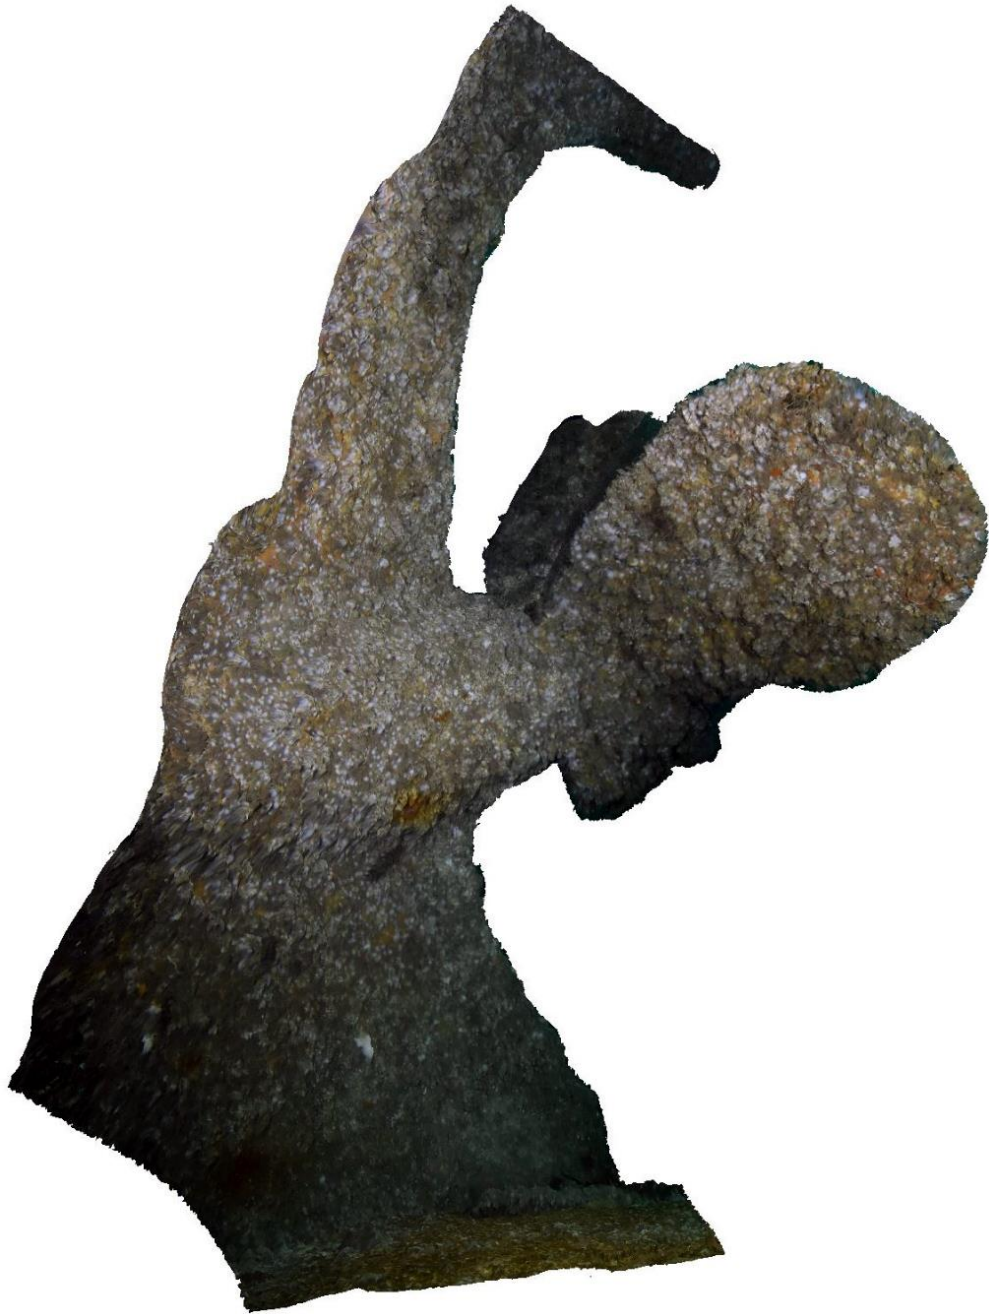
The iron propeller is in situ on the wreck, however one or more of the propeller blades is missing. The propeller was measured during the survey.

It should be noted that it was not possible to measure between the tips of the blades exactly. A variation of less than 60mm between the tips would have yielded a more exact result of 90 degrees. If the propeller had been three bladed the distance between the tips would have been approximately 2.39m, i.e. more than 0.5m greater than the observed measurements. Thus the conclusion is that the propeller would have originally had four blades.

Figure 30 EA4360 Image from a partial photogrammetry model of the propeller. (© Martin Davies)

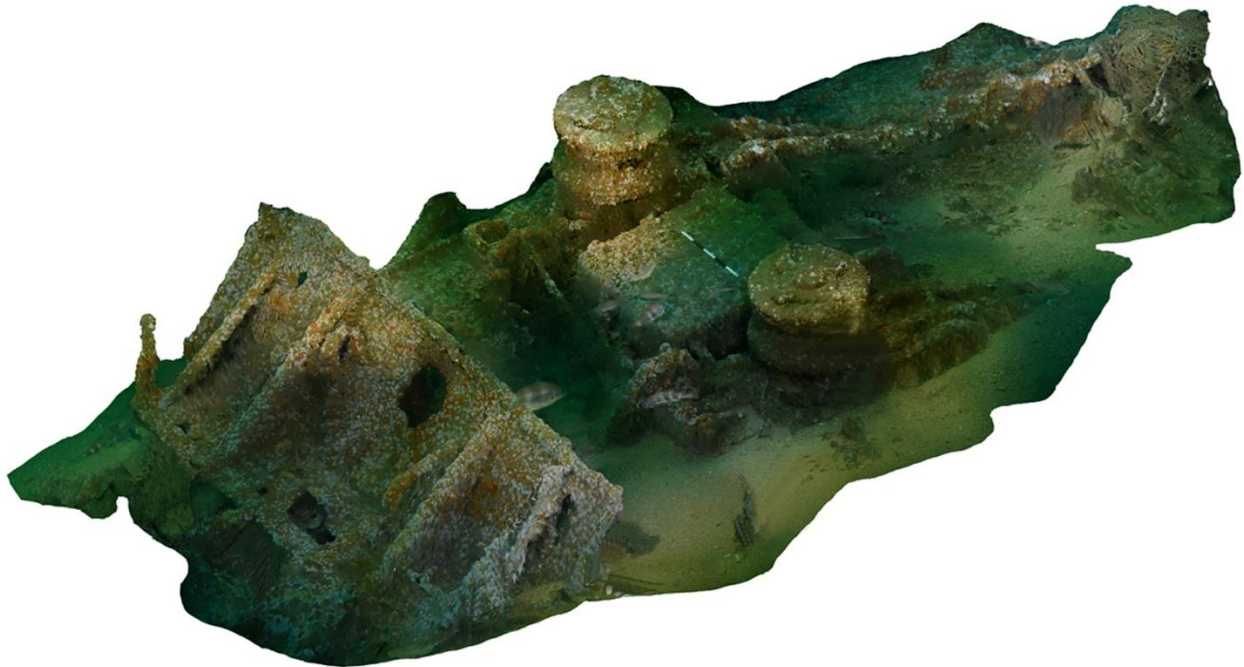
The bow is the most complete section of the ship and rests on its starboard side. On the deck behind the bow we observed a windlass anchor winch with vertical capstans. The chain to the port anchor was visible and extended down the hawser to the anchor.

Figure 41 EA3234 Photogrammetry image of the bow deck area note the vertical windlass capstans, port anchor chain and break-water. (© Martin Davies)

Observation 3 - There is no gunwale present on the wreck. However, a breakwater shield was found to be present behind the anchor winch.

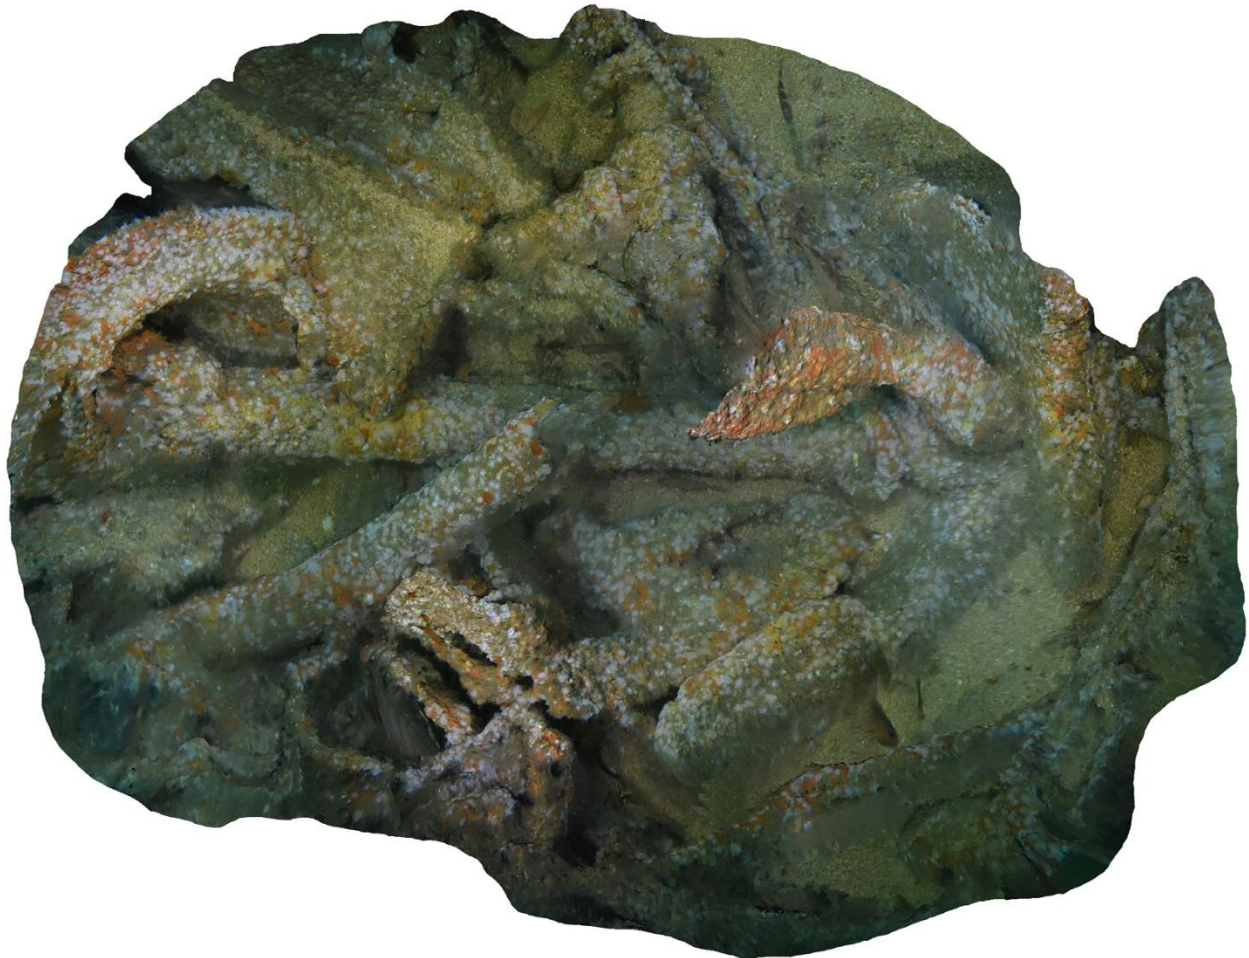
Figure 43 EA3234 the stockless anchor on the port side with the top of the shank entering the hawser (left) and the crown (base) of the anchor to the right (© Martin Davies)

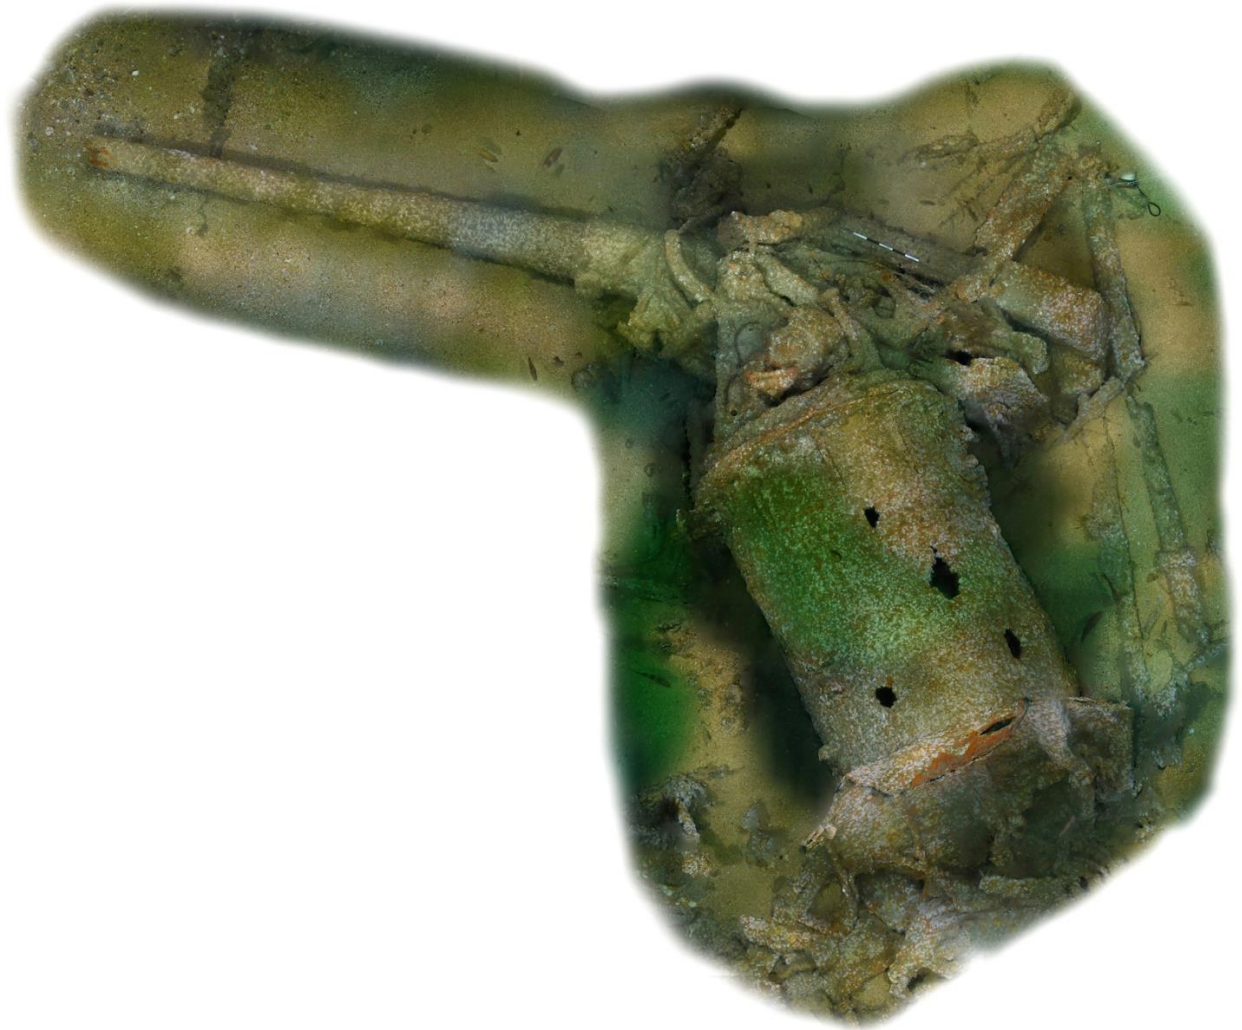
A total of three breach loading guns were found on the site; two guns behind the bow and one after the boiler section to the west.

Figure 44 EA3234 Image taken from photogrammetry model of Gun 1. (© Martin Davies)

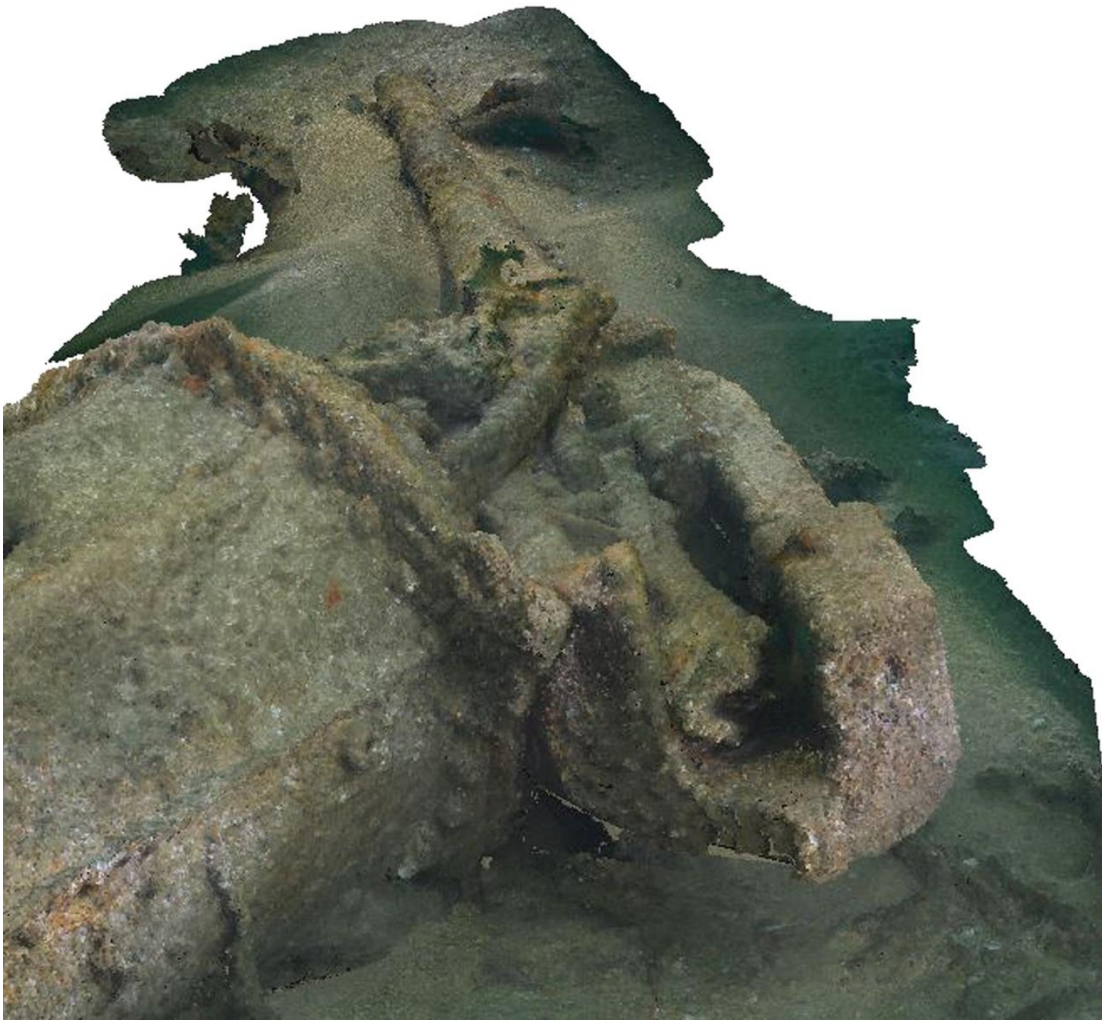
Figure 46 EA3234 Photogrammetry image of Gun 3 and breech mechanism. (© Martin Davies)

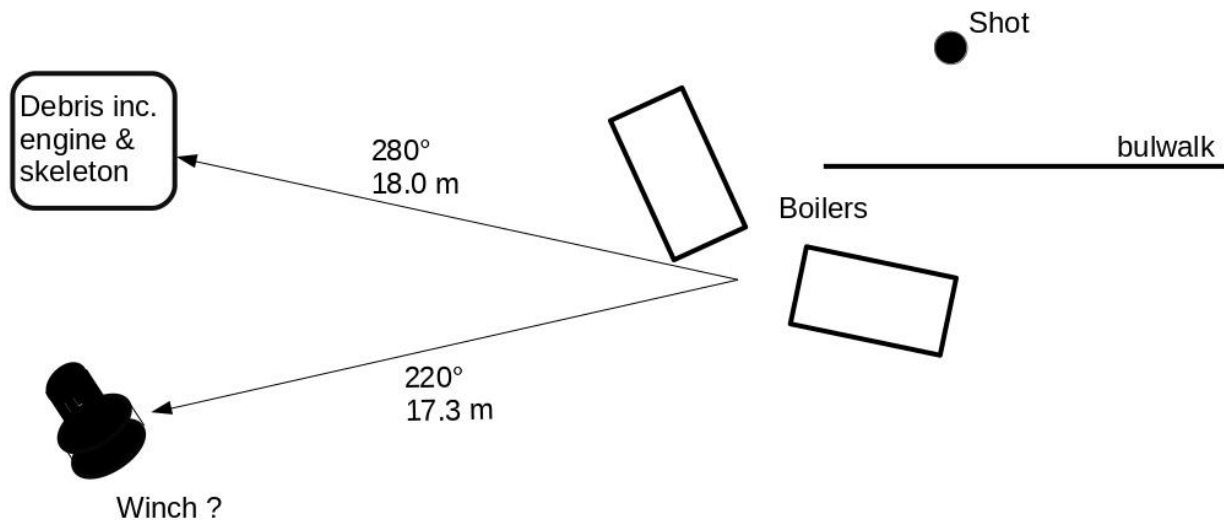
The highest part of the wreck is where the remains of the ship's steam boilers are located. We observed two cylinders surrounded by many lengths of broken pipes. The larger of the two cylinders had pipes extending vertically and the other, smaller cylinder, on its side, had pipes that extended horizontally. The boiler assemblage was very broken possibly as a result of salvage activity.

The area is bounded on one side by a length of port side deck or bulwark³³, complete with bollards. In this area we also observed the remains of a fishing trawler's gear and net.

Figure 49 EA3234 Diagram illustrating position of boiler cylinders and port bulwark. (© Jim Fuller)

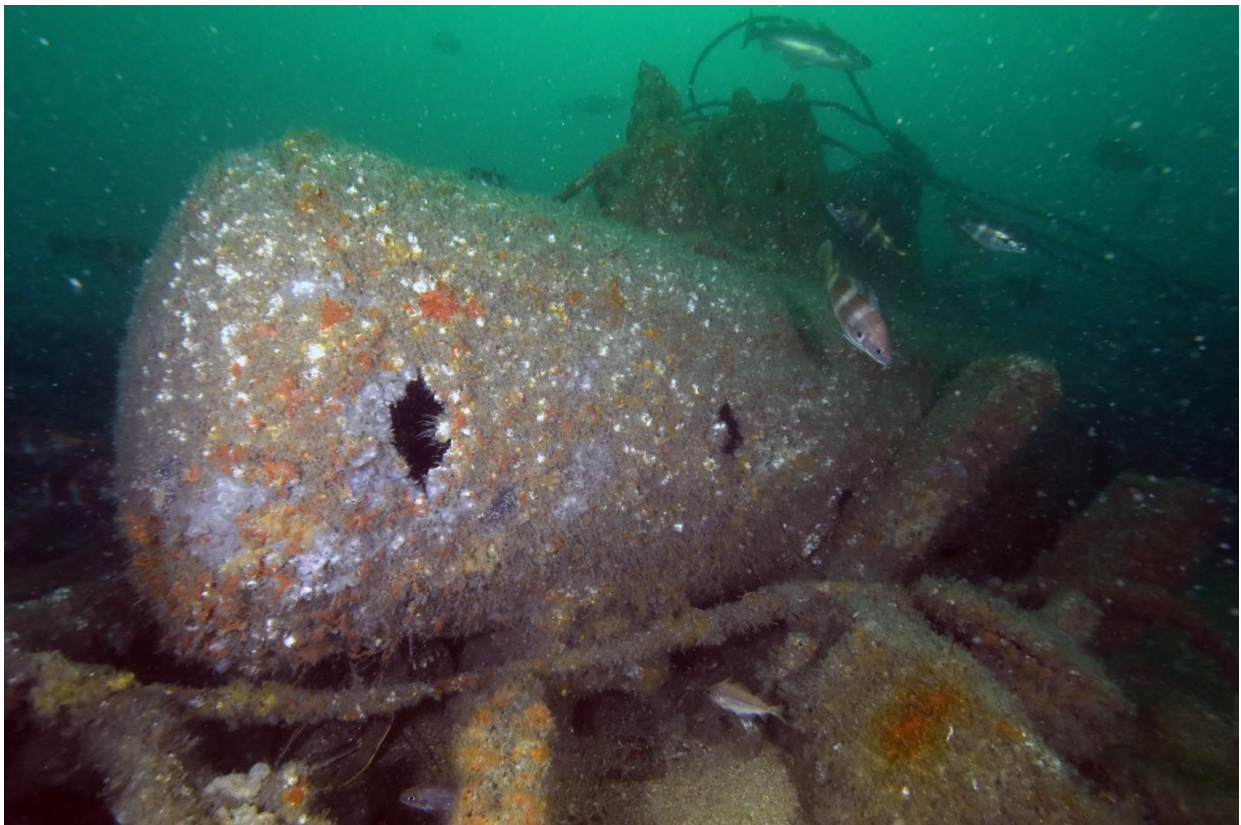
Figure 51 EA3234 the larger boiler steam cylinder with pipes extending vertically. (© Martin Davies)

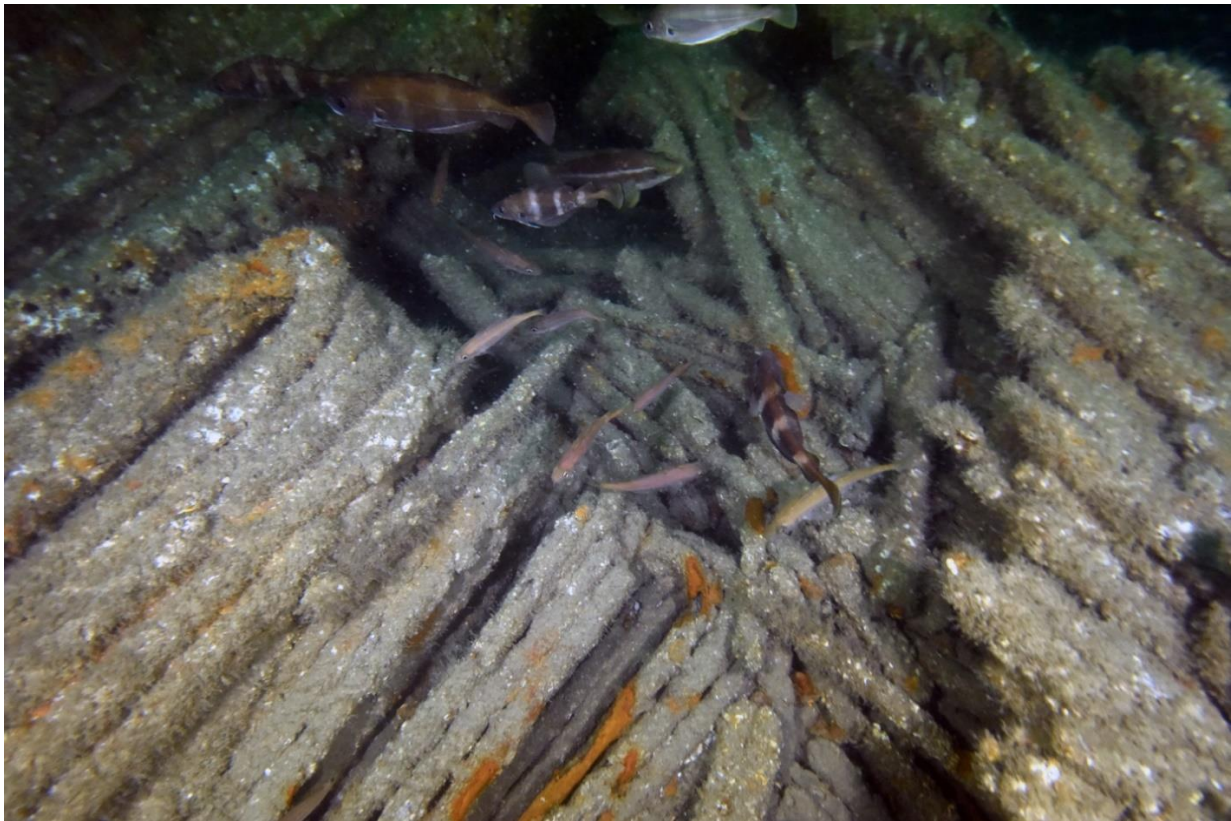
Figure 53 EA3234 a large amount of broken boiler pipes. (© Martin Davies)

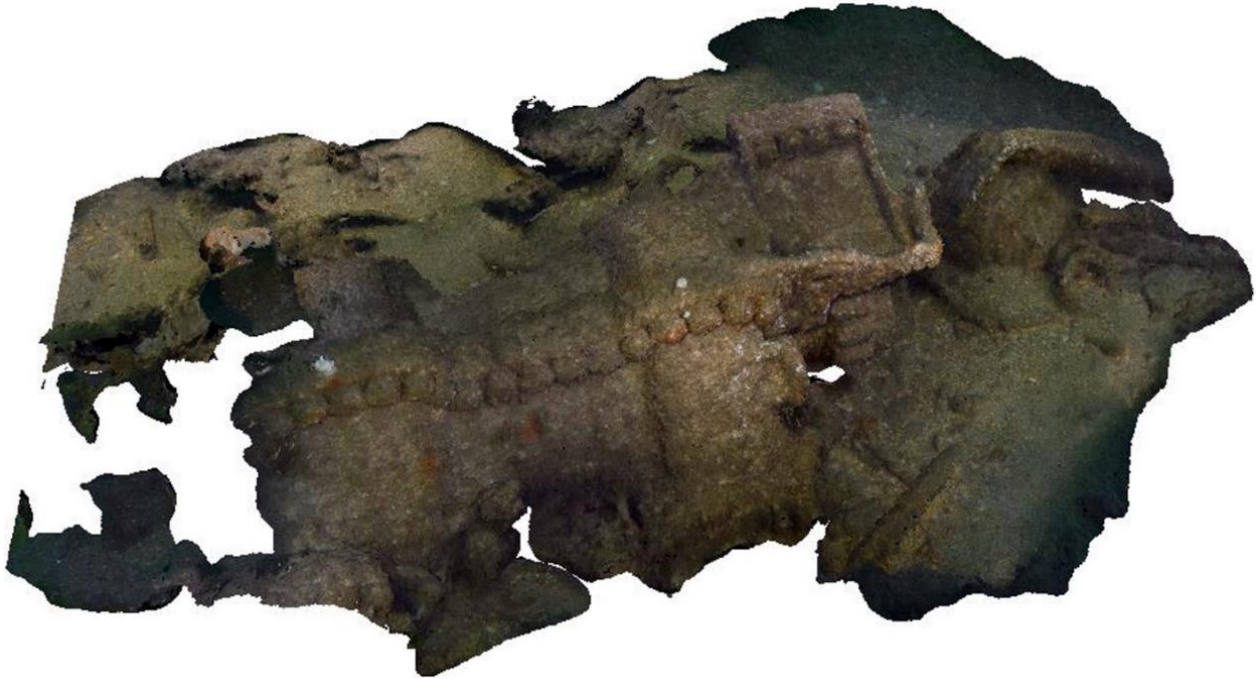
We also noted the presence of what appeared to be a part of a turbine assembly to the North of the boilers.

Figure 56 EA3234 Photogrammetry of a section of the probable turbine system. (© Martin Davies)

Observation 7: We did not find evidence of a triple expansion engine. However it is noted that the site has been subject to commercial salvage and this may explain why an engine was not found.

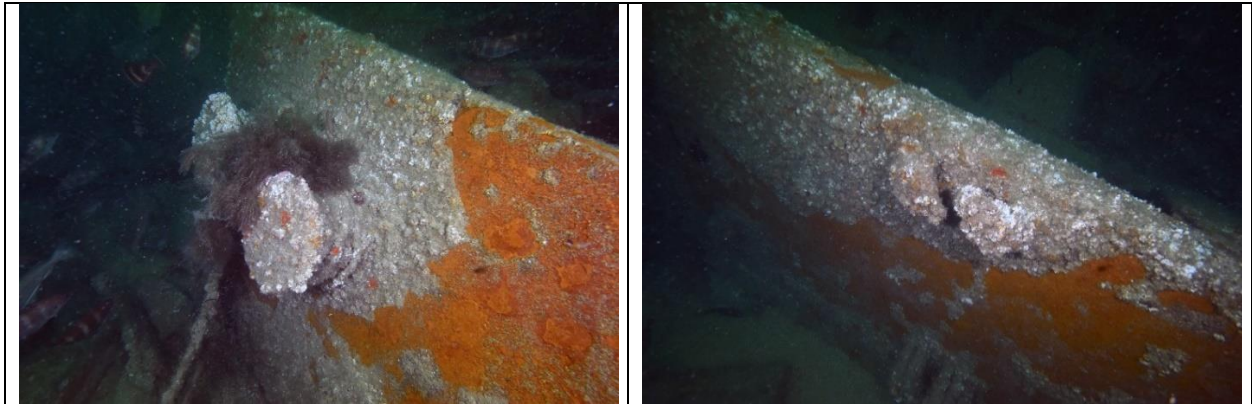
Figure 57 EA3234 Port Bulwark - Bollards and Fairlead (© Martin Davies)

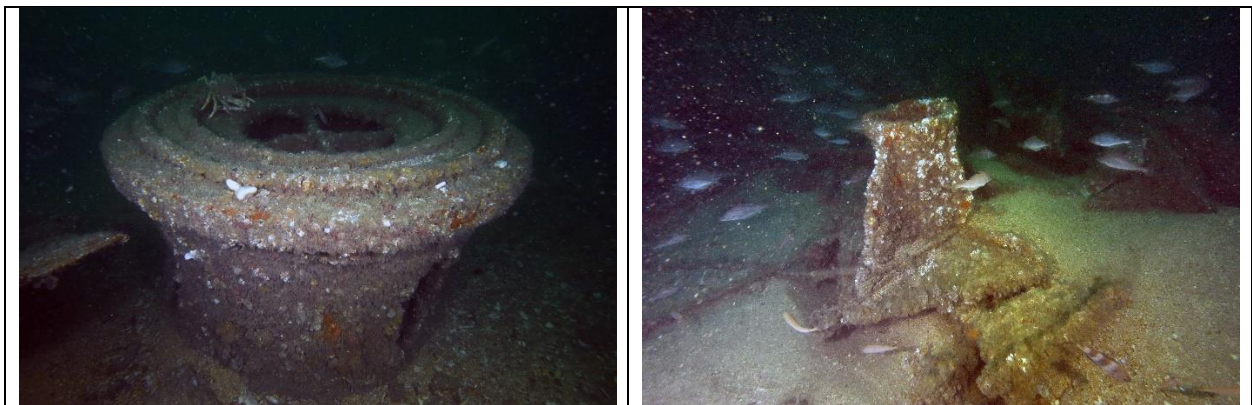
Figure 58 EA3234 Possible gun mountings and davit base. (© Martin Davies)
