PROJECT CATO

A Southsea Sub-Aqua Club project

Martin Davies

November 2018

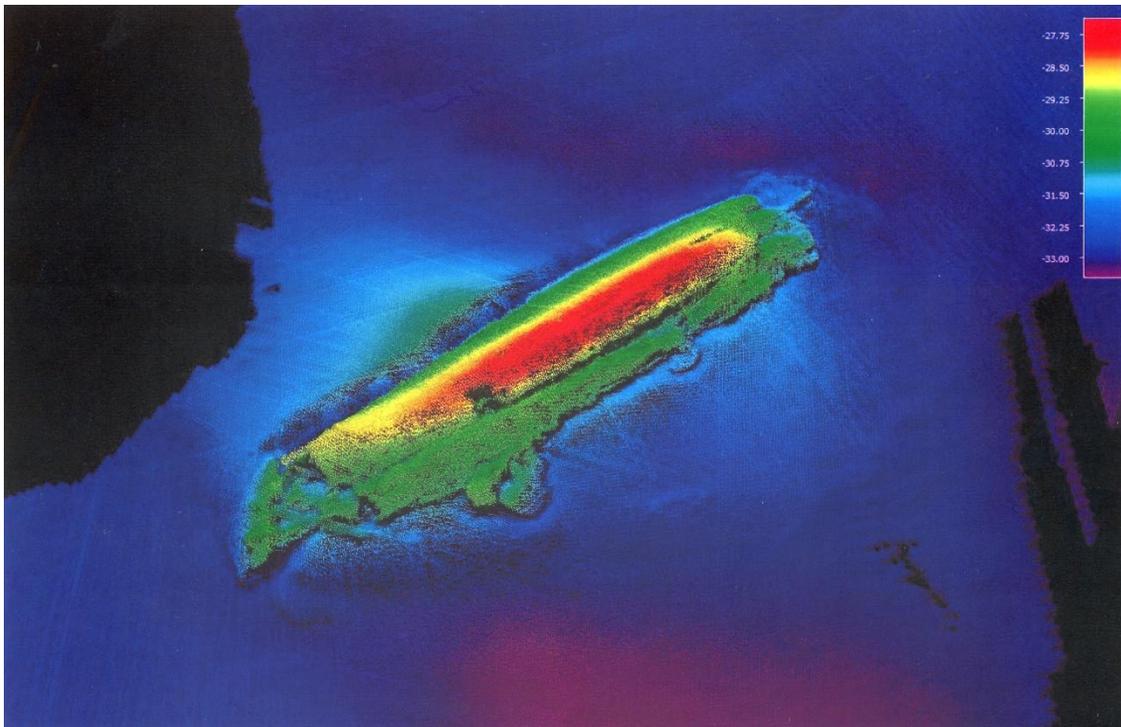
Figure 36 PYLADES multi-beam image courtesy of DRASSM (EA3118).

The wreck is orientated at 45°/ 315°. The wreck is recorded to be 67m long by 9.8m wide.

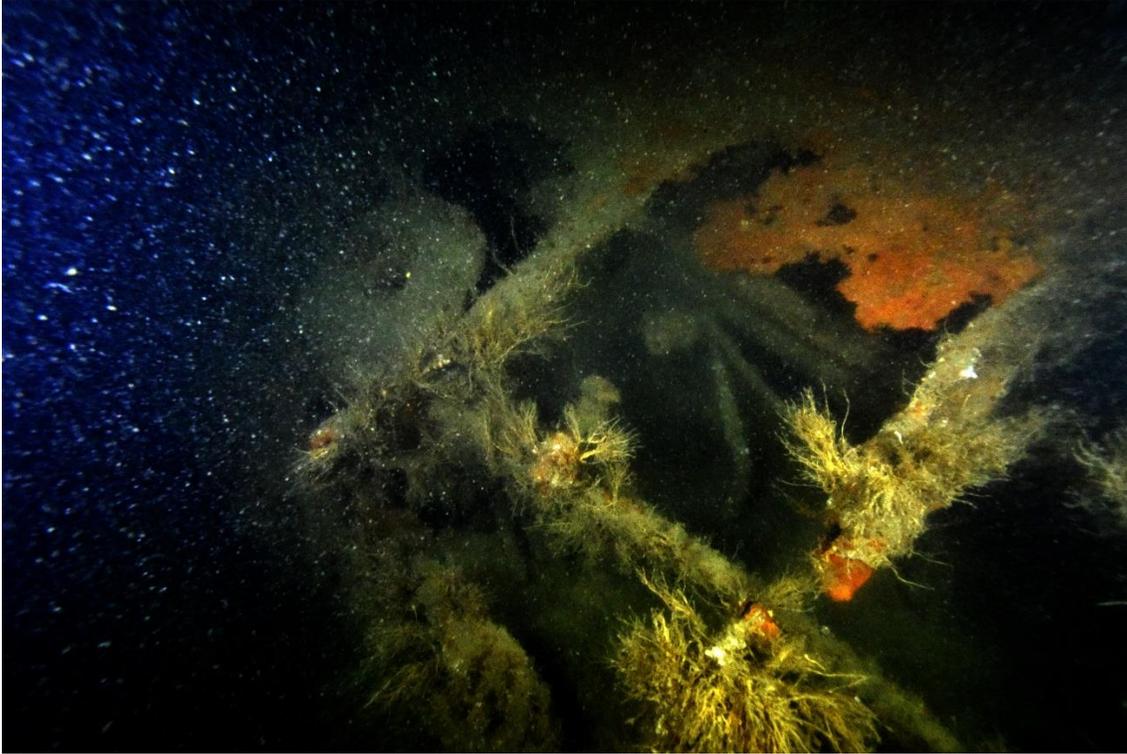
Figure 37 the outer hull plating has begun to erode away ©Martin Davies

The image above shows the extent of the weakening of the outer hull plates, a lot of the plating is very thin and dissolving quickly without the protection of being heavily concreted. The exposed red rusted steel is visible in many places.

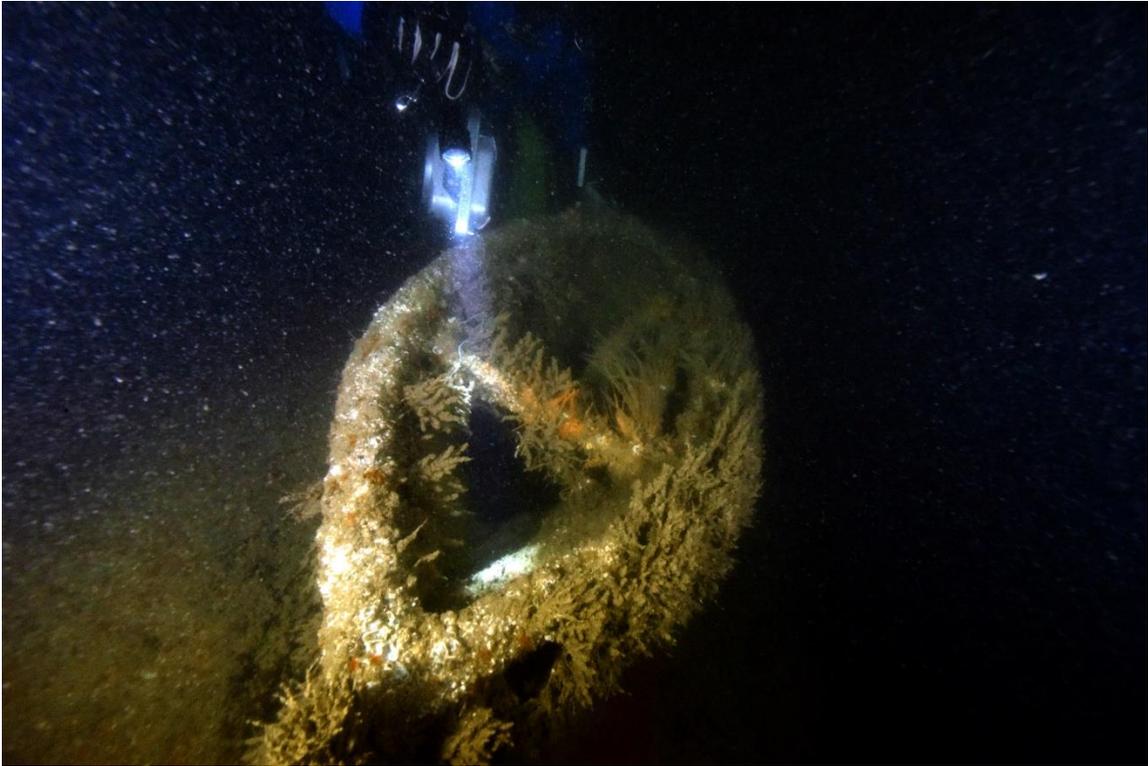
Measurements were taken it was 1.3m long and 0.58m at the widest point. The elliptical shape stood 0.45m high from the hull. See image below.

Figure 38 the elliptical metal shape on the hull (ASDIC) ©Martin Davies

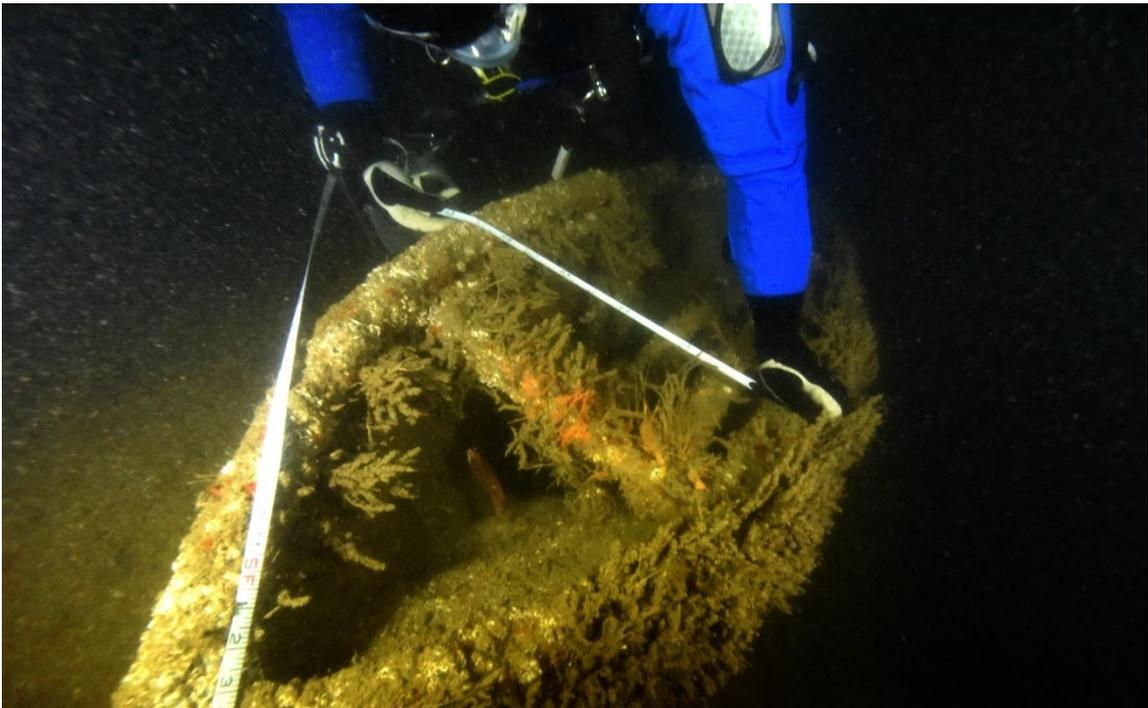
Figure 39 measurement being taken of the ASDIC mount ©Martin Davies

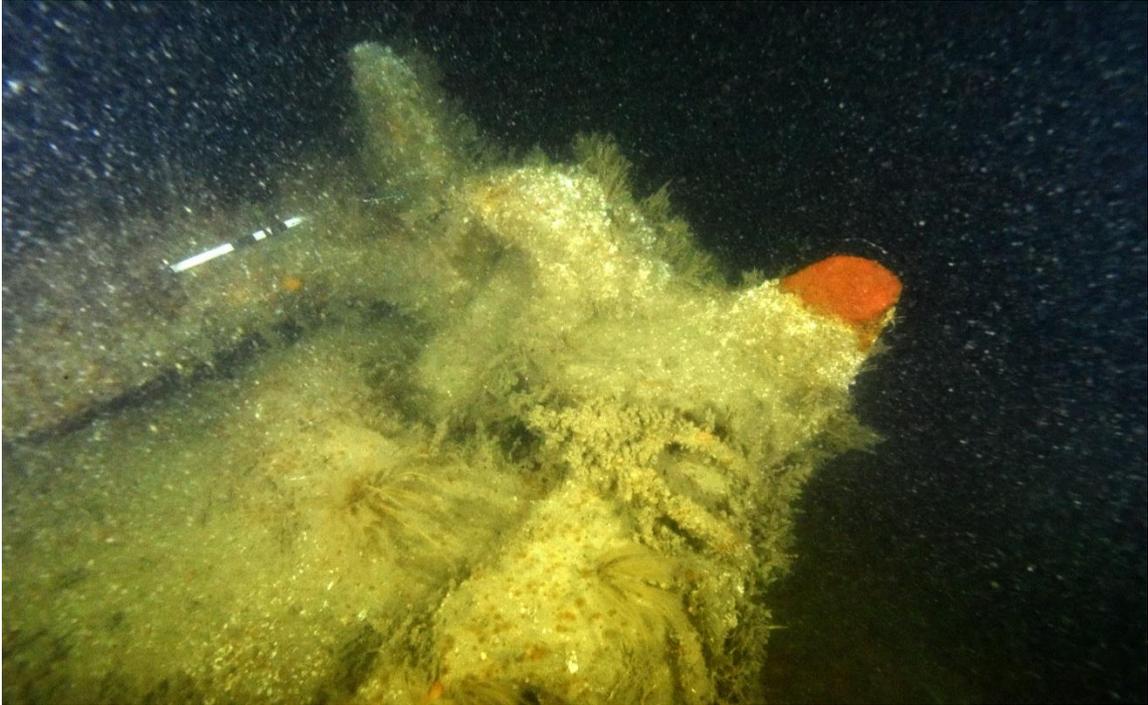
The other notable observation was one of the ship's anchors which was still stowed in place on the starboard side of the hull as seen in the image below.

Figure 40 starboard anchor still in place ©Martin Davies

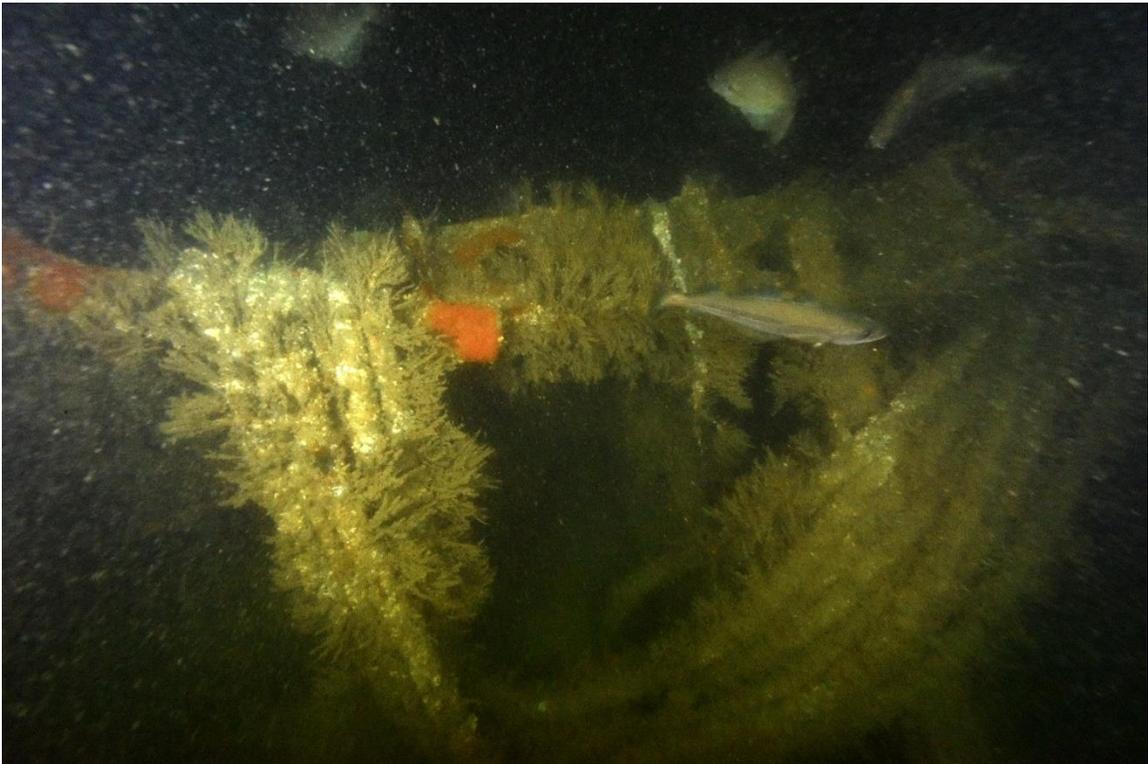
Figure 41 HMS PYLADES, degaussing cables. (Martin Davies)

Returning along the outer hull there were breaks in the fabric of the ship and some of the ship degaussing wire was observed, unsupported and hanging down (see above).

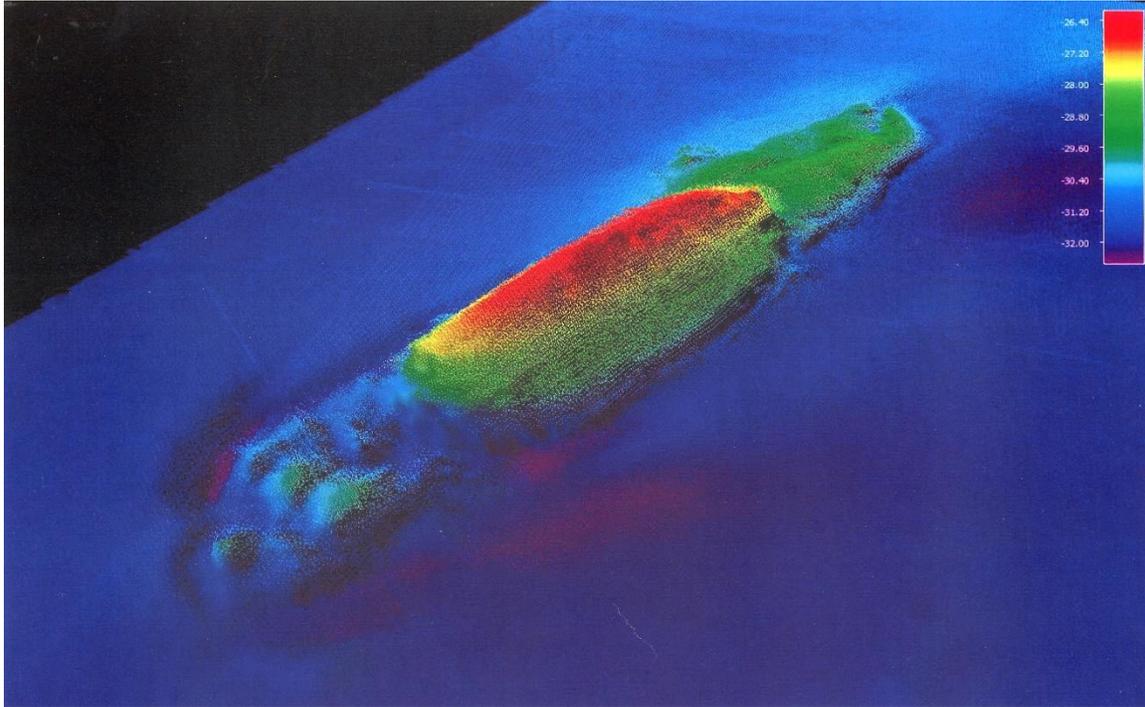
Figure 43 multi-beam image of MAGIC (EA3236). Courtesy of DRASSM

The overall impression of the wreck of MAGIC can be seen from the multi-beam image below. The wreck is not as complete as that of PYLADES with significant damage to the stern area. The bow has broken from the main hull structure.

The wreck site is 66m long by 14m wide and lies east / west, with the bow to the east.

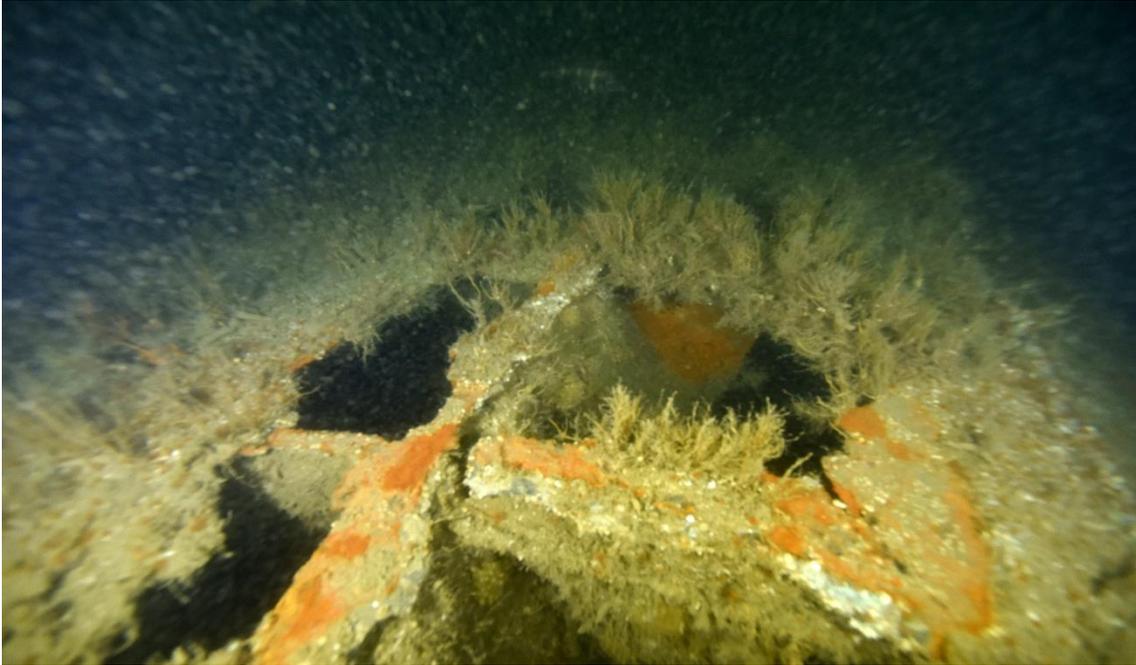
The top of the upturned hull being the highest point at 26m. The condition of the upturned hull is similar to that of PYLADES in that there are many access holes in the hull due to erosion of steel plating.

Figure 44. Numerous holes in the plating are visible along the length of the upturned hull ©Martin Davies

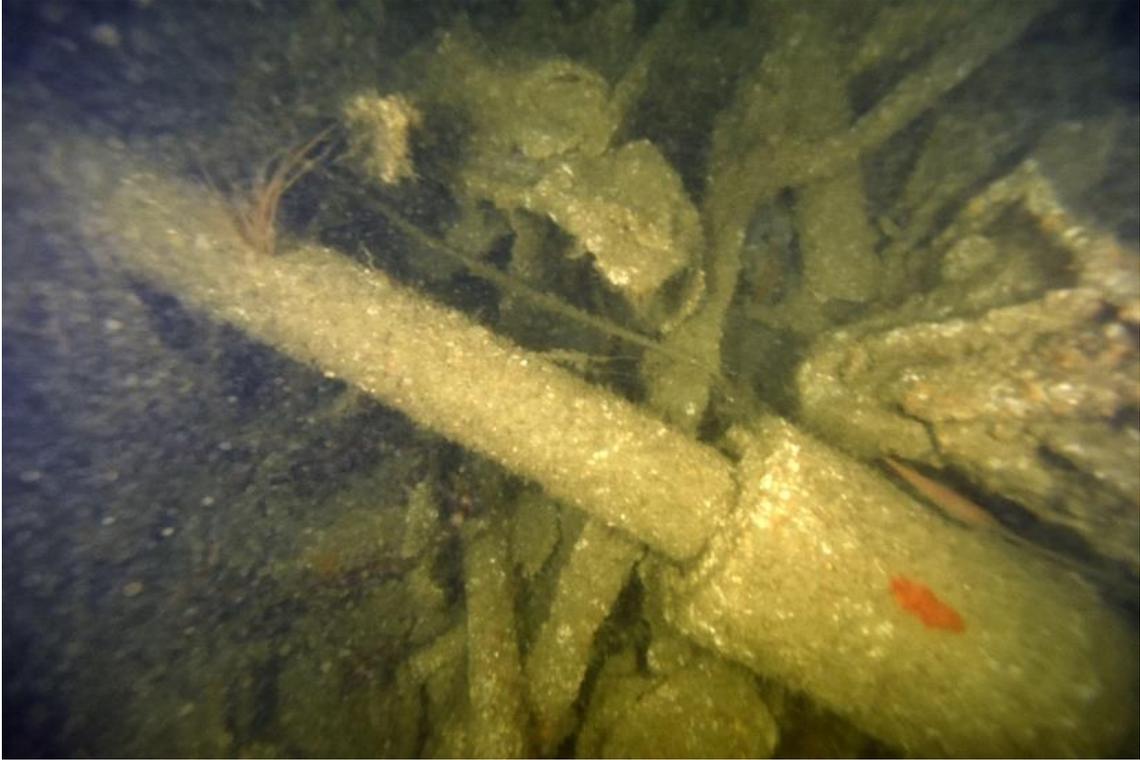
There is some evidence of the propeller shafts or part of them in this area and the main recognizable feature at the end of the wreck is one of the rudder posts still upright with the remains of a rudder visible.

Figure 45 Possible a section of one of the propeller shafts ©Martin Davies

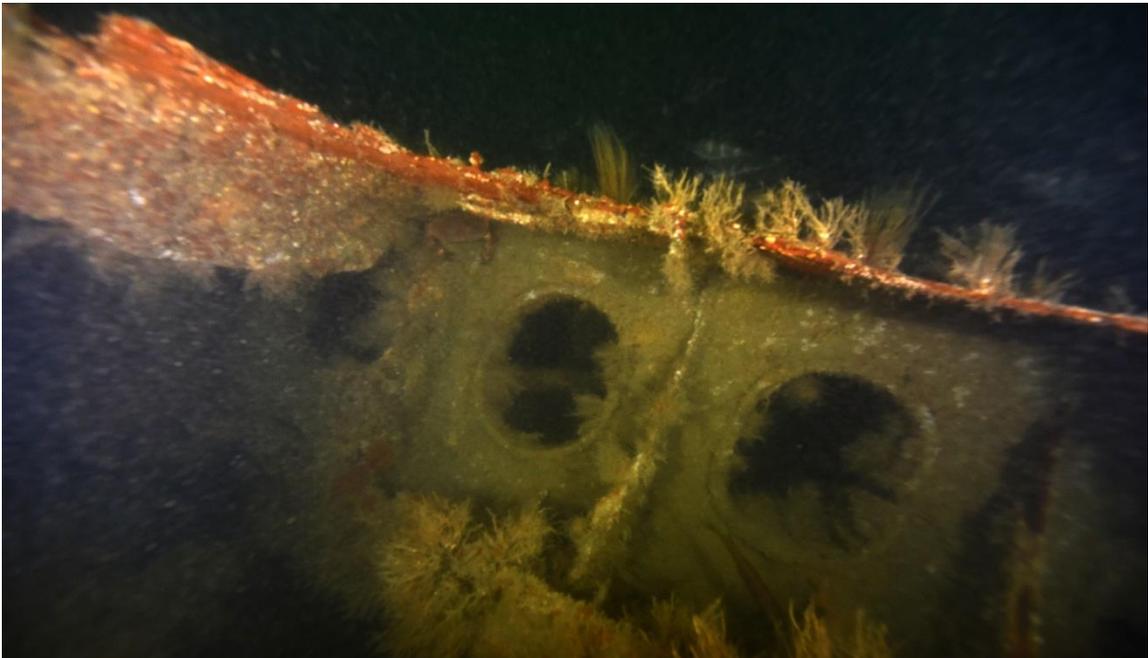
Moving forward over the hull some of the internal frames and bulkheads of the ship were still clearly recognizable. Some internal machinery was visible.

Figure 46 one of the internal frames now exposed ©Martin Davies

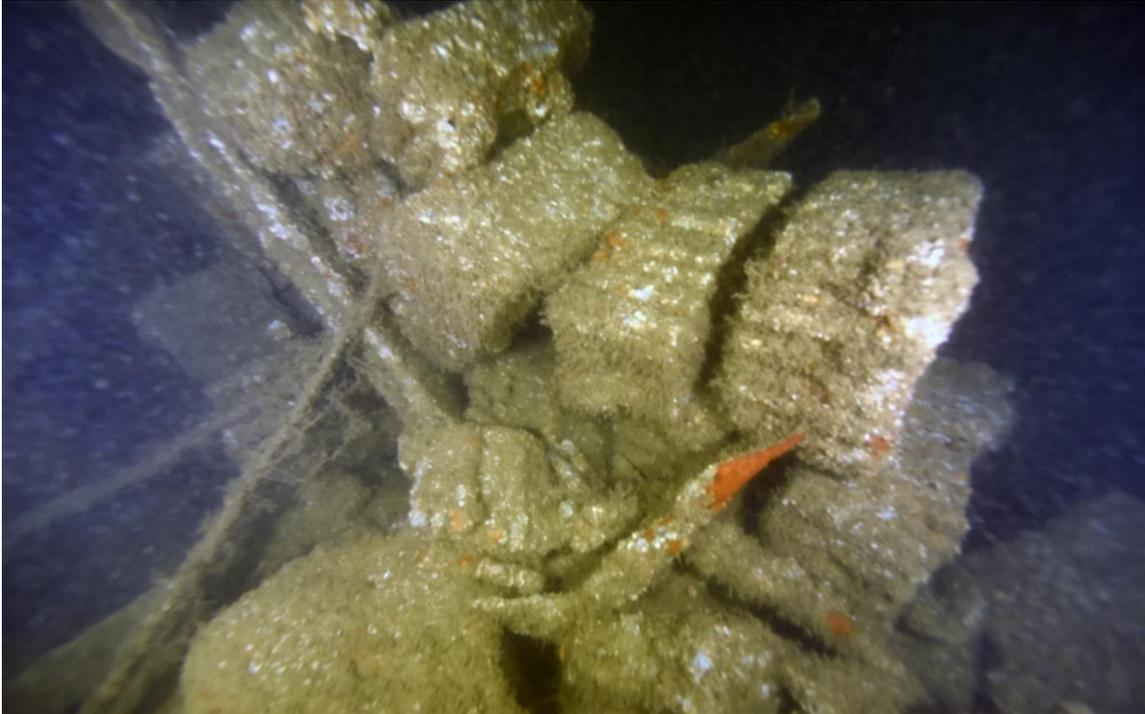
Figure 47 forward magazine with racks of 20mm ammunition ©Martin Davies

Moving forward towards the bow there is another area where there is a distinct break in the main hull and this area is exposed. It is unlikely the damage was caused by a torpedo as this would have triggered a large explosion and the damage would have been much worse. The fact that there are many boxes of 20mm ammunition neatly stacked suggests an alternate theory for the damage.

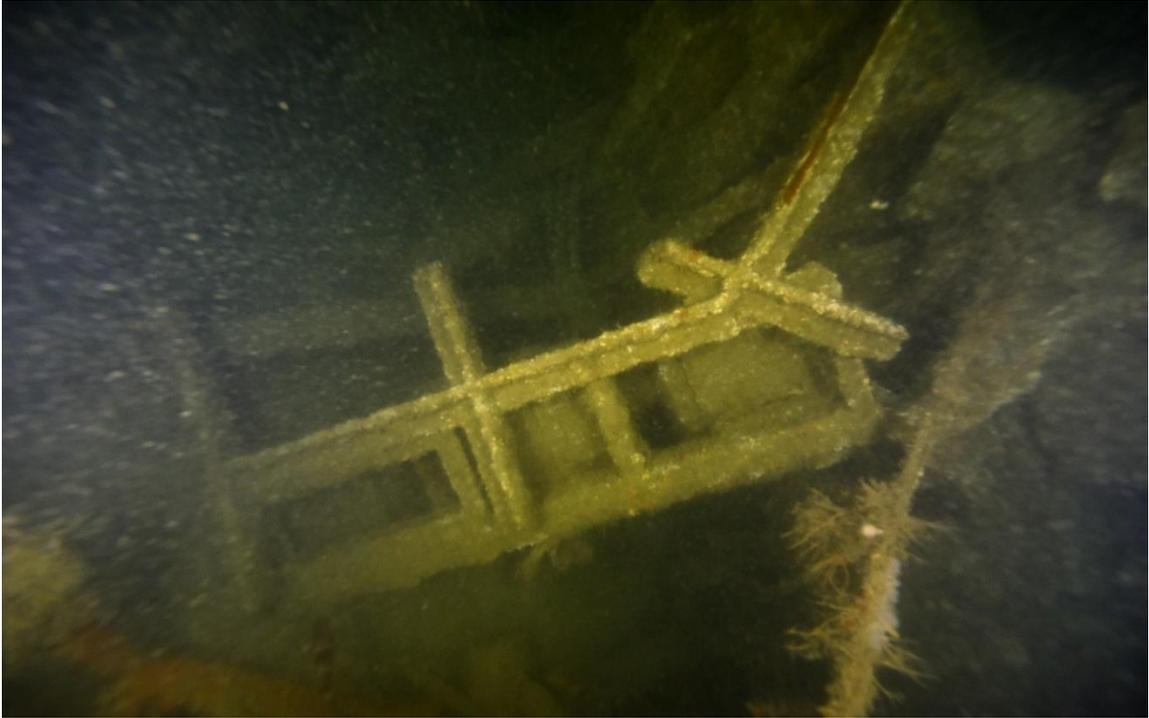
Figure 49 20mm ammunition shelf (©Martin Davies)

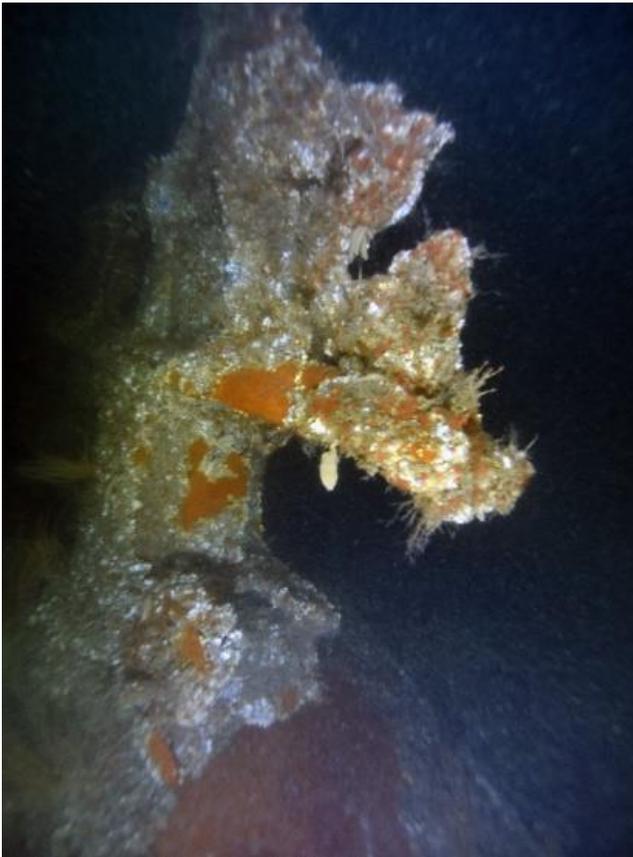
Figure 50 View of the rudder post standing upright (©Martin Davies)

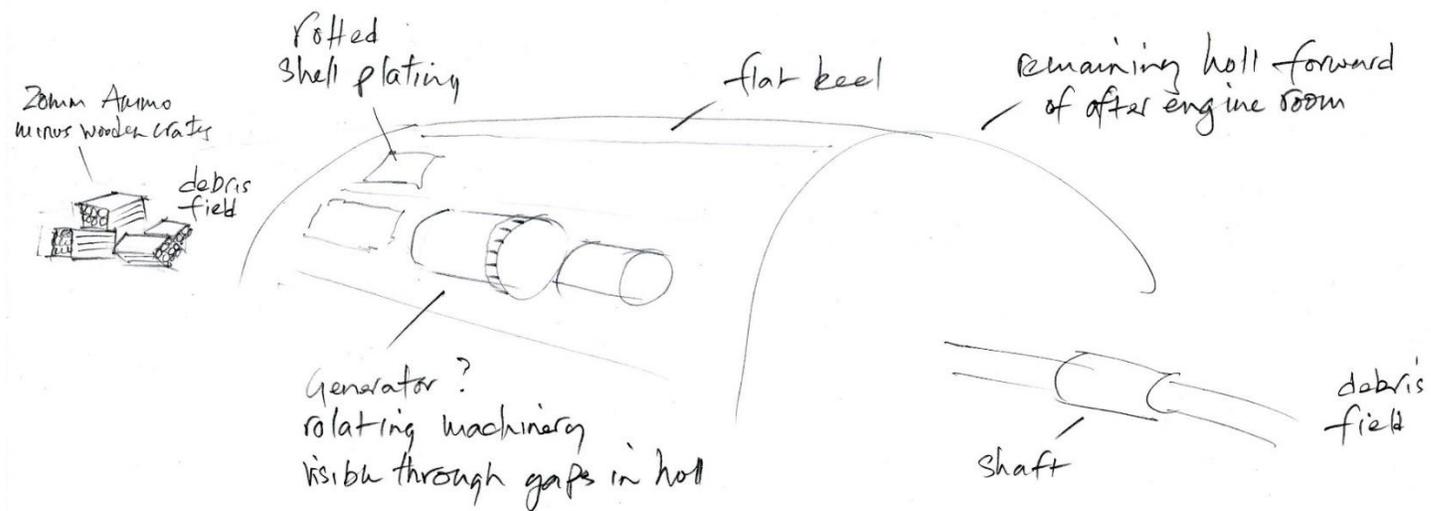
WRECK WAS AN UPTURNED HULL WITH BREAKS AHEAD OF THE STERN AND BOW. THROUGH THE GAPS IN THE HULL MACHINERY WAS EVIDENT. JUST AHEAD OF THE STERN THERE IS A GAP OF APPROX 6-7 METRES BEFORE THE RUDDER ASSEMBLY IS FOUND. IN THIS AREA WE FOUND WHAT LOOKED TO BE THE PROPELLER SHAFT.

TOWARDS THE BOW THERE WAS ANOTHER AREA WHERE THE HULL HAD COLLAPSED/WAS MISSING. IN THIS AREA WE OBSERVED A NUMBER OF RECTANGULAR BOXES. (? AMMUNITION?).

Figure 52 Sketch of the general lay out of the wreck of HMS MAGIC. (Tom Templeton)

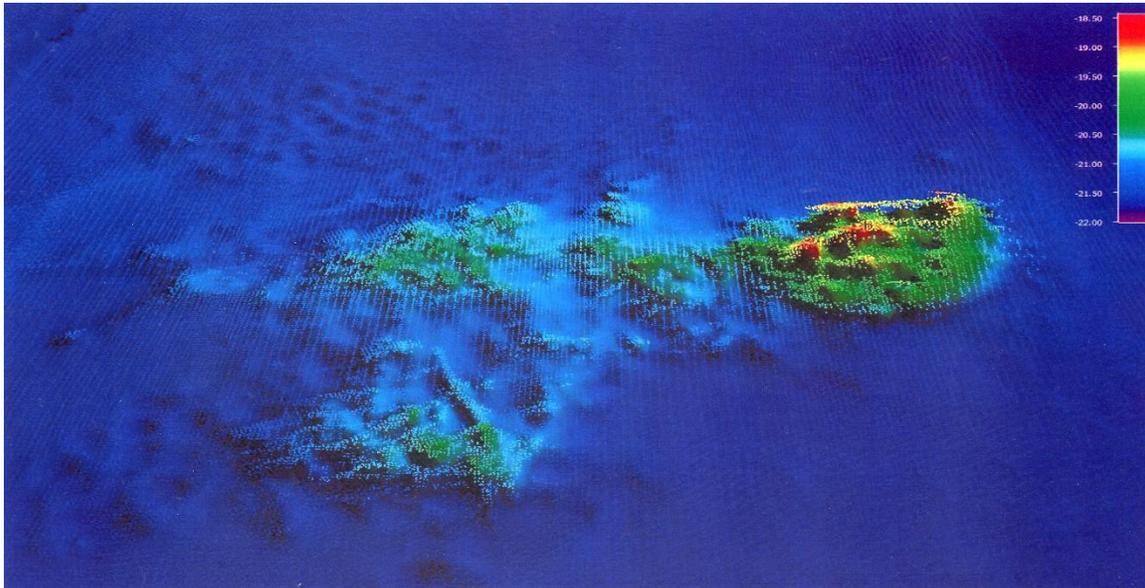
Figure 53 multi-beam image of CATO (EA3235) courtesy of DRASSM

The site was visited twice by the dive team. The wreck is very broken and the majority of the site is not recognizable. See below.

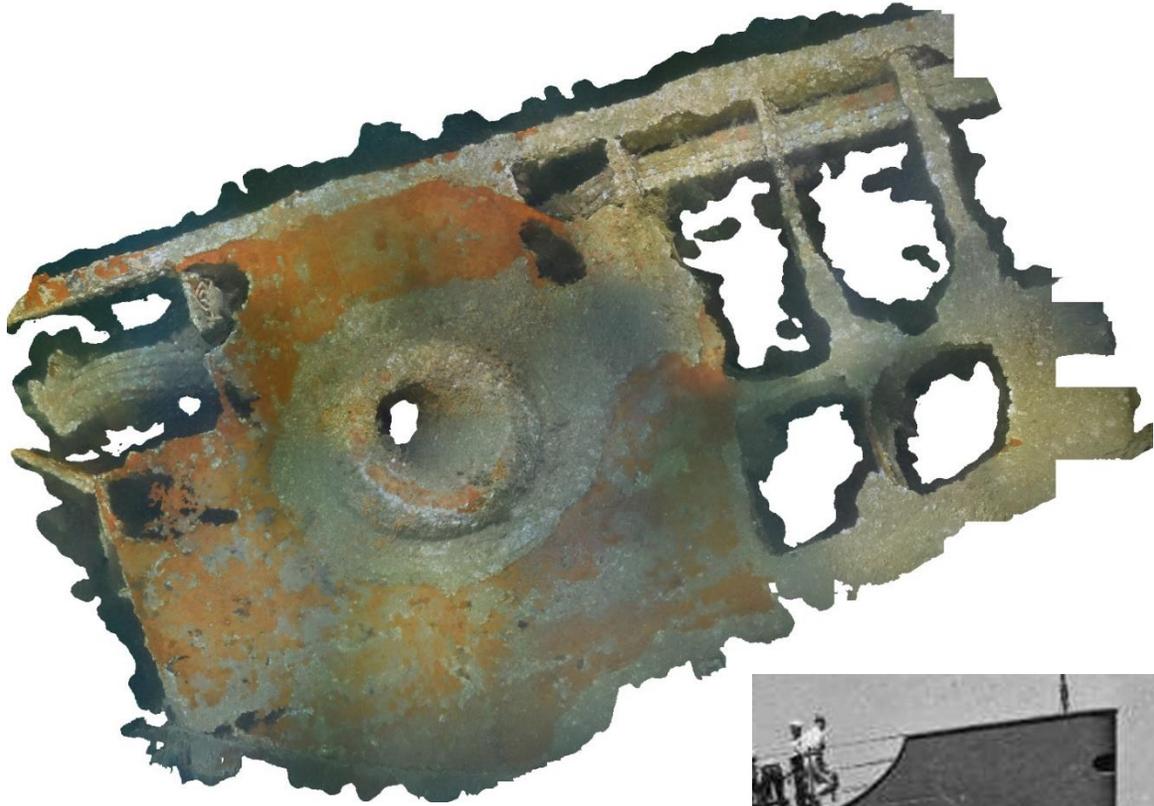
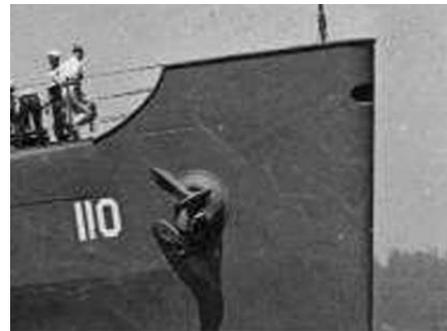
Figure 56 Photogrammetry - Starboard view of the bow ©Martin Davies Inset image of hawser and anchor at the bow of an Awk class minesweeper.

The above image clearly shows the remains and condition of the starboard side of the bow. Some exposed metal is red with rust where there is no concretion. Large holes have appeared in the hull plating where the hull material has degraded.

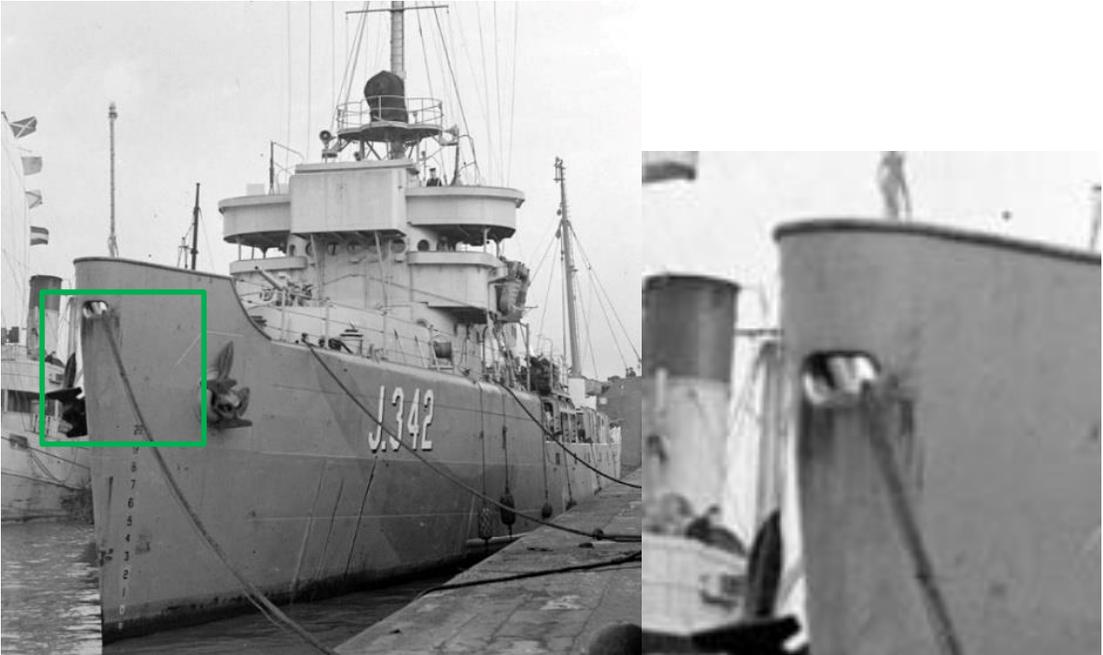
At the very front of the bow there is a large, distinctive oval shaped structure known as a 'Bullnose'. This would have been used as a guide for mooring ropes.

Figure 58 The Auk class 'Bullnose' - for mooring ropes.

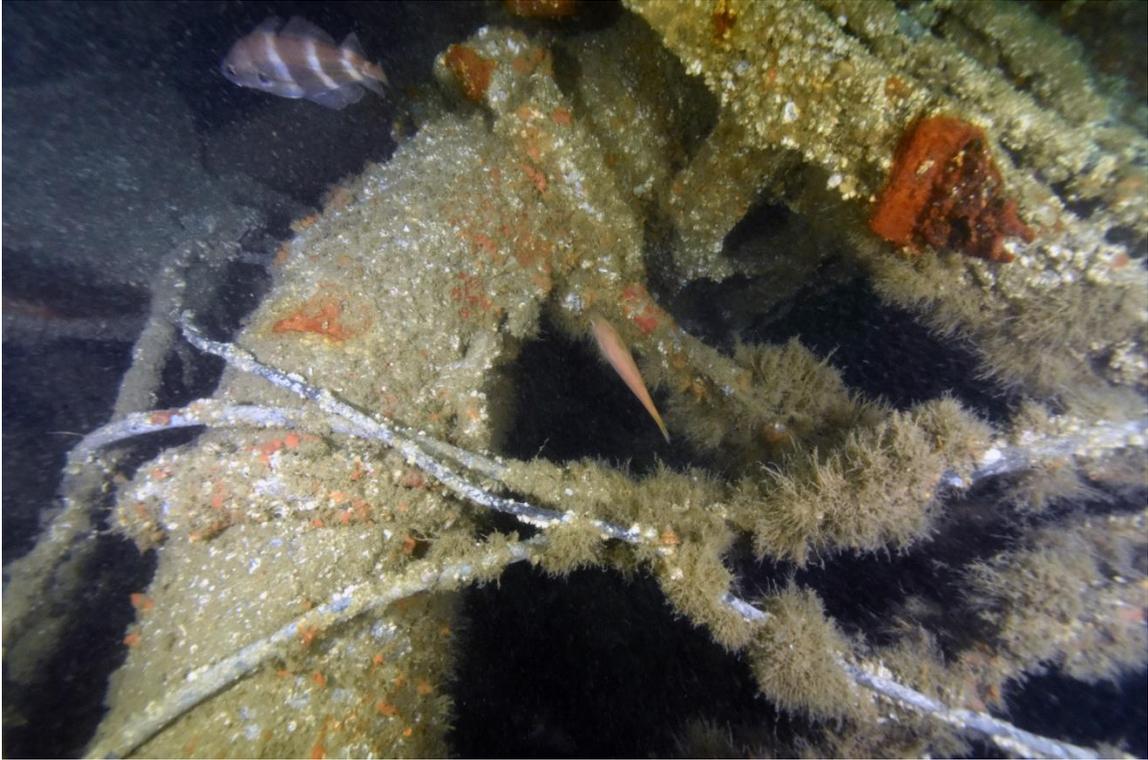
Figure 61 the chain guide to and from the chain locker ©Martin Davies

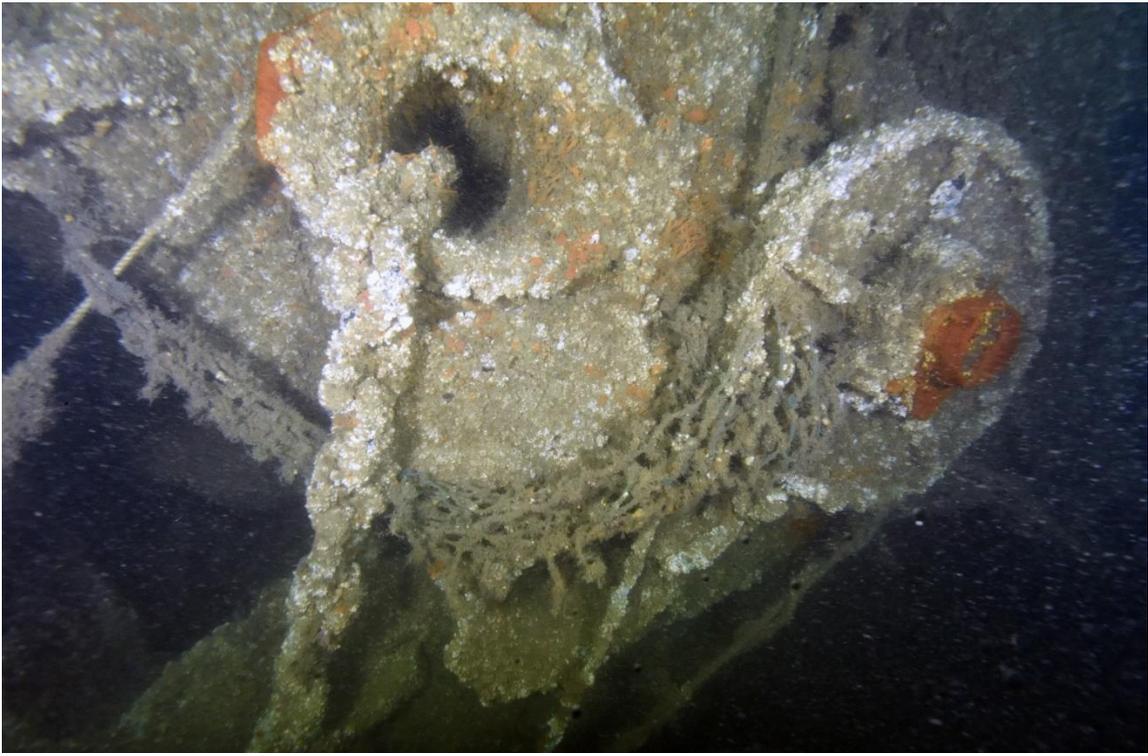
Figure 62 starboard anchor chain from the chain locker ©Martin Davies

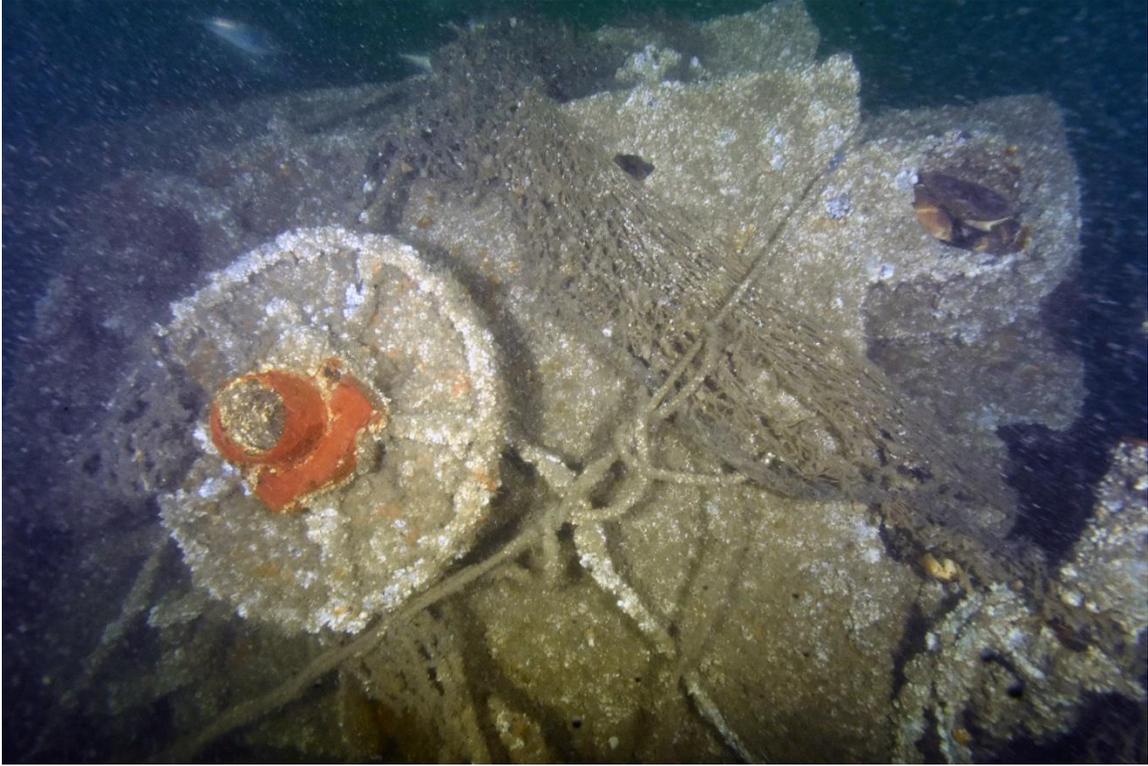
Figure 63 the anchor chain capstan winch ©Martin Davies

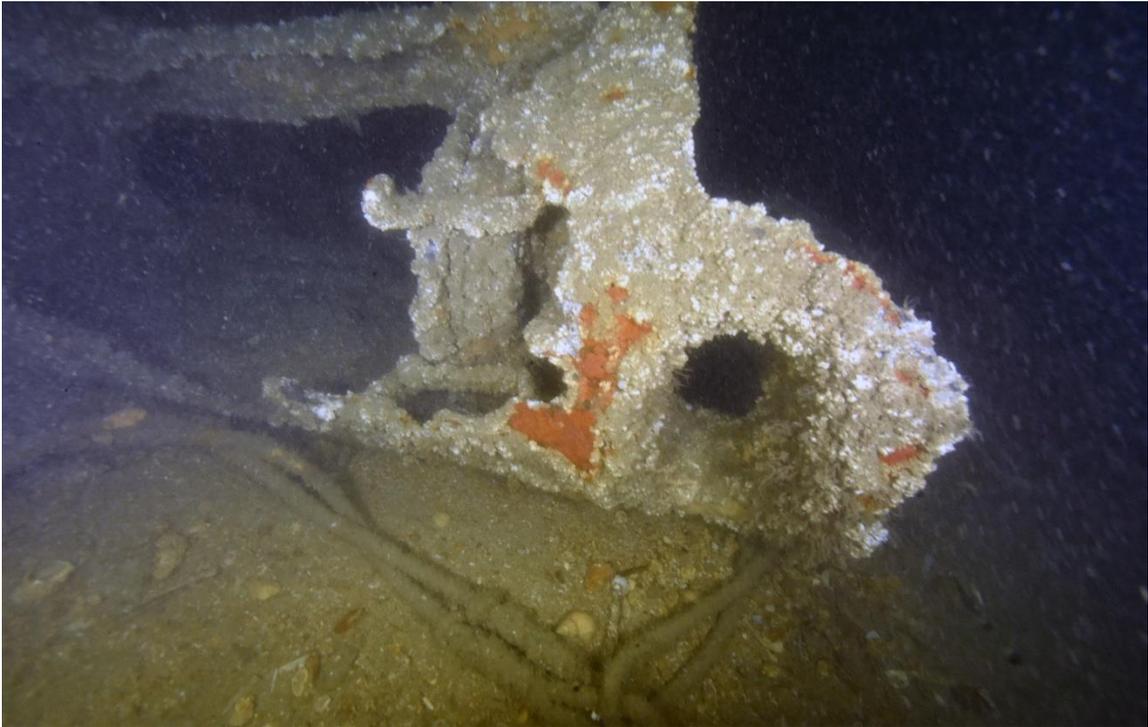
Figure 64 the bullnose of the ship ©Martin Davies

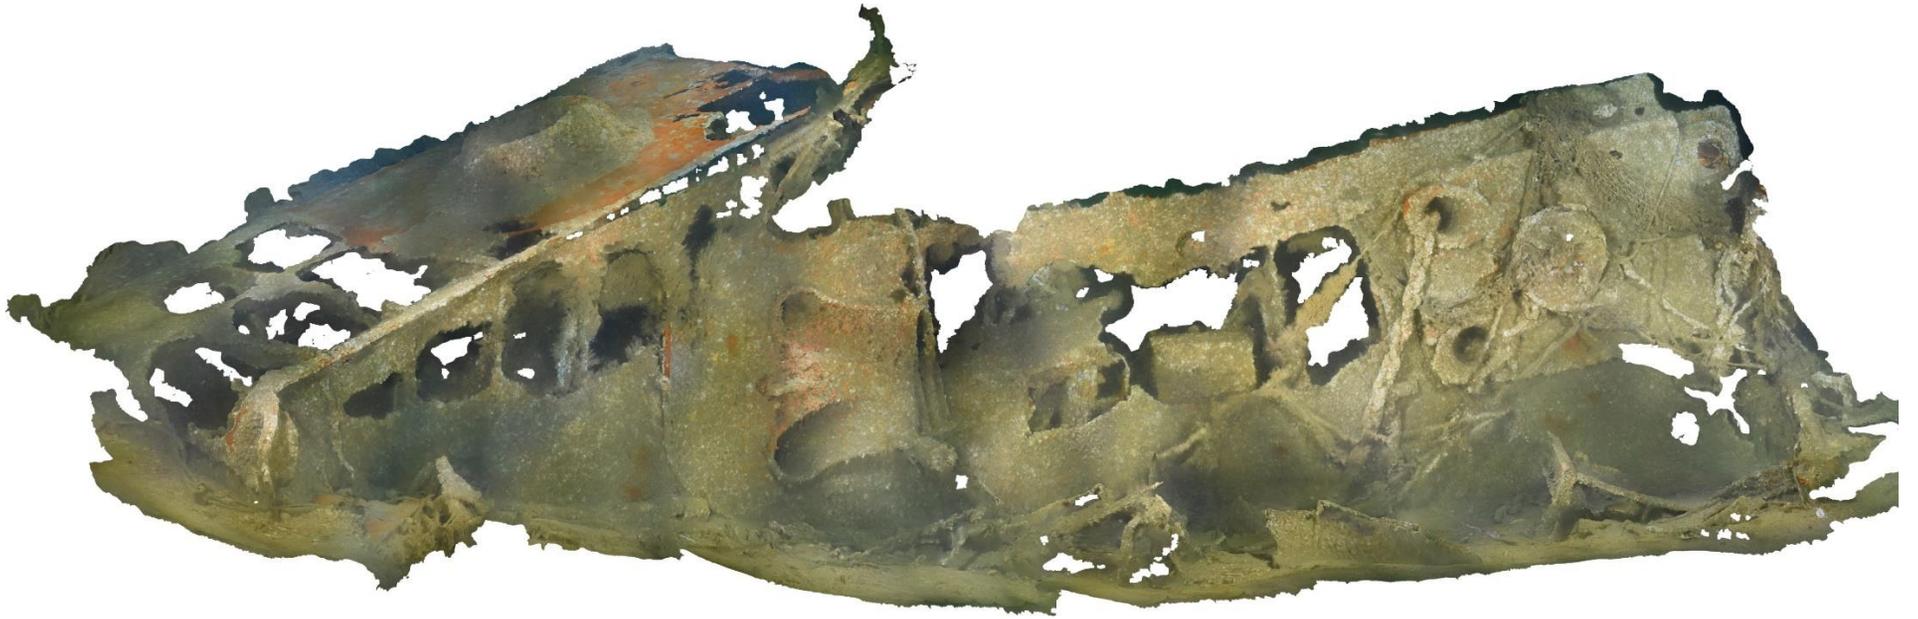
Figure 65 Photogrammetry image - side view of the bow of the wreck which rests on the port side. (©Martin Davies)

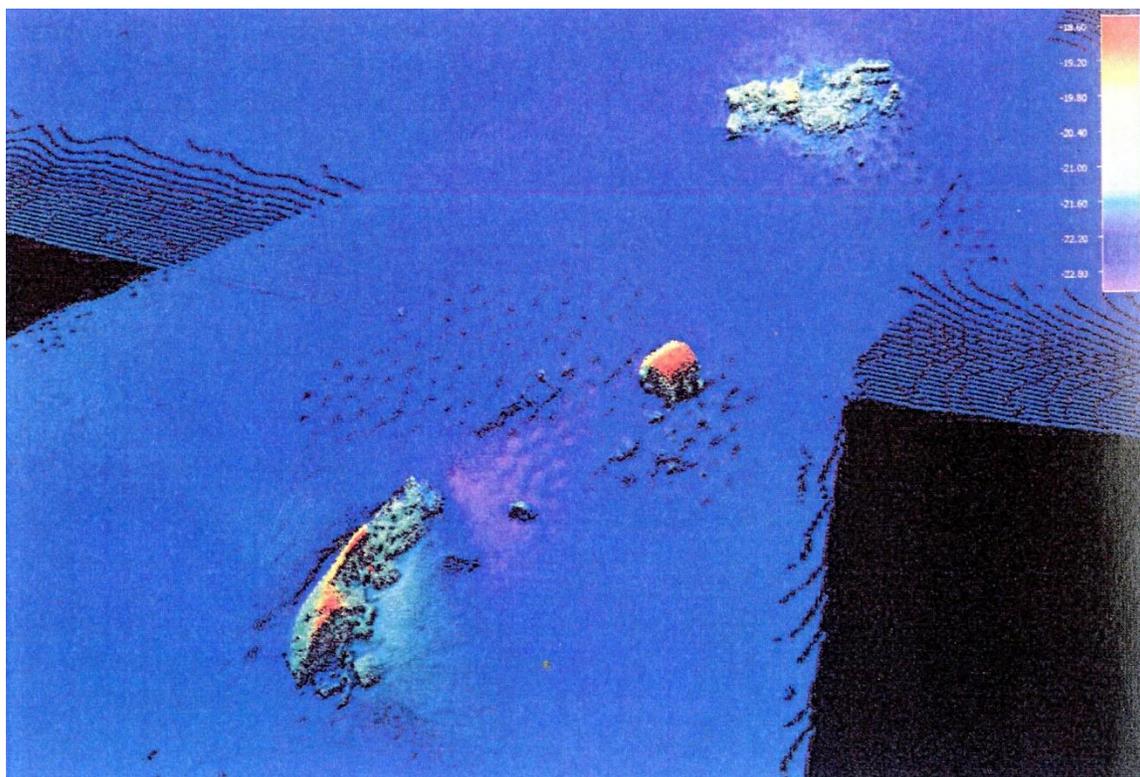
Figure 67 the wreck site known as Lord Austin, multi-beam courtesy DRASSM

A single dive was done on this site known as HMT Lord Austin, this consisted of a wreck site in 3 parts, as seen below.

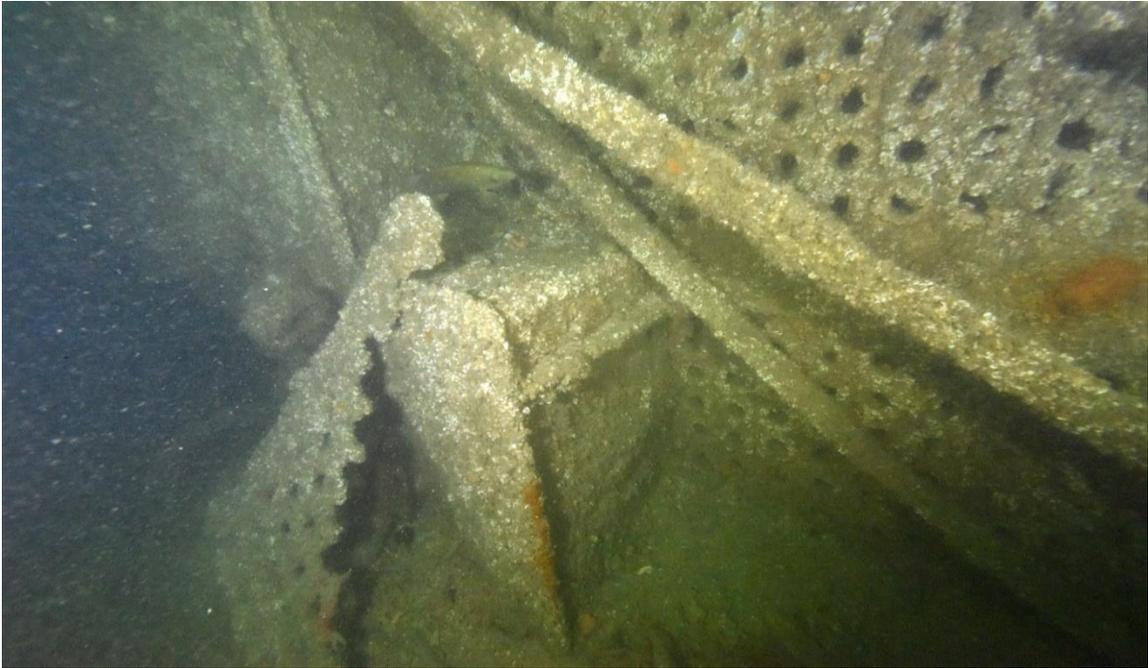
Figure 68 detail of the boiler construction ©Martin Davies

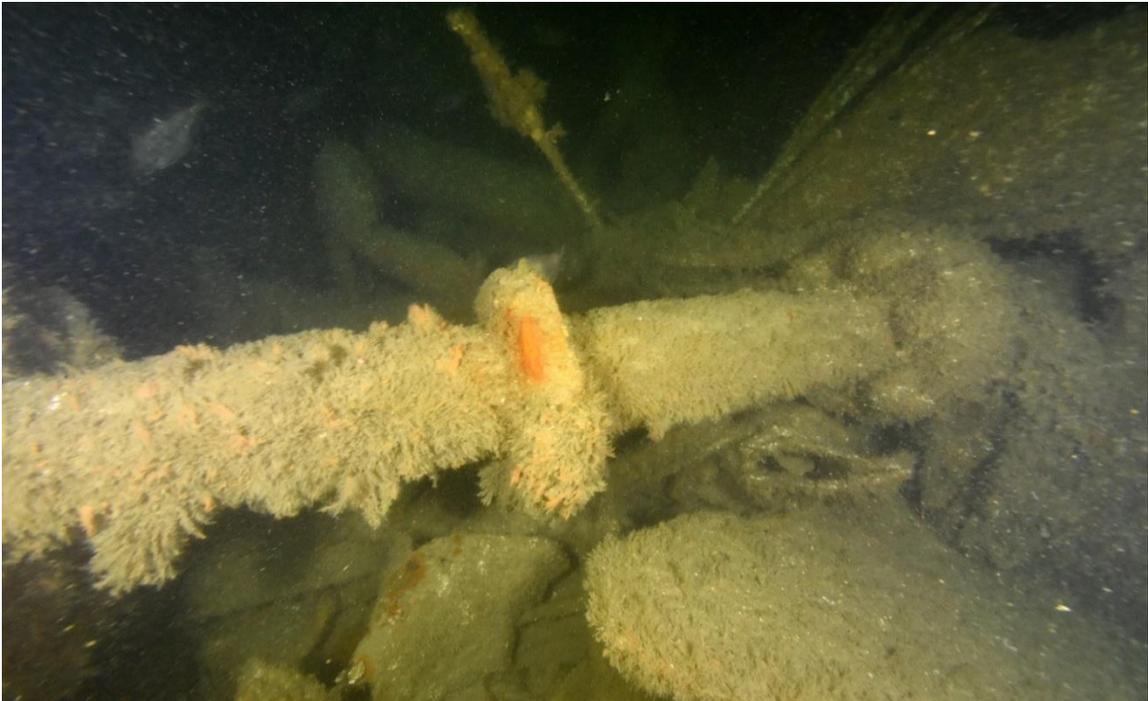
Figure 69 Propellor shaft and propeller blade ©Martin Davies

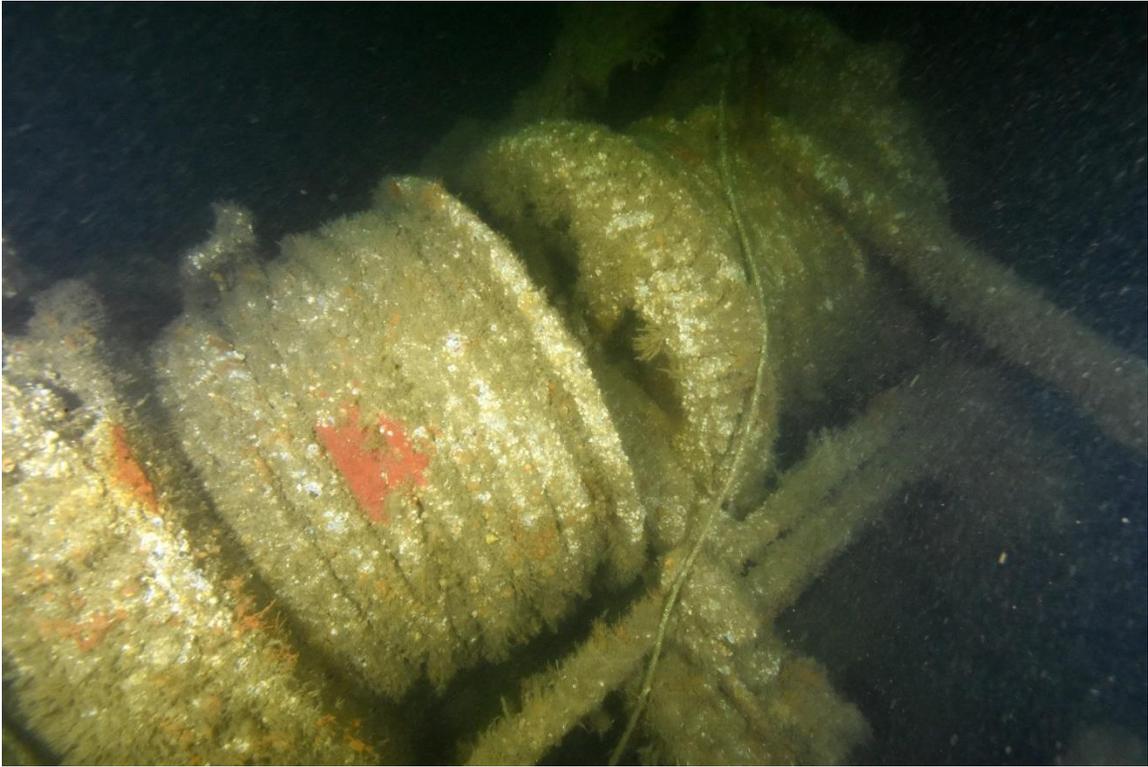
Figure 70 Heavy trawl winch used for minesweeping activity ©Martin Davies
