PROJECT CATO

A Southsea Sub-Aqua Club project

Martin Davies

November 2018

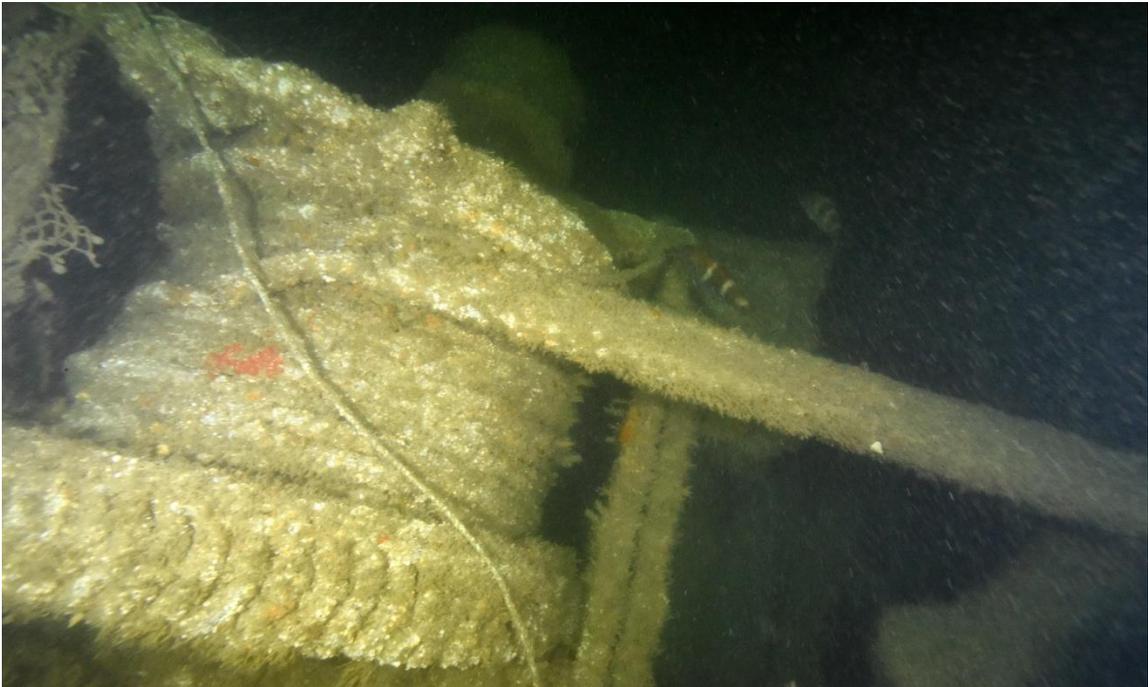
Figure 71 Detail of buoyant minesweeping electric cable ©Martin Davies
