## **NEPTUNE WRECKS PROJECT REPORT**

## Neptune Wrecks Project Report

### **Part 1 - Report Summary**

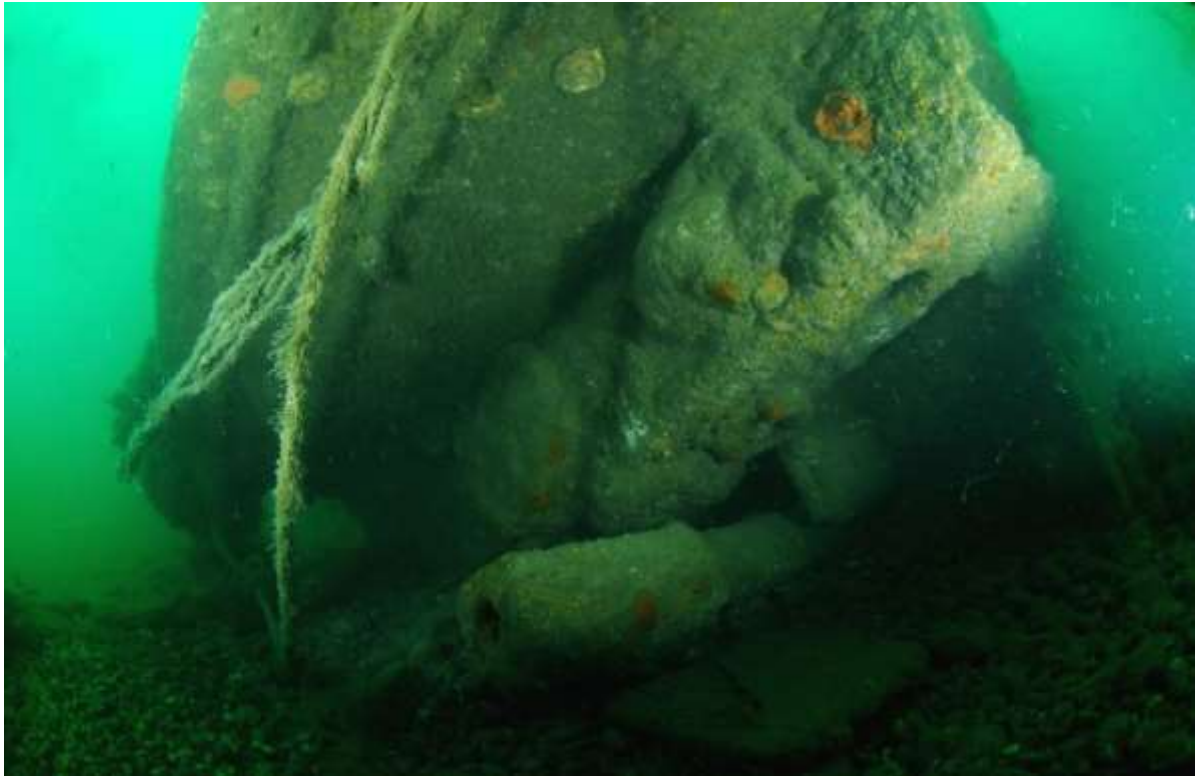
**Tank A** lies almost upside down and as a result much of the turret is buried into the sea bed. However there is one small open hatchway. The tank has lost much of its tracks and track pieces lie on the sea bed around the tank. It is not in as good condition as the other tank (B).

Image 1 – Tank A. Front view – (Image Martin Davies)

In this image you can see the open hatch above the gun and the hatch cover on the sea bed. You can also see the remnants of ropes which have been tied to the wreck. I believe these ropes to be from small dive boats who have secured themselves to the wrecks to conduct diving activities and then cut the ropes once divers have returned. There was evidence of both line and potting fishing.

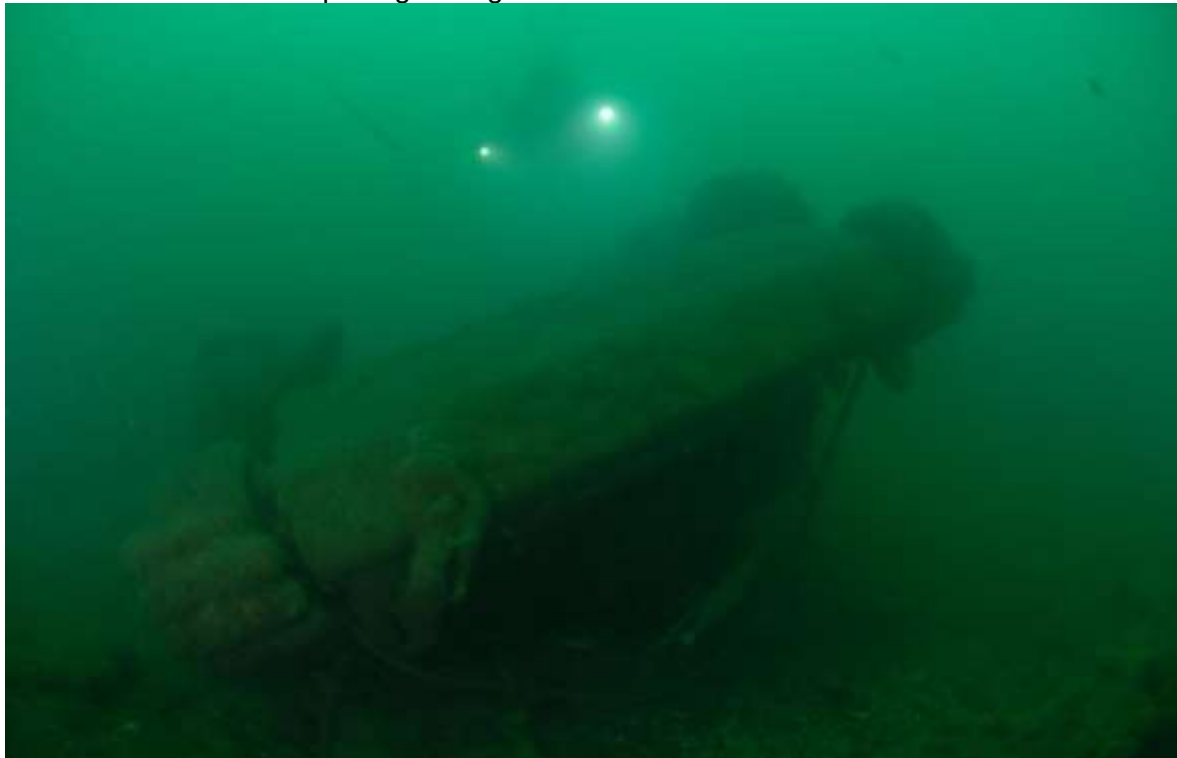
Image 2 Tank A front view (2) (Image Martin Davies)

In this image (2) you can see that the tracks are missing from the tank in many places. This may have been caused by the way the tanks were secured in the landing craft when it capsized but my belief is that it has occurred as a result of boats mooring themselves on to the tank. The underside of the tank is beginning to show signs of deterioration and holes have appeared in the plating though this also provides a excellent haven for marine life.

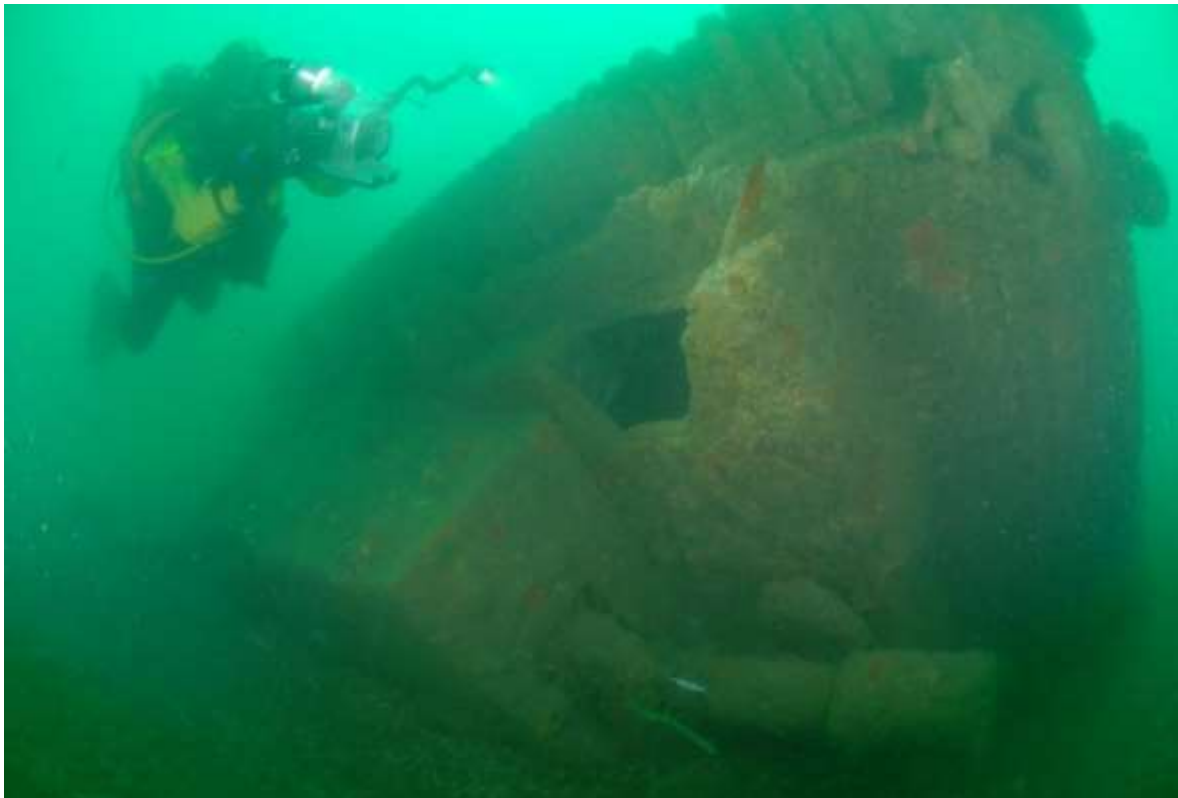
**Tank B** lies at an angle of approx 45 degrees and therefore the turret is more visible. The driver and turret hatches are open and it is also possible to see into the engine compartment. The majority of track is present though as with Tank A the plating on the underside is deteriorating.

Image 3 Tank B front view. It is possible to view inside the tank through the open hatch. (Image Alison Mayor)

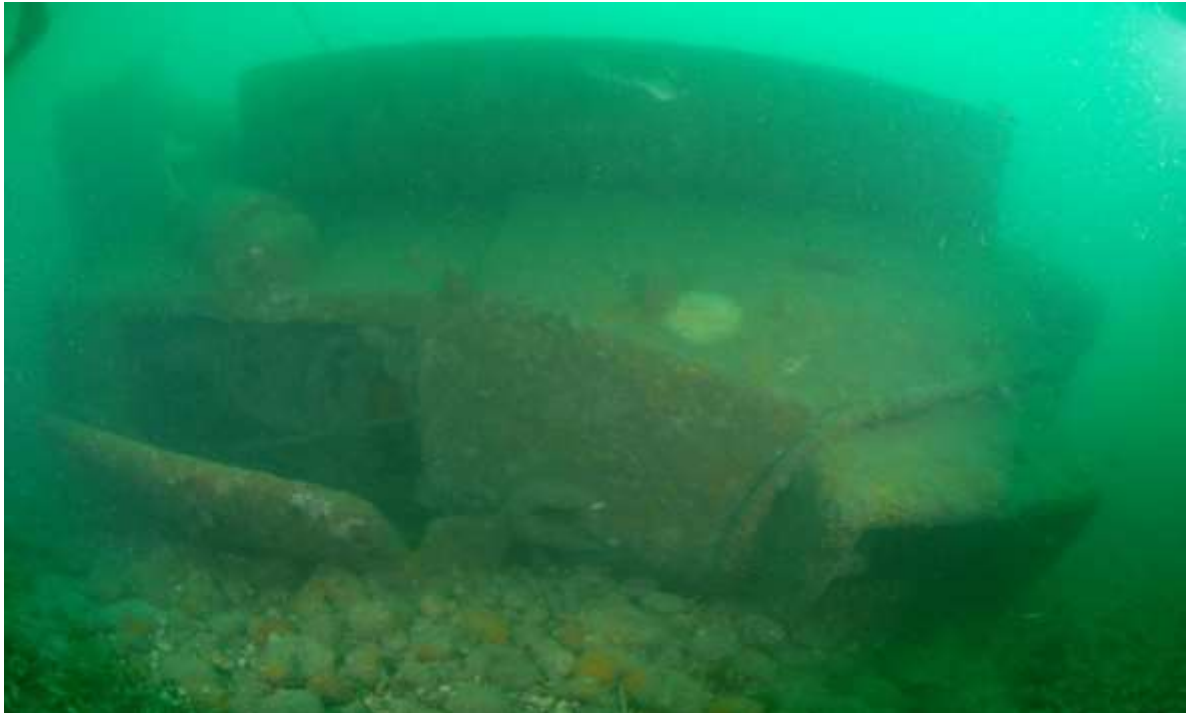
**Bulldozer A** is in better condition than the other bulldozer. It lies on its left hand side with its large plough/scoop pointing upwards. Other than the engine cover being open there is little sign of obvious damage, though underside plating is developing holes.

Image 4 Bulldozer A (Image Martin Davies)

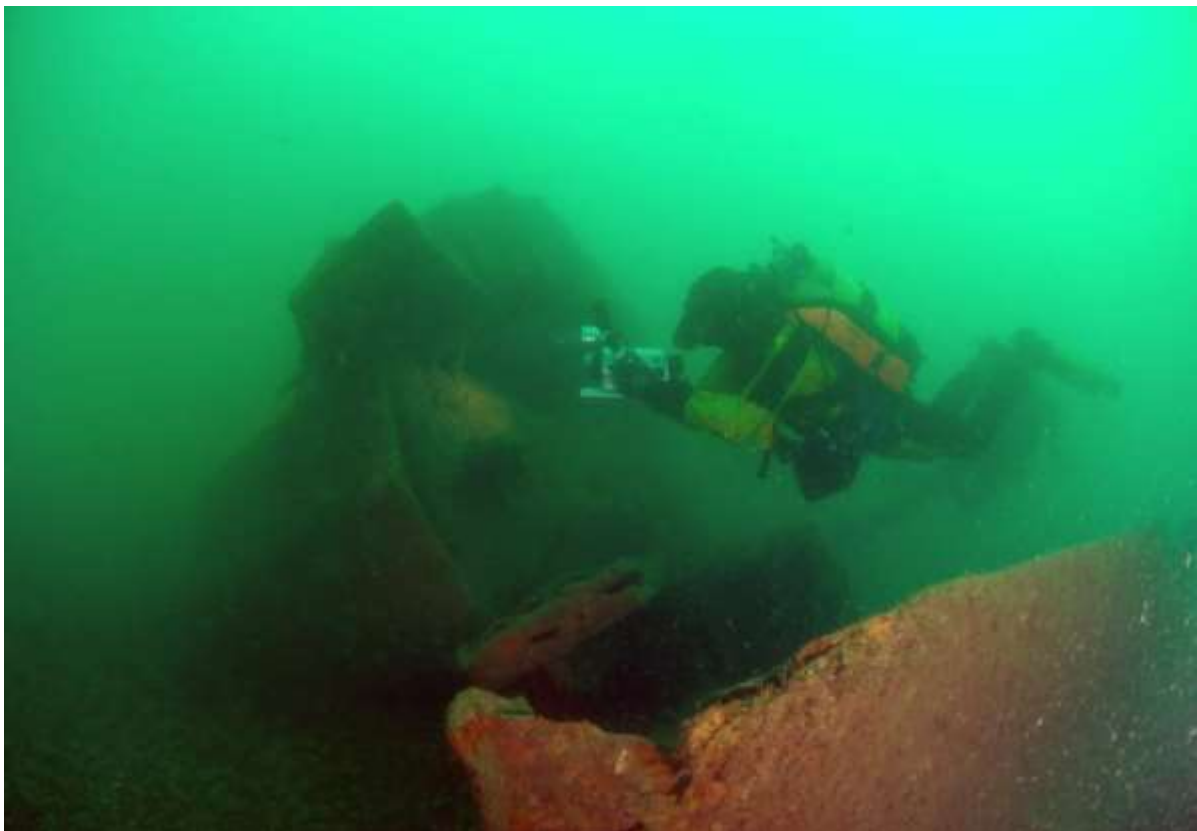
**Bulldozer B** Sadly the plough of Bulldozer B has broken off and lies on the sea bed just in front of the bulldozer. Anecdotal reports from regular divers said this happened in the last 2-3 years.

Image 5 Bulldozer B Front view. The blade/plough has broken off from the ramming arms. (Image Alison Mayor)

This is the most significant damage to the bulldozer and I can only speculate as to what had caused the plough to become detached. It could be from a boat tethering or anchoring in the area. I believe the plough weighs almost 3 tons

Care needs to be taken in the way boats anchor at the site, to either fish or dive. My opinion is that the majority of damage to the vehicles has been as a result of boats attempting to secure to the site for diving or fishing purposes.

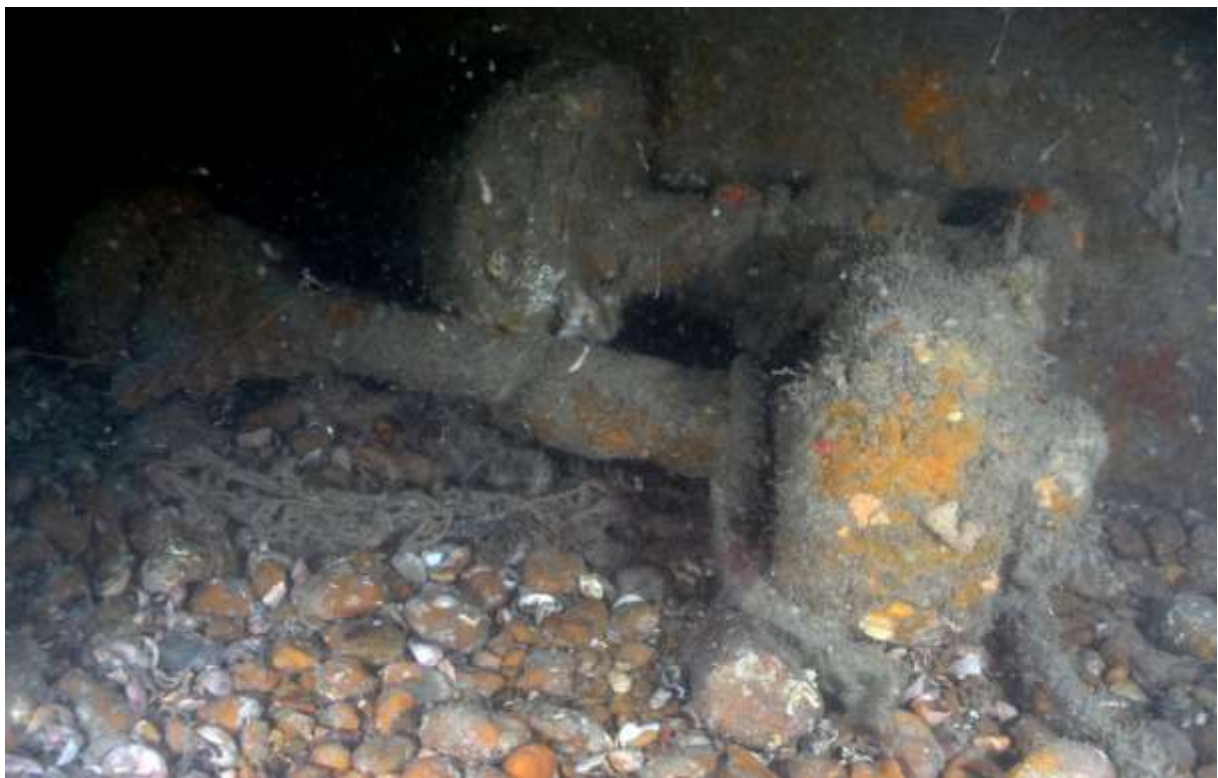
**4x4 car** -There is also the remains of a 4x4 car. Here again there is evidence of interference with ropes being tied to one of the axles. This axle is some distance away from the other parts of the vehicle.

Image 6 Car axle with rope lies alongside Tank A and several meters away from the rest of the vehicle. (Image Martin Davies)

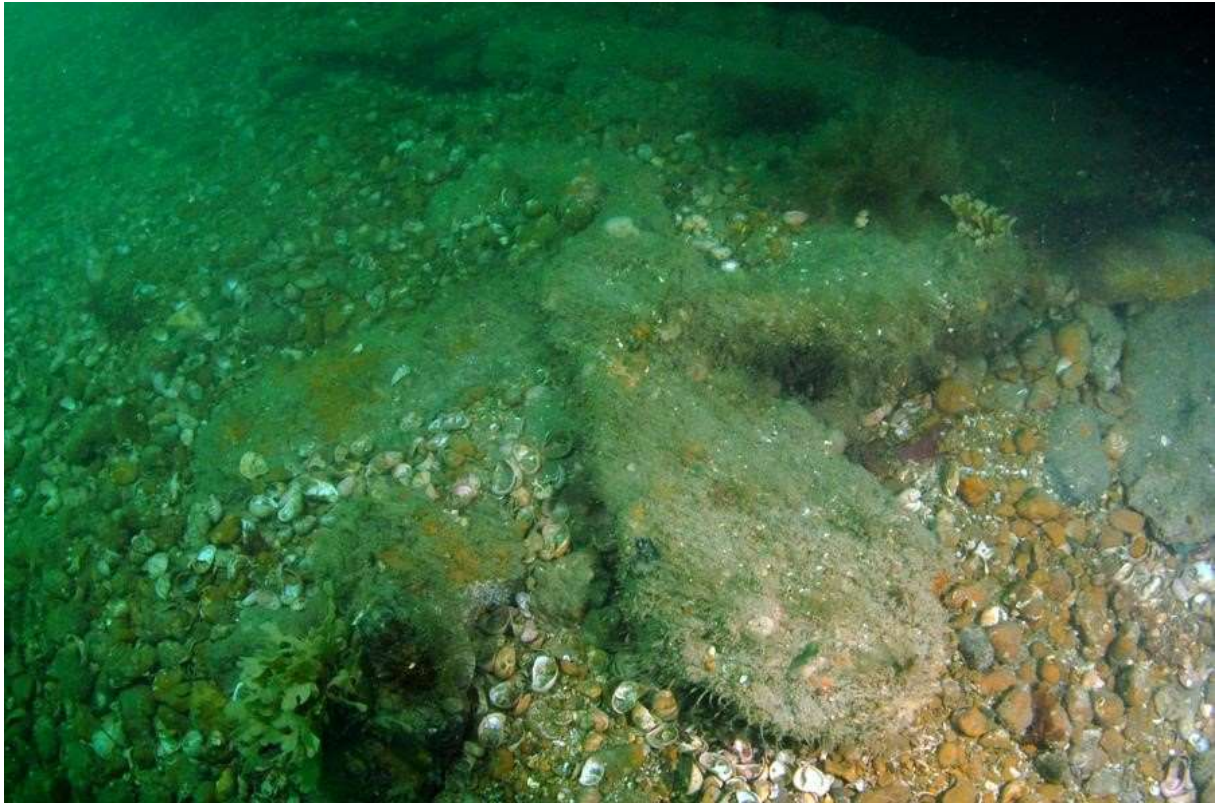
**Landing Craft Anchor and propellers.** We found 2 x four bladed propellers on the site of the same size that would have been used by a landing craft. (37" diameter). I don't believe them to be brass and therefore of little value commercially but are capable of being removed. The Danforth 'Kedge' anchor, of the size and type used by Tank Landing Craft, is located just behind the turret of Tank B. It would be difficult to remove because of its position. It is believed to weigh approx 7 cwt.

Image 7 One of two 4 bladed propeller (Image Martin Davies)

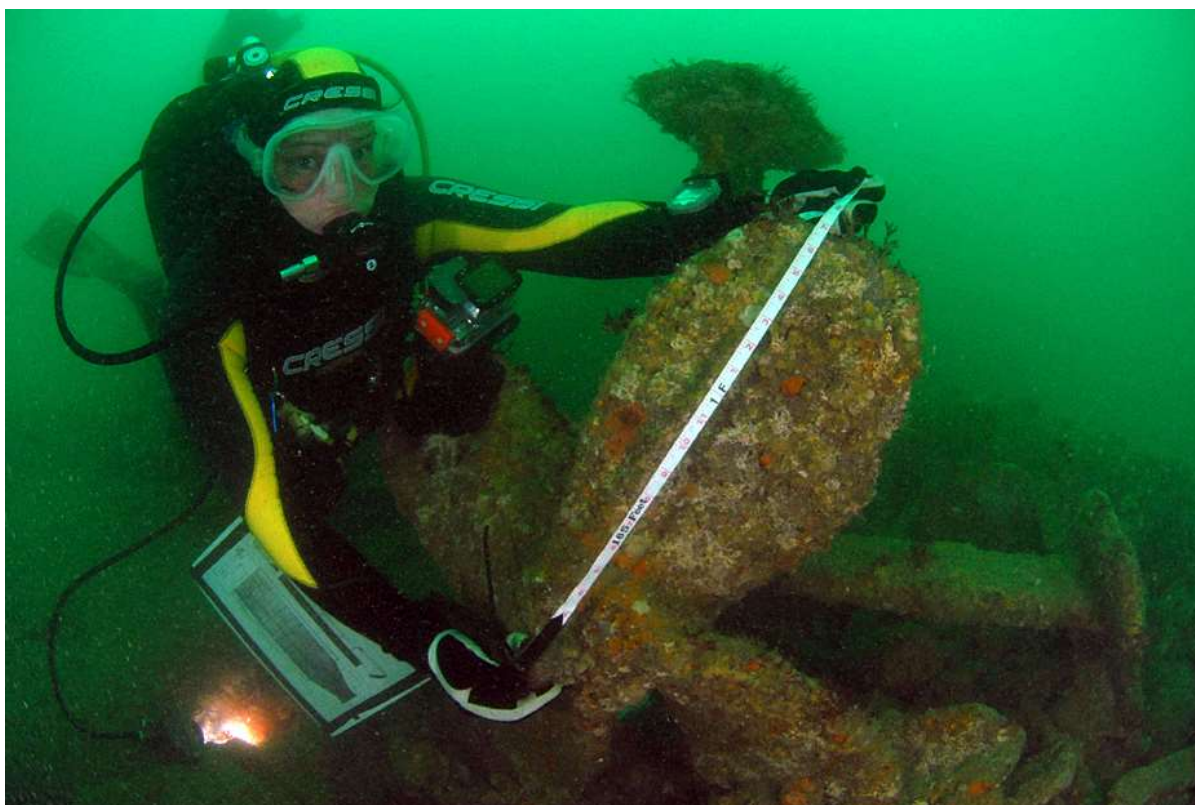
The general visibility on the site was around 3 to 4m; this was reasonably good for the area that the wreck lays. The wreck is difficult to find as there is not a great deal raised off the seabed. The stern area still forms a lump on the echo sounder as does the remains of the bulkhead structure which was nick-named the “goal posts”.

Figure 7 - Measuring the LCT propeller (Image Martin Davies)

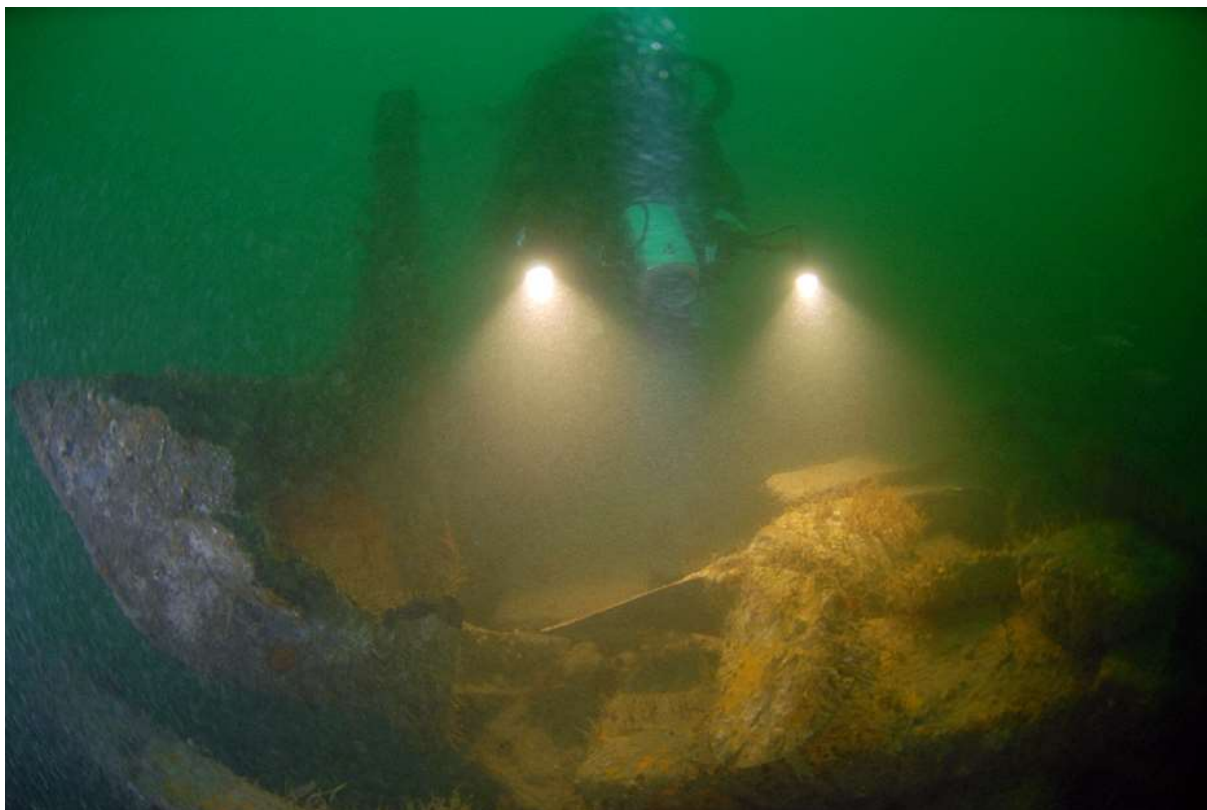
One dive was completed on this barge during the main survey. Reported originally as some kind of water/oil carrier the large cylinder has been wire swept and the cylinder was not evident on the wreck. The Barge lies at 20m and was dived on slack water. The structure that is left is mainly the ribs and bulkheads, it is not clear whether the barge was propelled or towed, and a lot of the structure has collapsed inward. Some artefacts were seen around the perimeter and embedded in the seabed which is hard clay covered in shingle. The barge sits upright. The site has been fished heavily and there is a lot of line and pots around and over the wreck.

Figure 8 - Poor visibility at the site made video and photography difficult videoing the barge spare propeller (Image Alison Mayor)

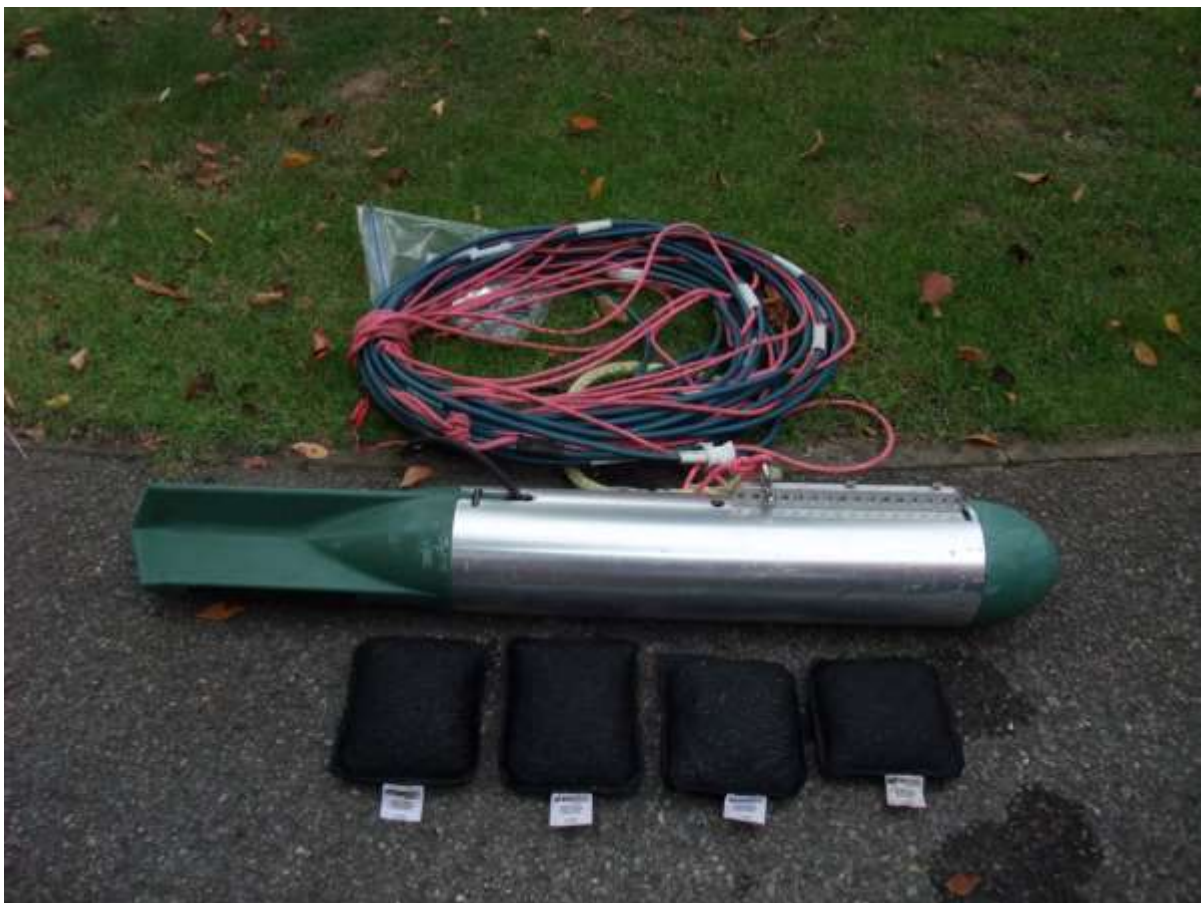
The Nautical Archaeology Society (NAS) had recently acquired a side-scan sonar and kindly let us trial it for our survey in return for a small donation. We tried out the equipment on three occasions with increasing success as we got used to the equipment. We learnt that conditions need to be very good to obtain reasonable results and the attitude of the 'tow fish' in the water and speed of the boat are critical to obtaining good results. With a degree of trial and error and plenty of patience we have some good images of some of the survey sites and also others we used in the practice sessions.

Figure 9 -Side Scan Sonar equipment kindly loaned by Nautical Archaeology Society (NAS)

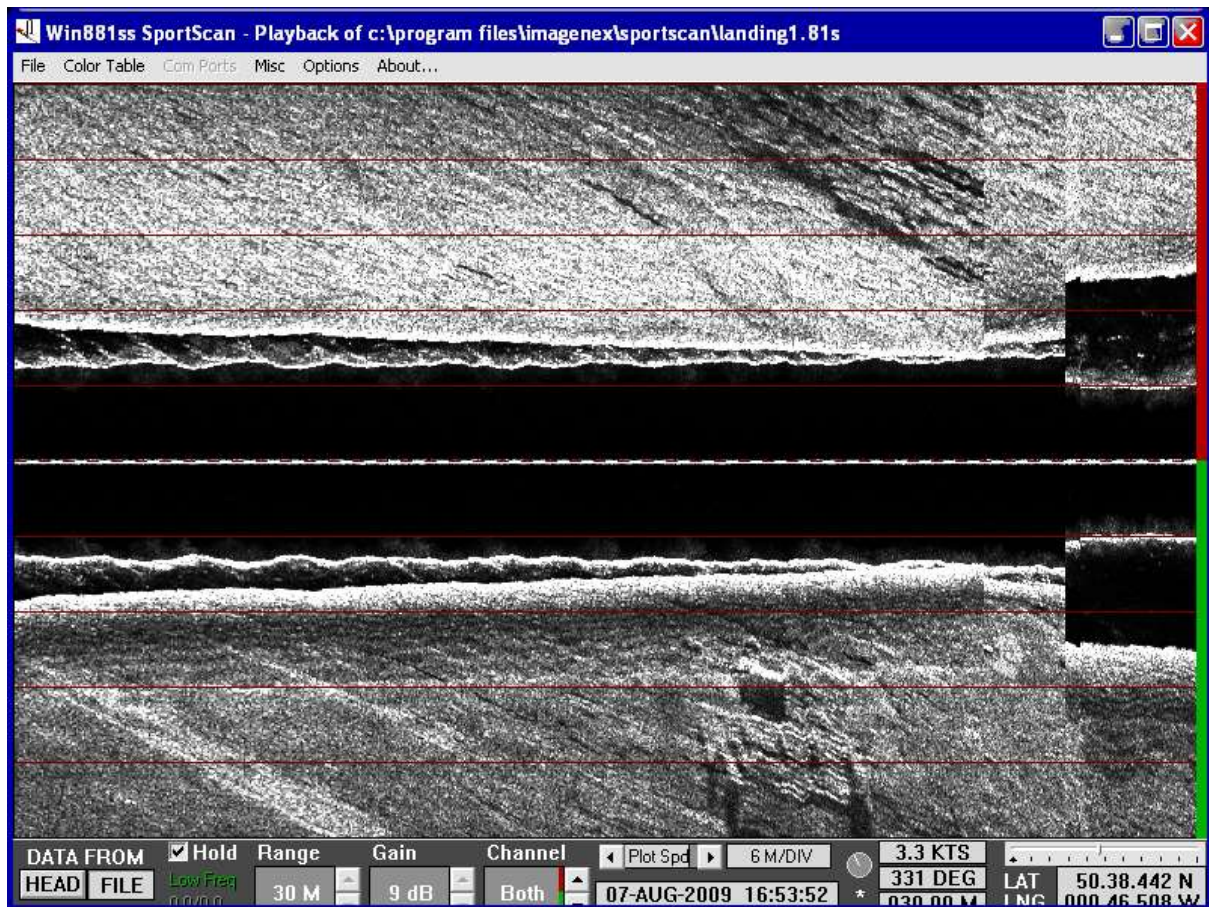
can be found. To the left and right of the 3 engines are sections of bulkhead and armour plating.

Figure 14 Side Scan Image of the Landing Craft site 20004.

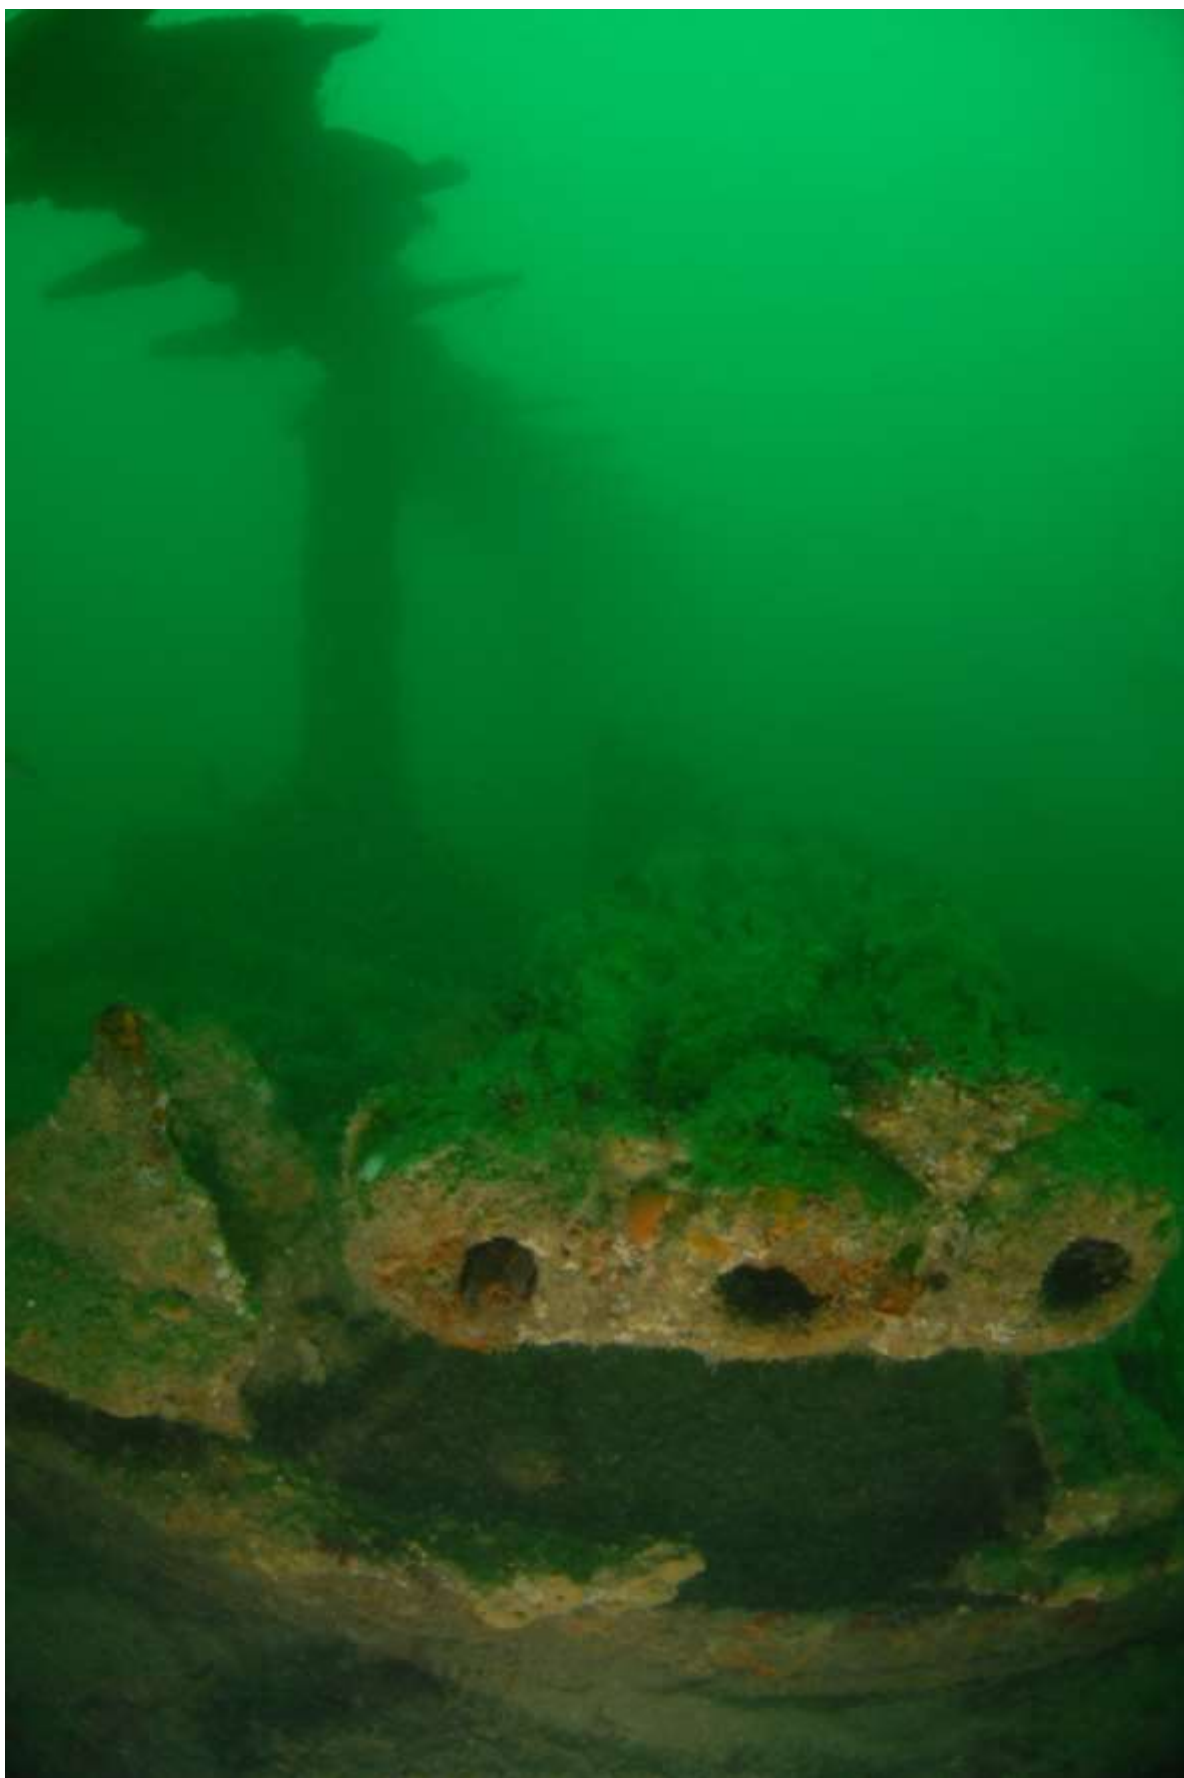
There were 2 pieces of wreck structure which resembled 'goal posts' at the site. The first set, nearest to the shot line was easily identified as it had 3 pipes which ran along its length. They both measured 9.8m (32 feet 6 inches) wide which closely matches the beam or width of a LCT Mk 5. These are assumed to be the remains of bulkheads separating the 3 sections of landing crafts construction.

Figure 15 Image of the 'Goal Post' 1 showing the three pipes that run its length. (Image Martin Davies)

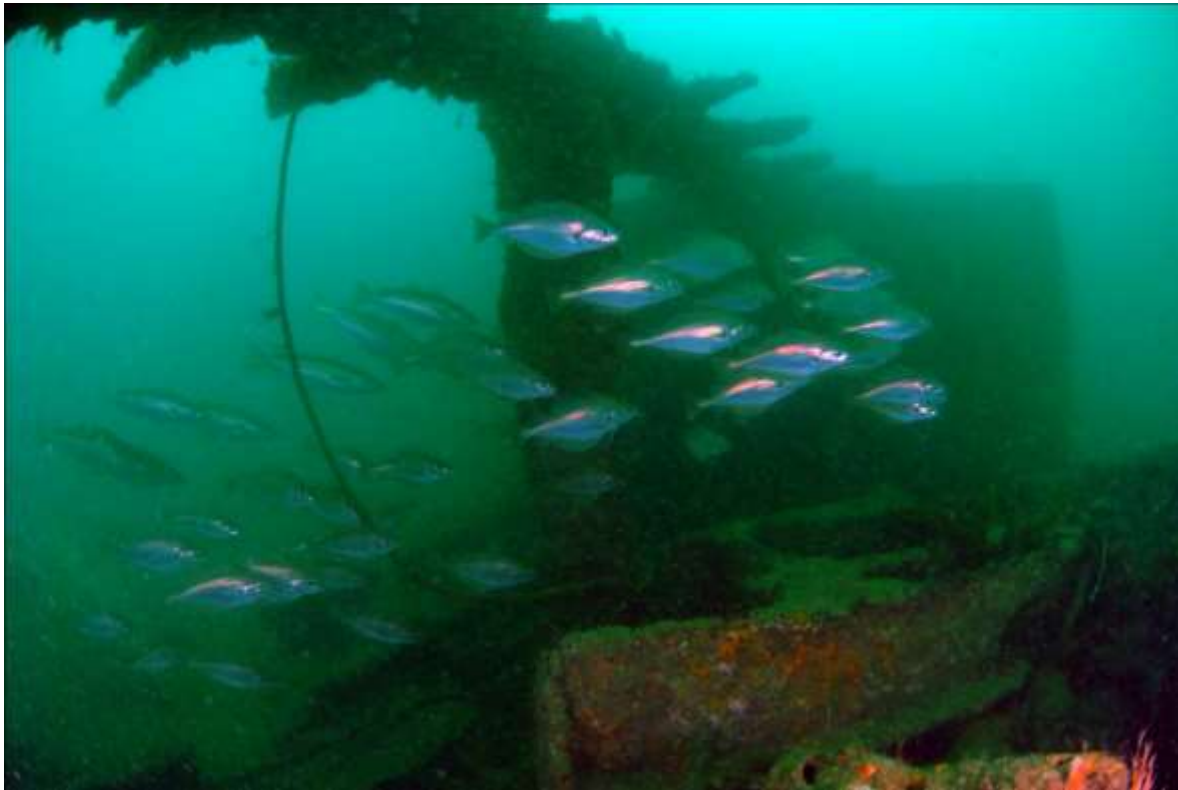
The 2<sup>nd</sup> goal post was close to the engines and at right angles to them. There were some remnants of the sides and armour plating attached to this bulkhead.

Figure 16 - Goal Post 2, showing debris field near engines and part of vessel side (Image Martin Davies).

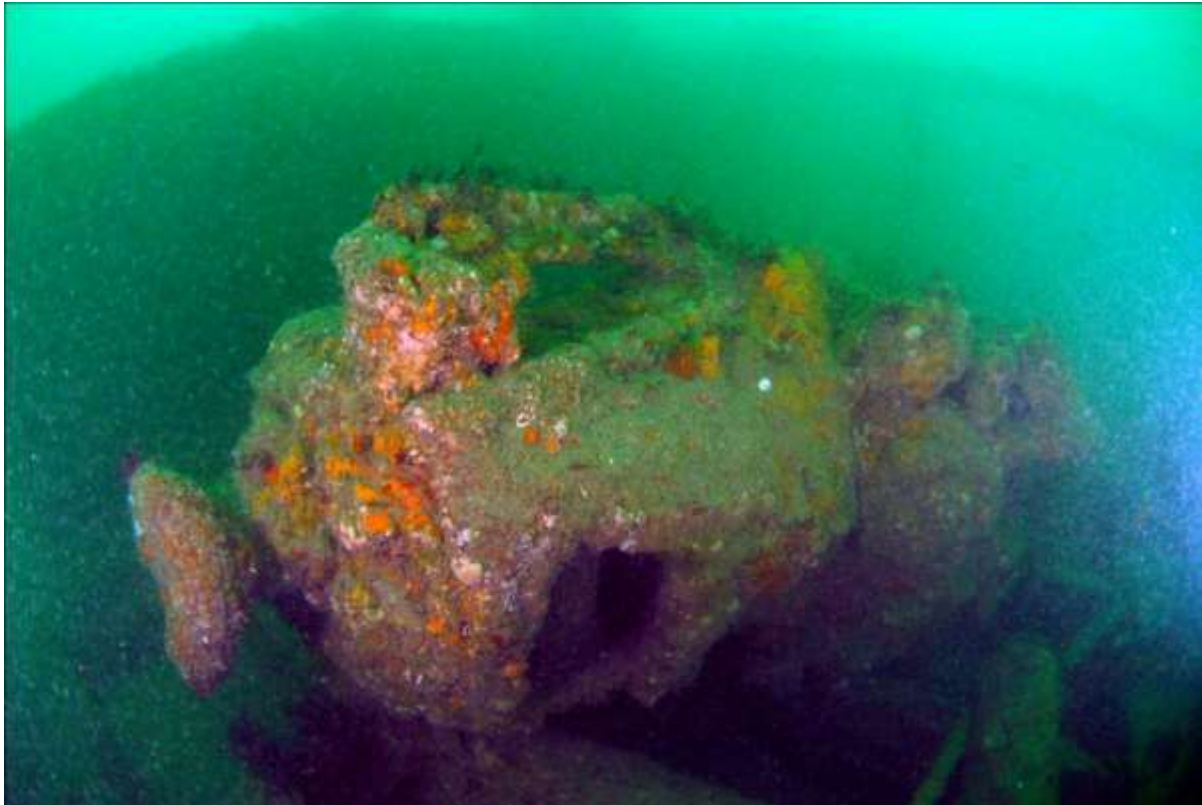
We found 3 engines laying parallel to one another and close to the 2<sup>nd</sup> goal post. The engines had prop shafts leading from them but only one could be traced to a propeller. (See below).

Figure 17 - One of three engines and Goal post 2 in the background (Image Martin Davies)

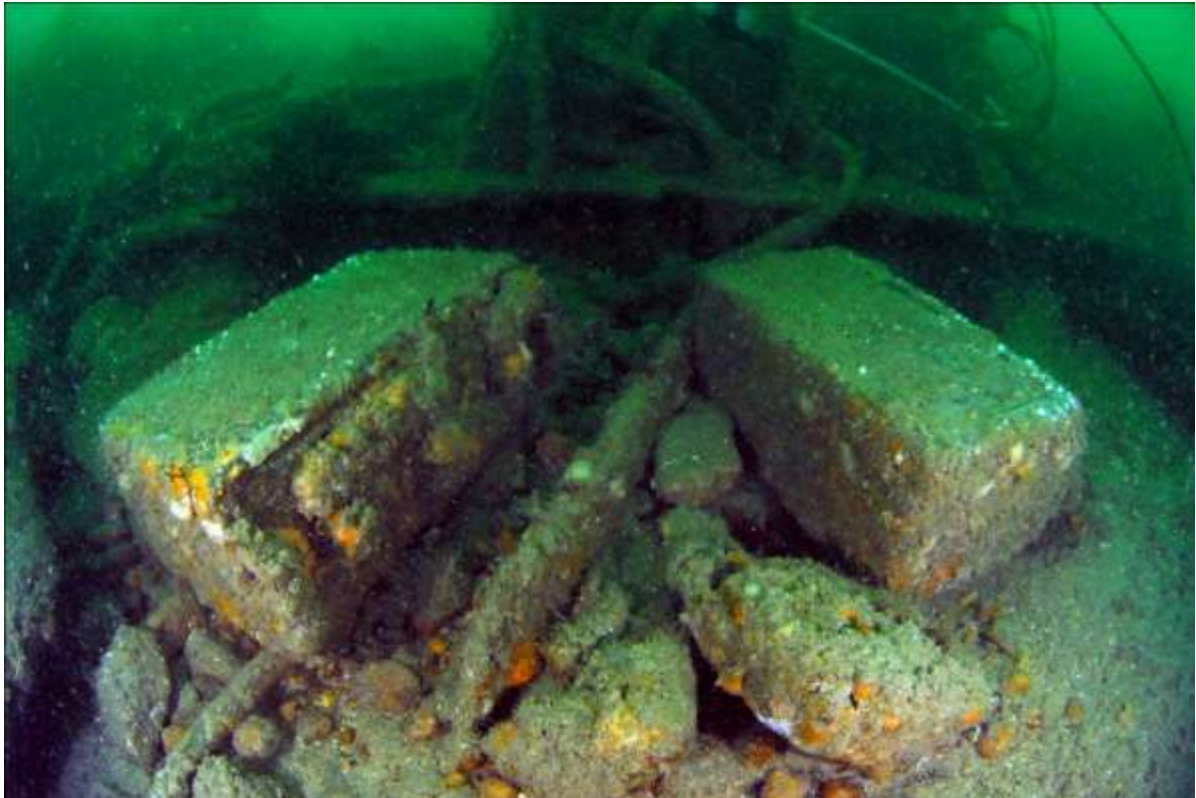
In the vicinity of the Engines were several large batteries and electrical components.

Figure 18 - Batteries and wiring (Image Martin Davies)

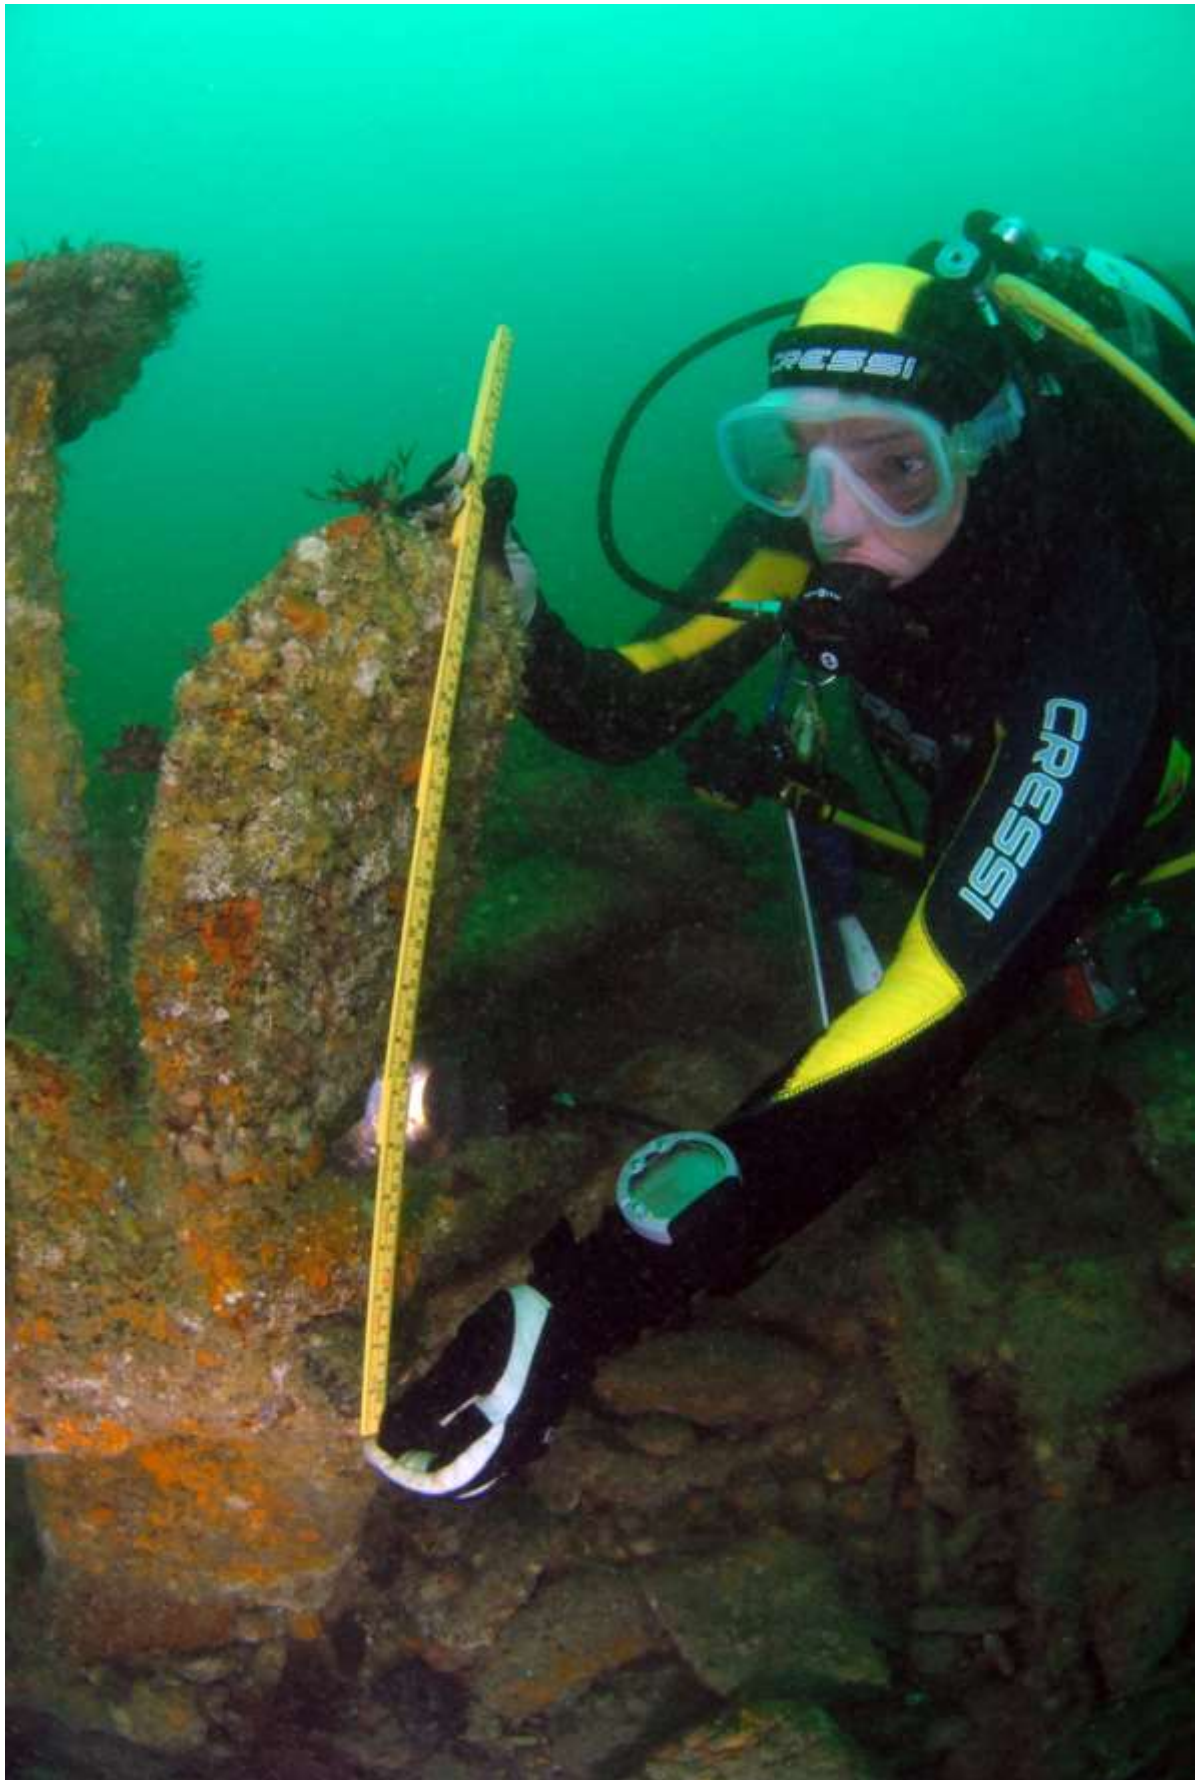
The three propeller shafts leading from the engines were visible to varying extents. They were bent at right angles to the engines. Two shafts disappeared into the sea bed and under wreck structure but one of the shafts still had the propeller exposed. The 4 bladed propeller appeared to be very similar to the two propellers found at the tanks and bulldozers site with a dimension of 37" diameter – the same was used on Mk5 Landing Craft Tanks. The propeller is not thought to be bronze, but possibly steel and is very similar to the two propellers found at the Tanks and Bulldozers site.

Figure 19 - Propeller - 4 blade and 37 inch diameter (Image Martin Davies)

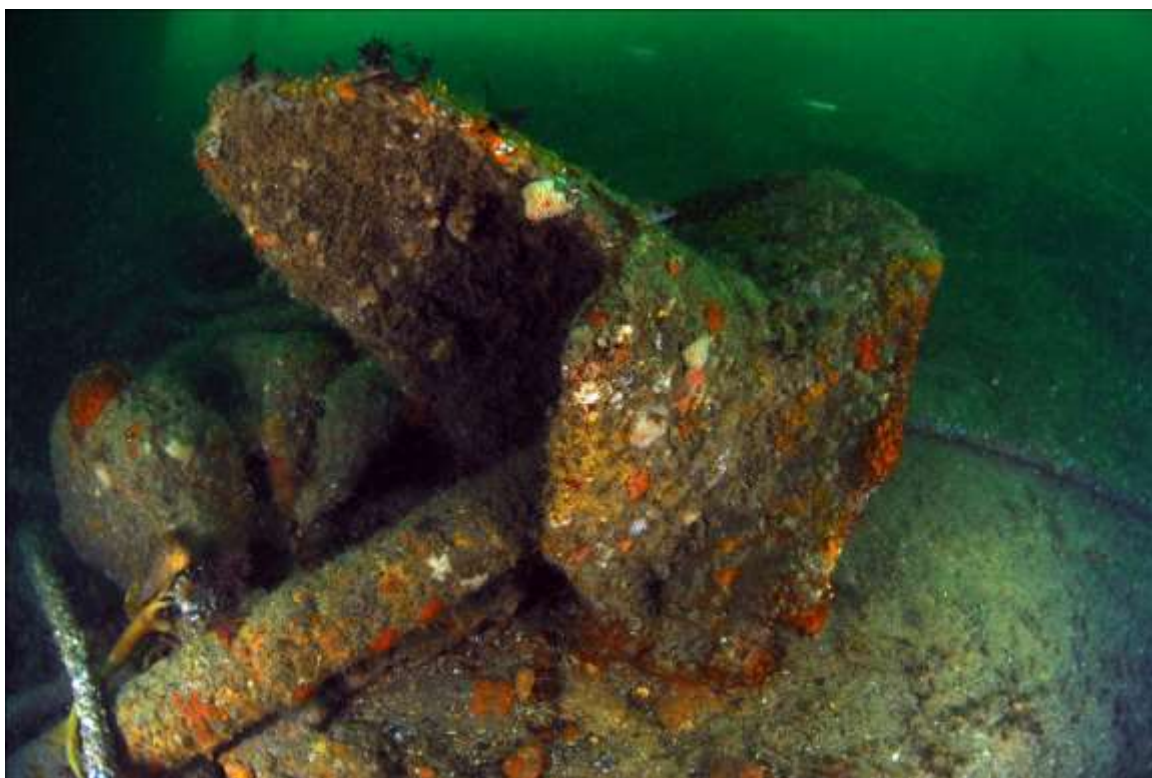
Figure 20 - Propeller shaft. (Image Martin Davies)

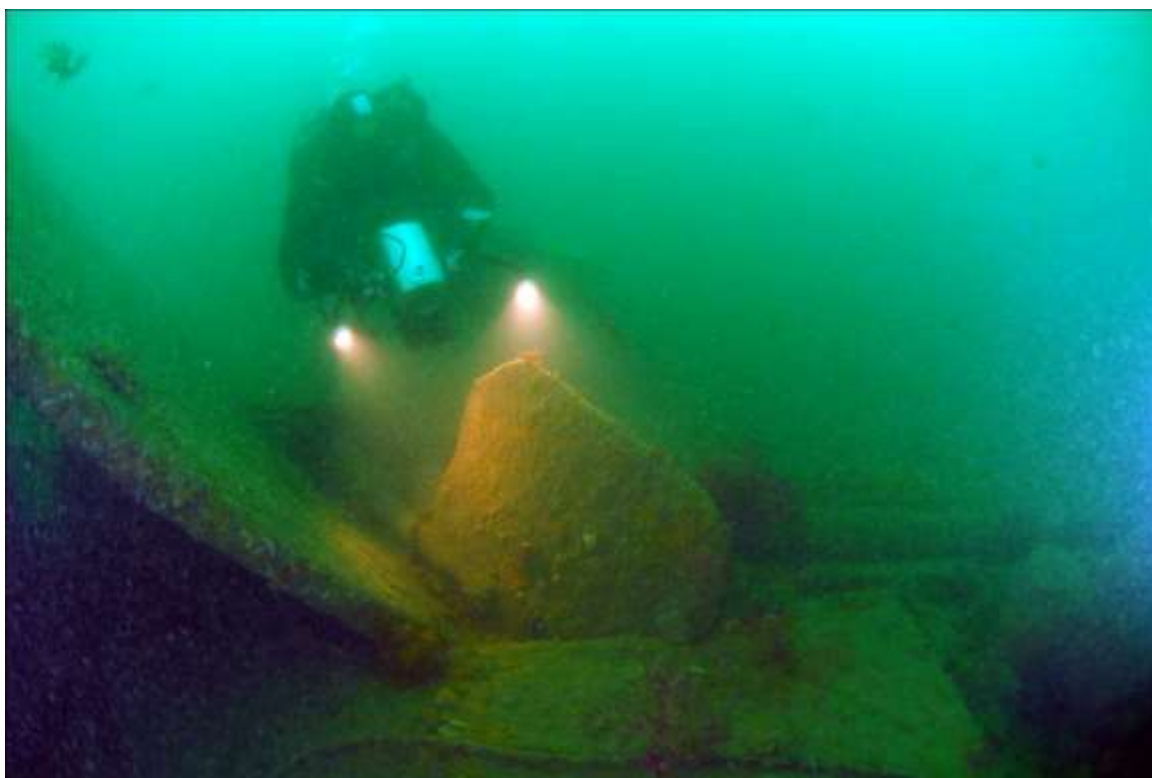
Mk 5 LCTs had 2 rudders and we found two rudders at the site, close to the propeller.

Figure 21 - One of two rudders found at the site (Image Alison Mayor).

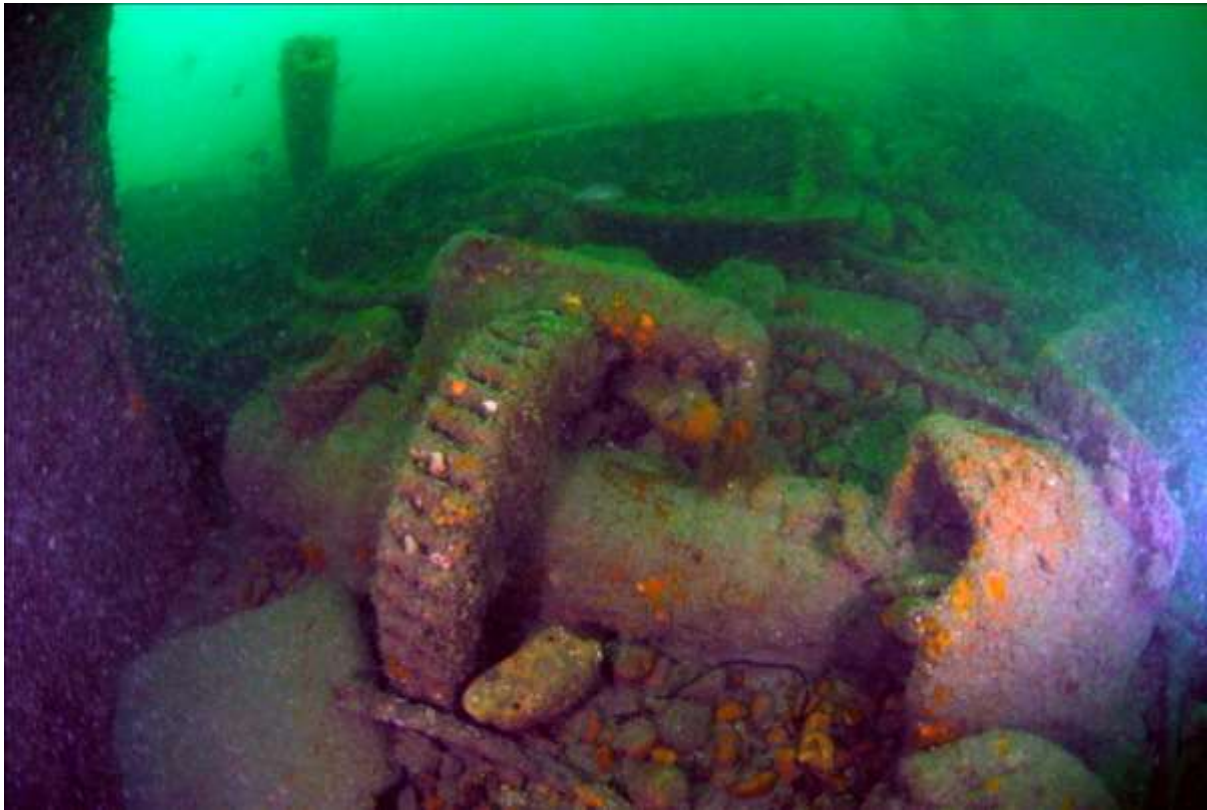
There appear to be 2 winches at the wreck site near the guns, rudder and propeller and these are believed to be that used to deploy/recover the landing crafts kedge anchor. No anchor was found at the site but there is a large anchor at the tanks and bulldozers site tucked just under a tank.

Figure 23 - One of two winches found at the LCT site (Image Martin Davies)
