## **NEPTUNE WRECKS PROJECT REPORT**

## Neptune Wrecks Project Report

### **Part 1 - Report Summary**

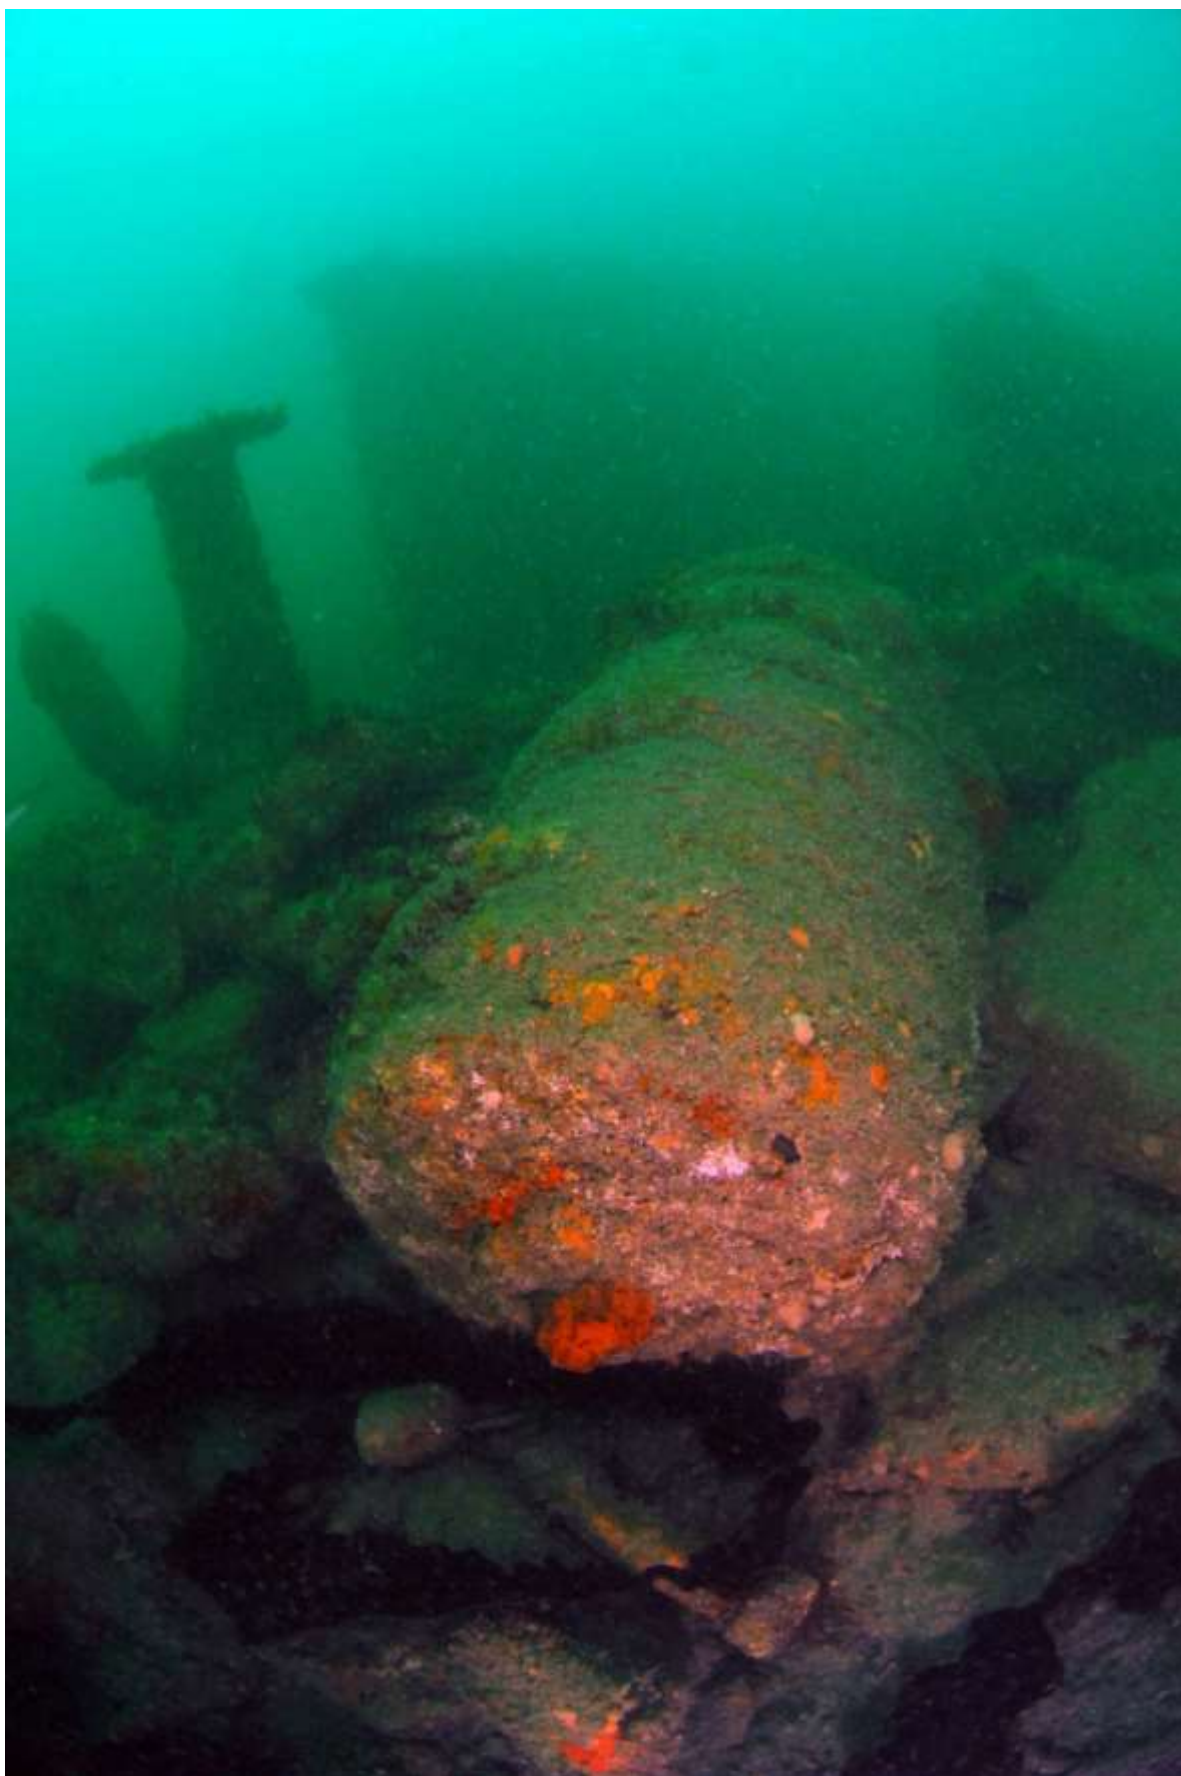
Figure 24 - 2nd winch note propeller and engine in background. (Image Martin Davies)

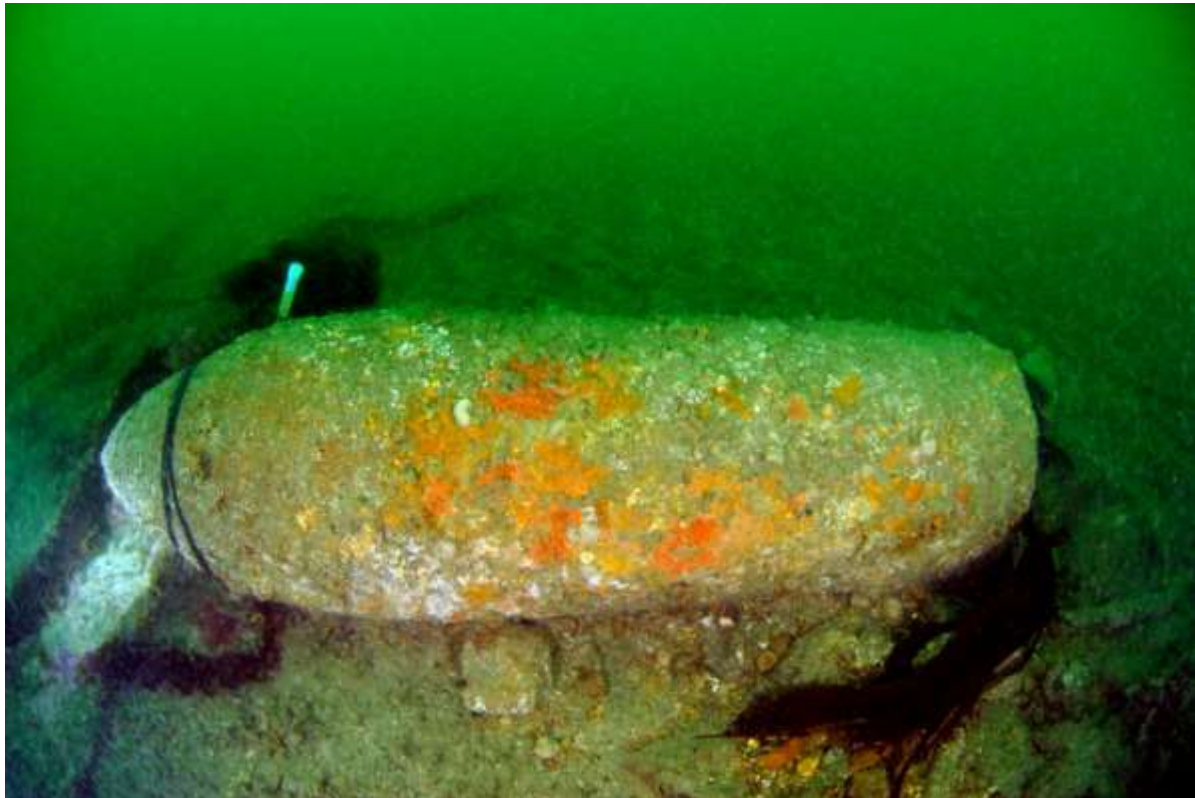
We were very surprised to find what appeared to be a large bomb at the site. The bomb was 4 feet long and measured 12 inches across the base and was laying on a small piece of wreckage.

Figure 25 A 500lb bomb was discovered at the wreck site. (Image Martin Davies)

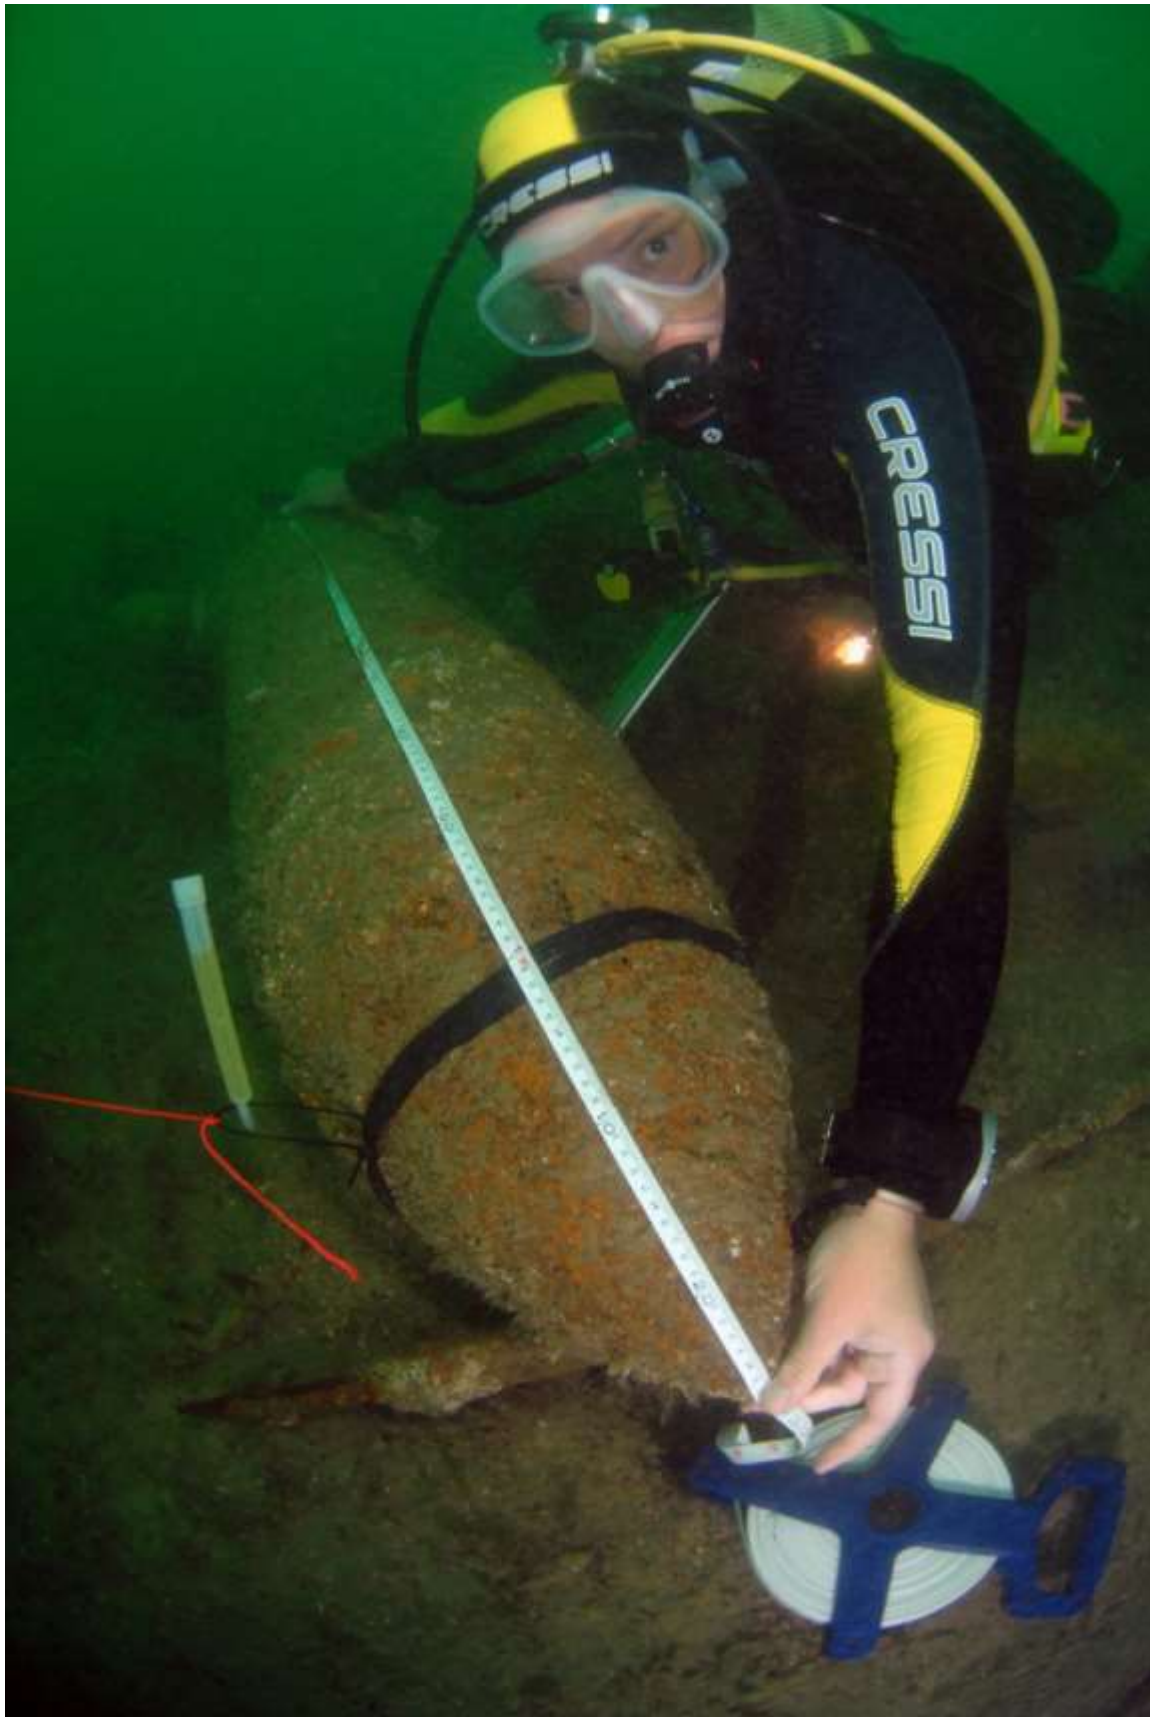
Figure 26 Alison Mayor carefully measures the length of the bomb (Image Martin Davies)

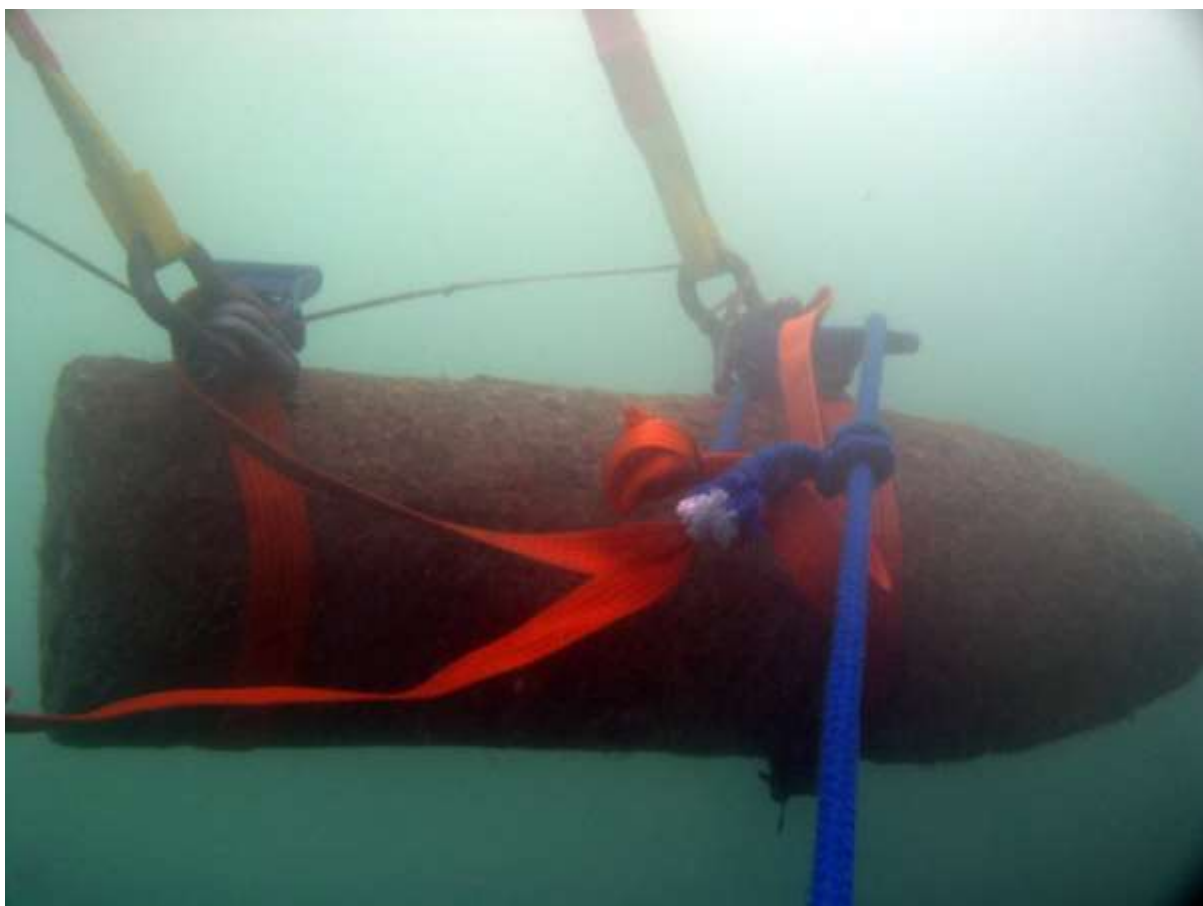
This exercise was successfully completed using a large 500kg automatic lifting bag. The bomb was lifted and towed 3 miles to a site identified by the Coastguard where the bomb was set down on the seabed 10m below the surface. The lifting equipment recovered before charges were set around the bomb. The bomb was successfully destroyed.

Figure 28 Bomb being suspended underneath 500kg lifting bag ready to be towed to the safe area for disposal.

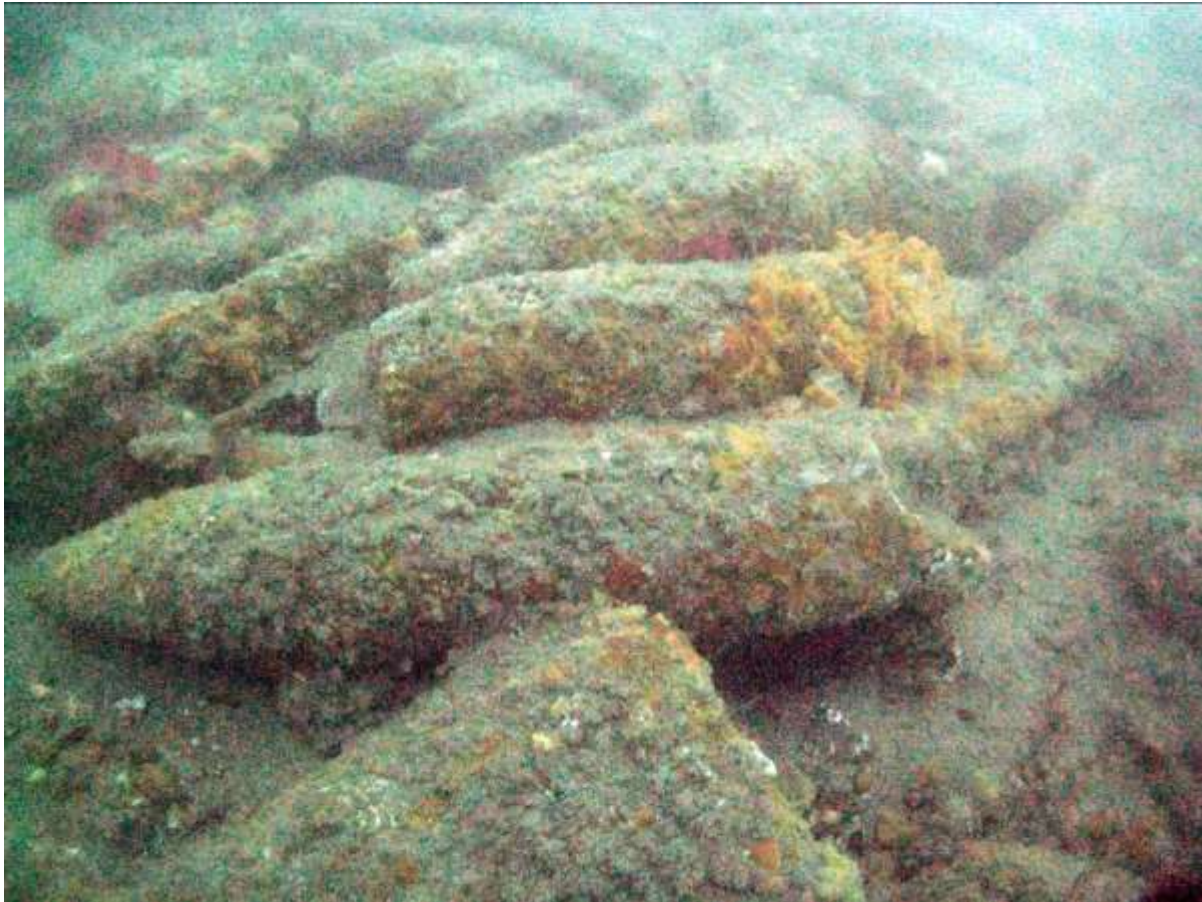
Figure 29 - 95mm HE ammunition (image Jim Fuller)

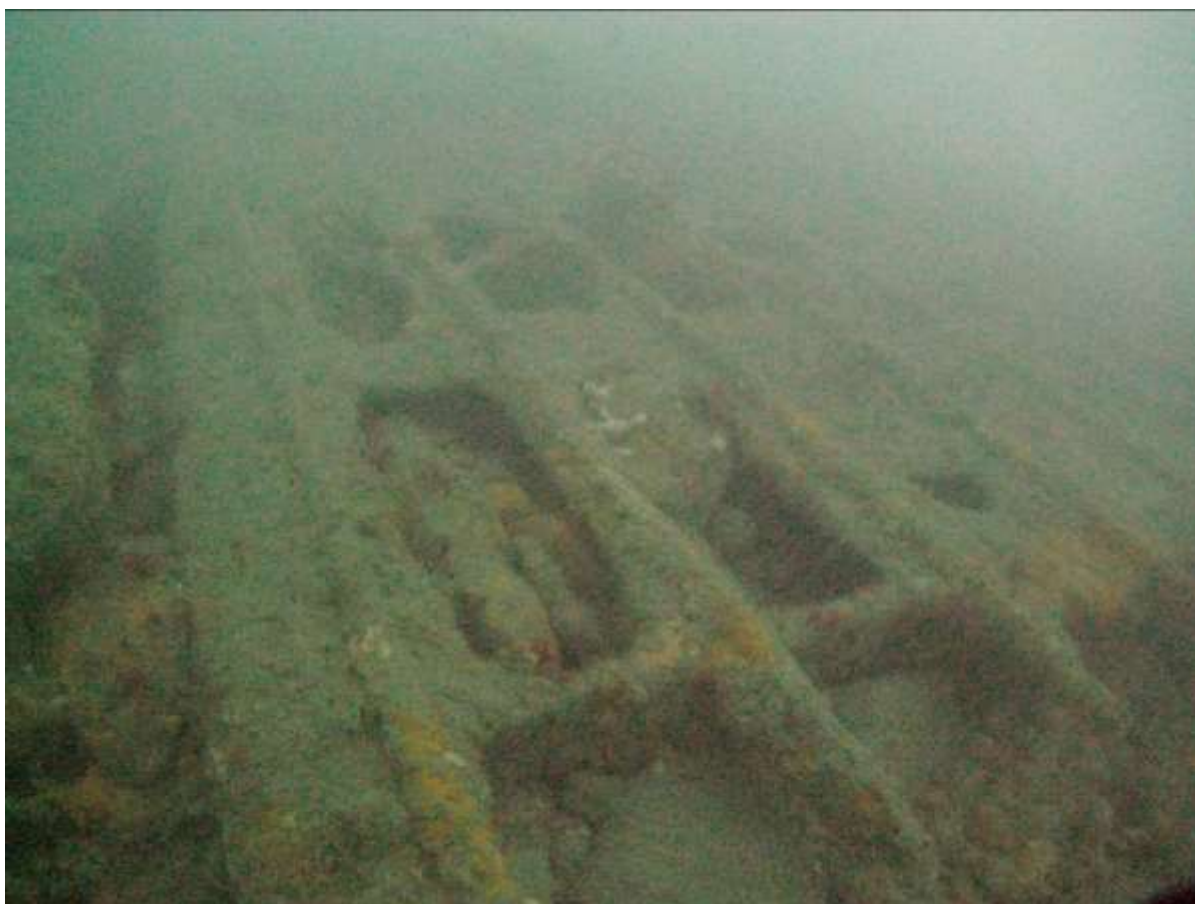
Figure 30 Decking/Hull (Image Jim Fuller)

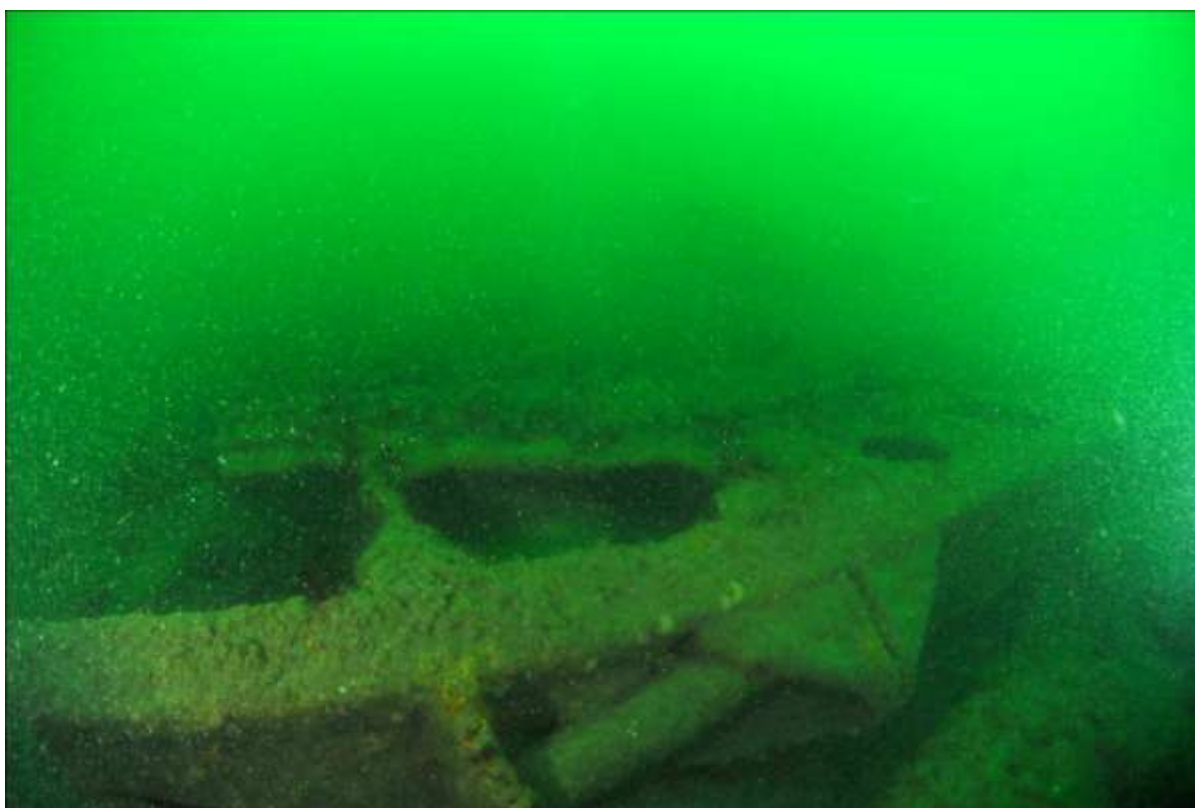
Figure 31 – LCT Door/ramp? (Image Martin Davies)

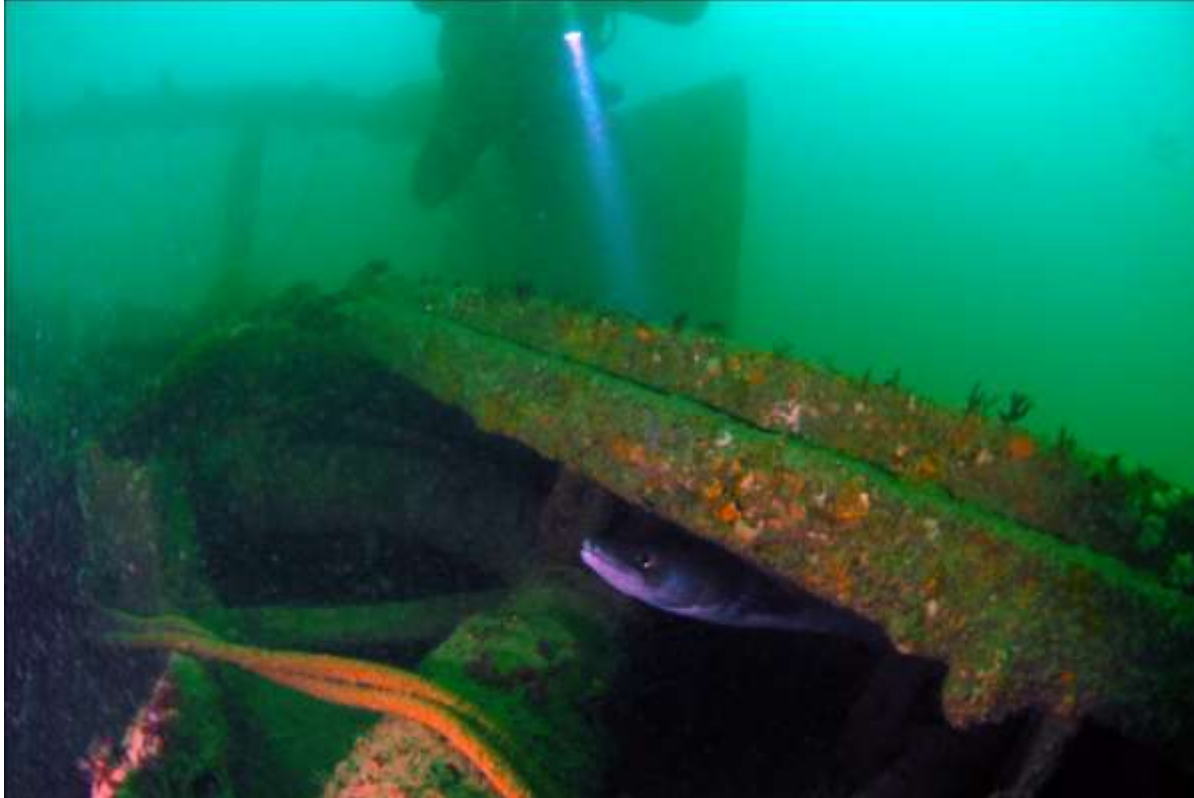
In the stern area around the engines there was evidence of armour plating on the sides of the wreck plates. This was consistent with the 2 ½ inch plastic armour plating added to LCT(A)s as part of the modification package.

Figure 32 - Armour plating (Image Martin Davies)

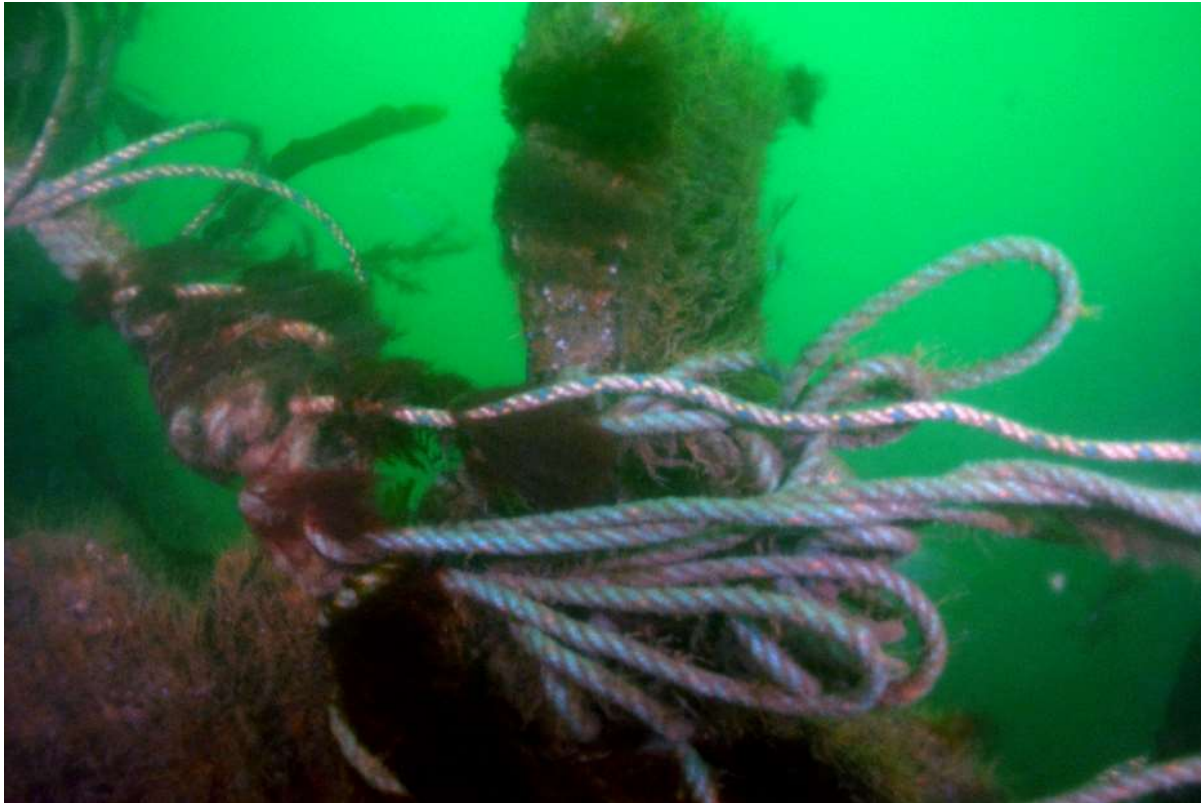
Figure 35 - Ropes and lines from potting/fishing was a hazard to divers.  
(Image Martin Davies)

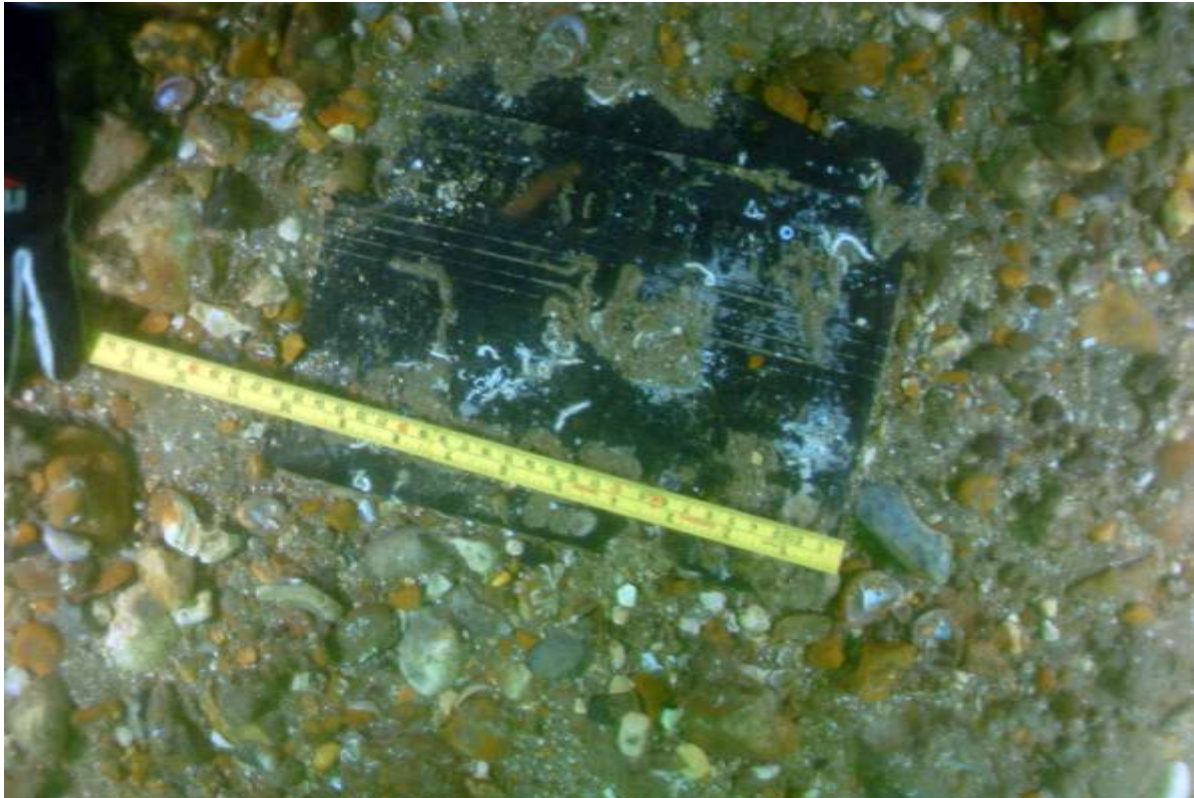
Figure 36 - 'AUTOLITE' battery found buried in the shingle near the stern  
(Image Martin Davies)

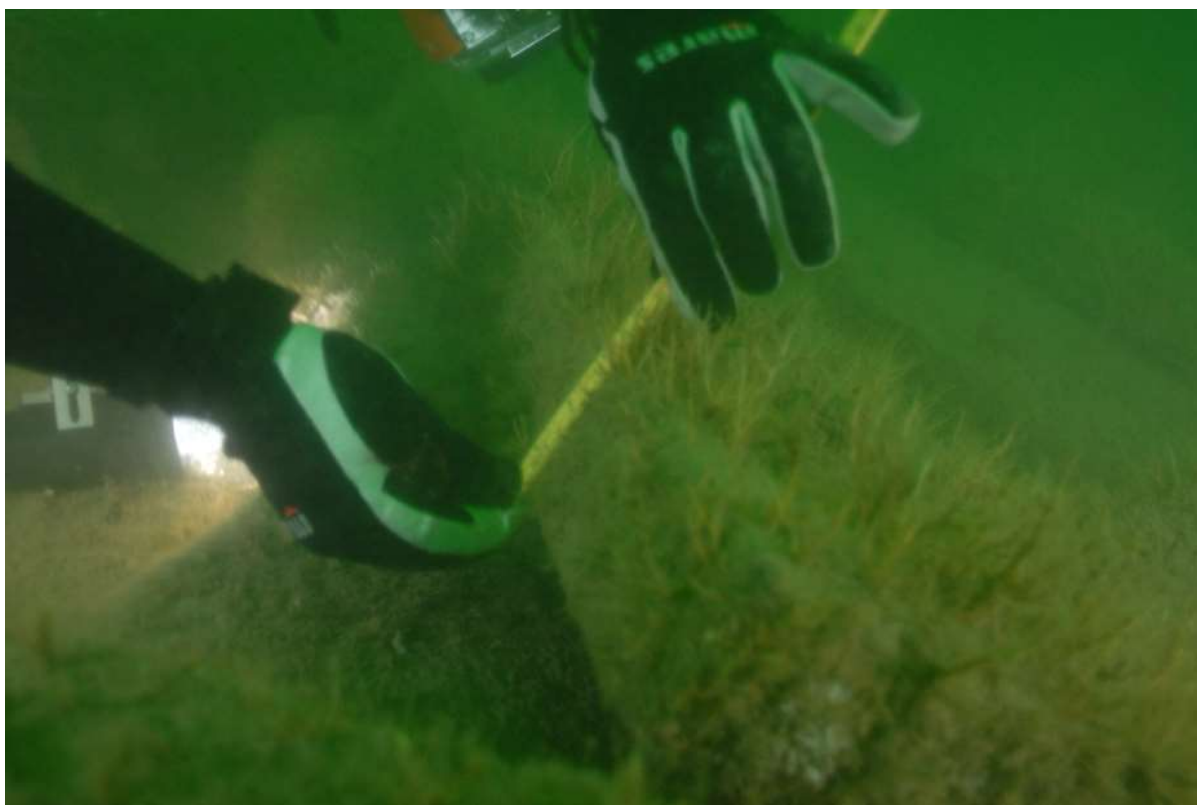
There were numerous sections of material believed to be armour plating. They were generally of a uniform size of 3 feet long x by 18 inches by 3 inches thick and resembled slabs of marble.

Figure 37 - 3 inch thick armour plating. (Image Martin Davies).

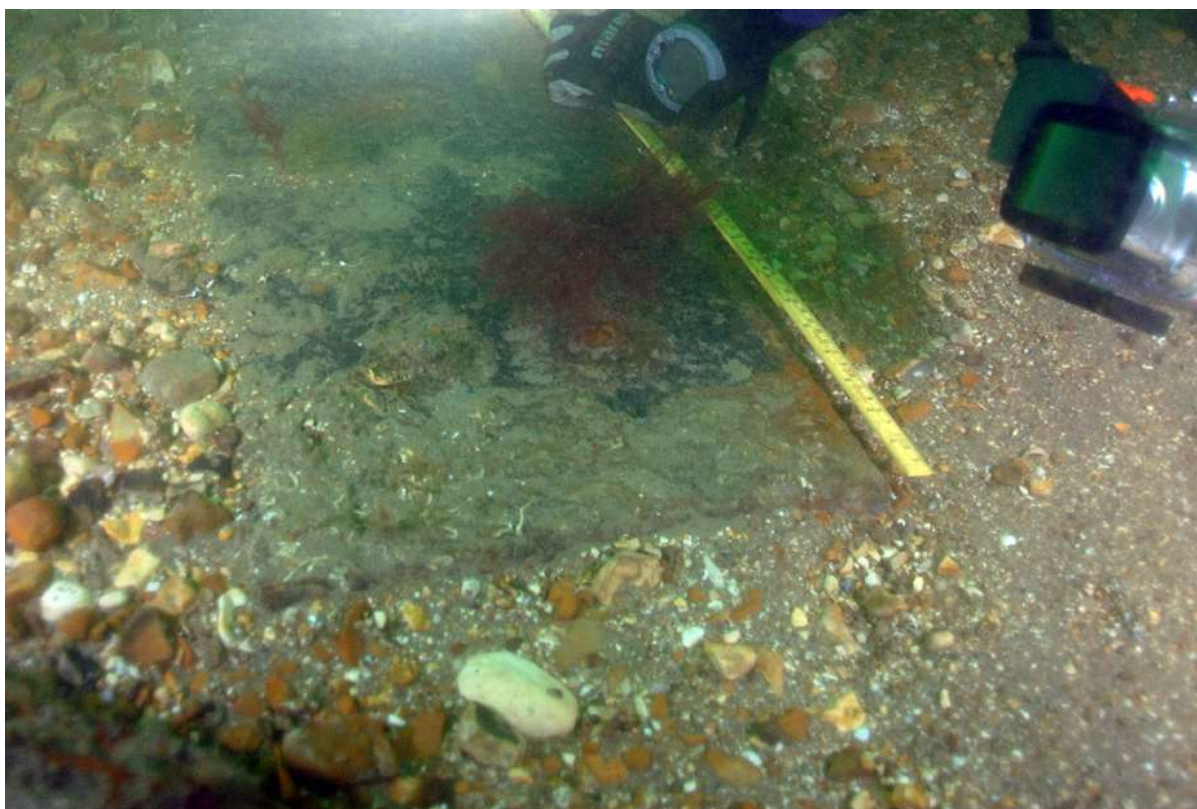
The sections had remains of metal fixings at points in the middle of the sections.

Figure 38 – Armour plating section. (36 x 18 x 3 inches) (Image Martin Davies)

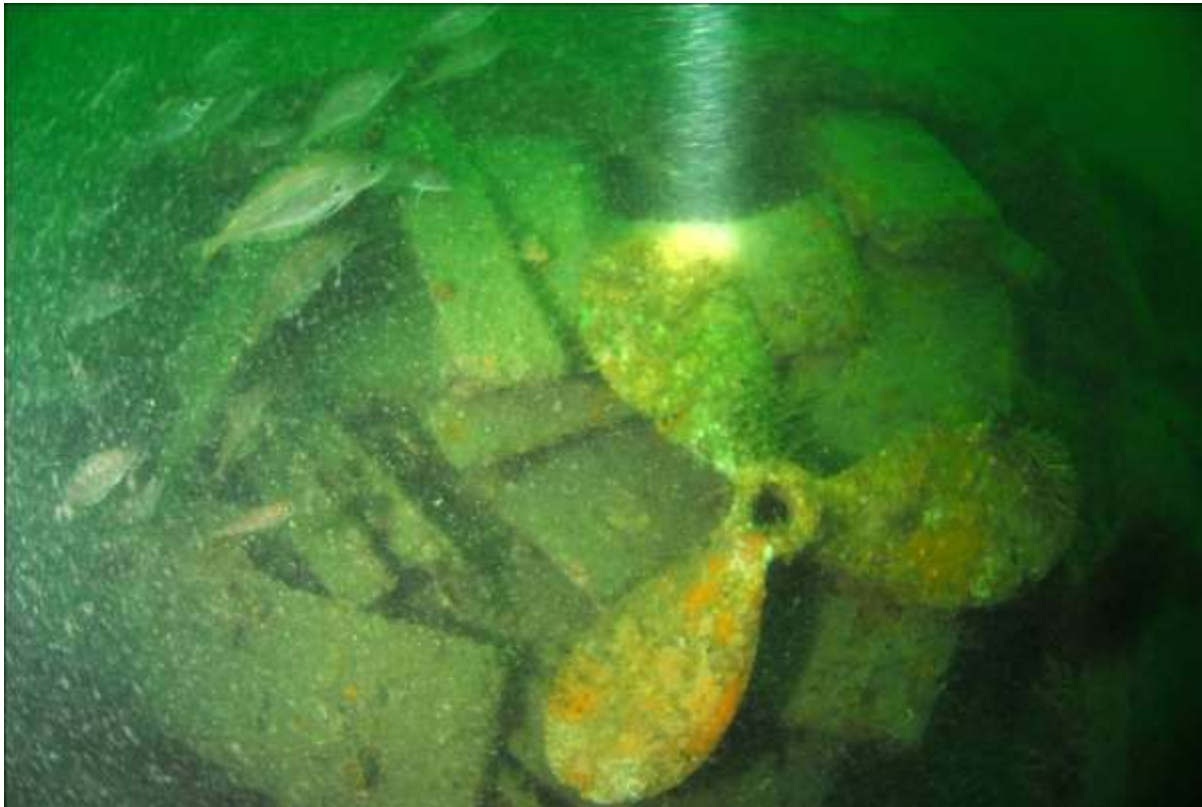
Figure 39 - A bronze propeller found on top of the wreck near the stern.  
(Image Martin Davies)

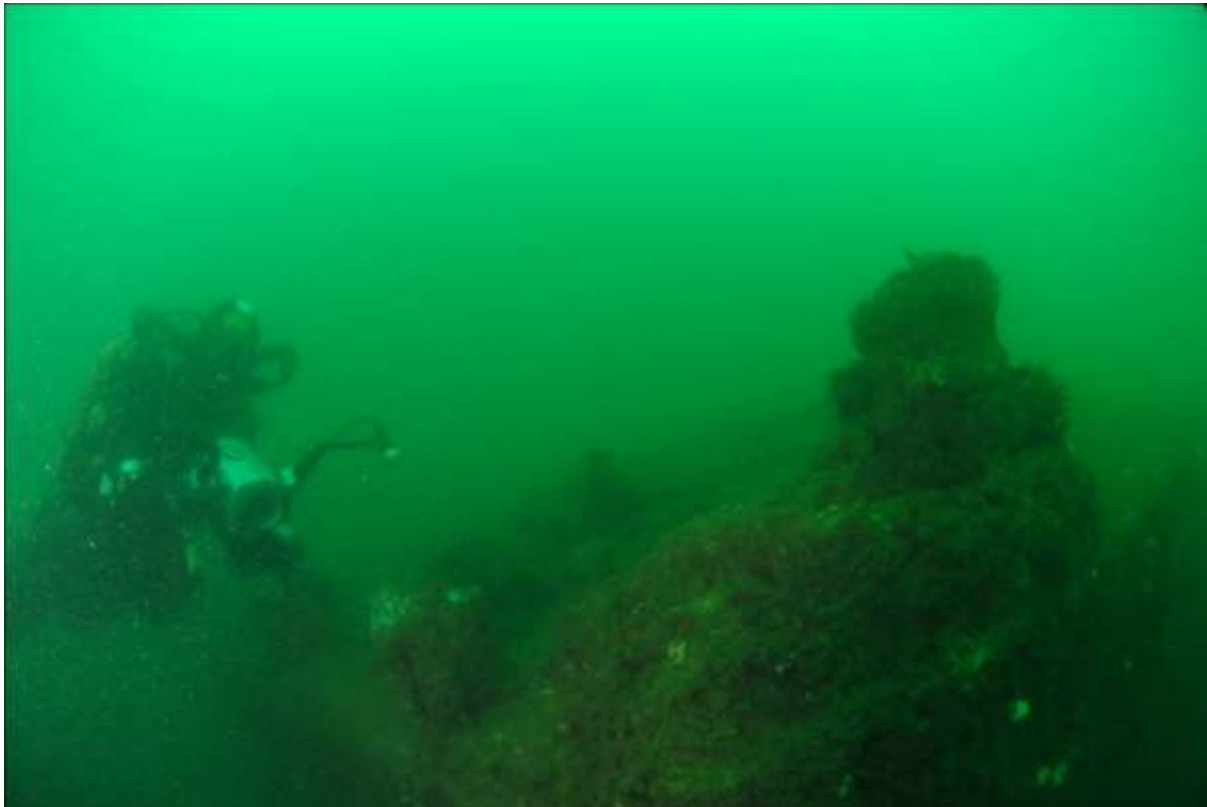
Figure 43 - Barge 20244 - top section. (Image Alison Mayor)

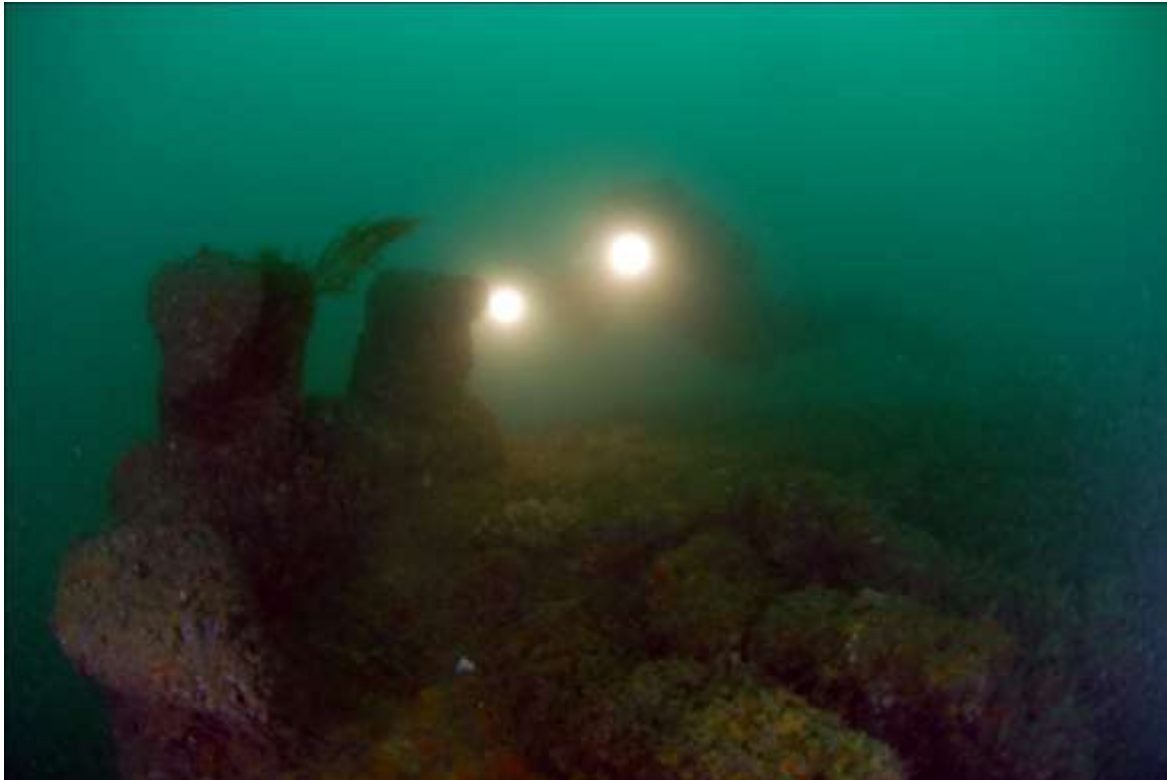
Figure 44 – Bollards on the top end of the wreck (Image Alison Mayor)

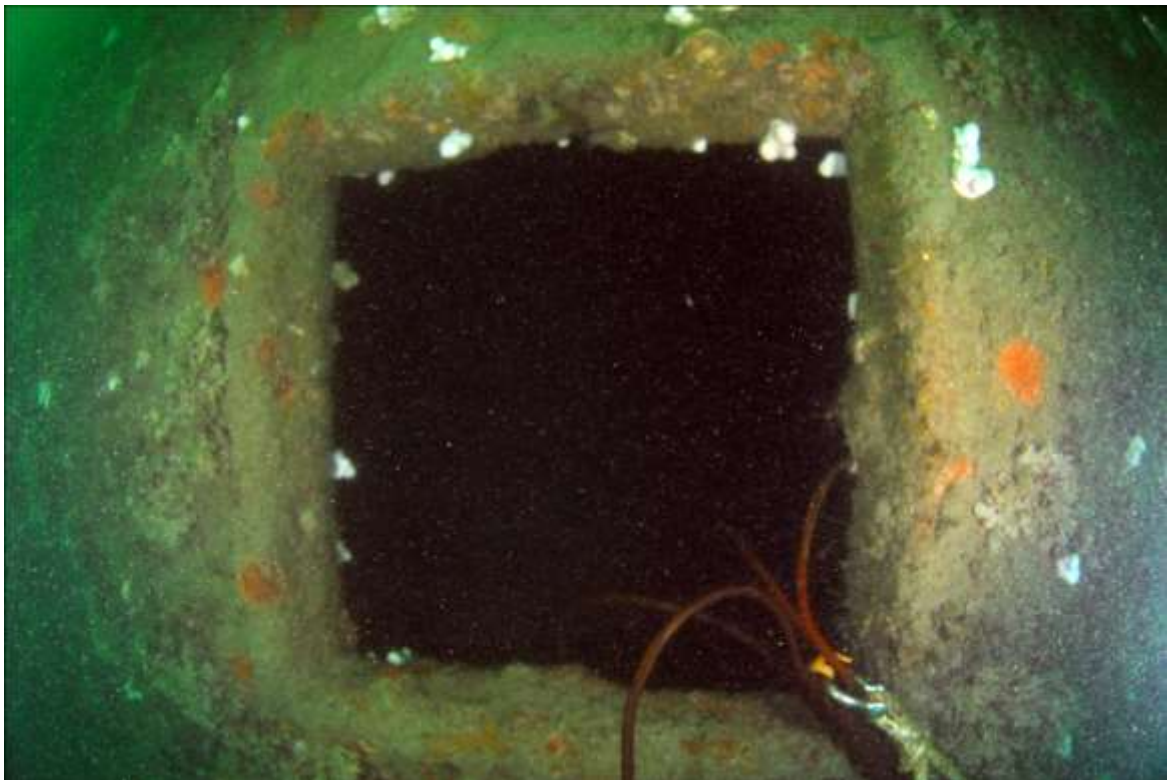
Figure 45 - Small opening / hole (Image Martin Davies)

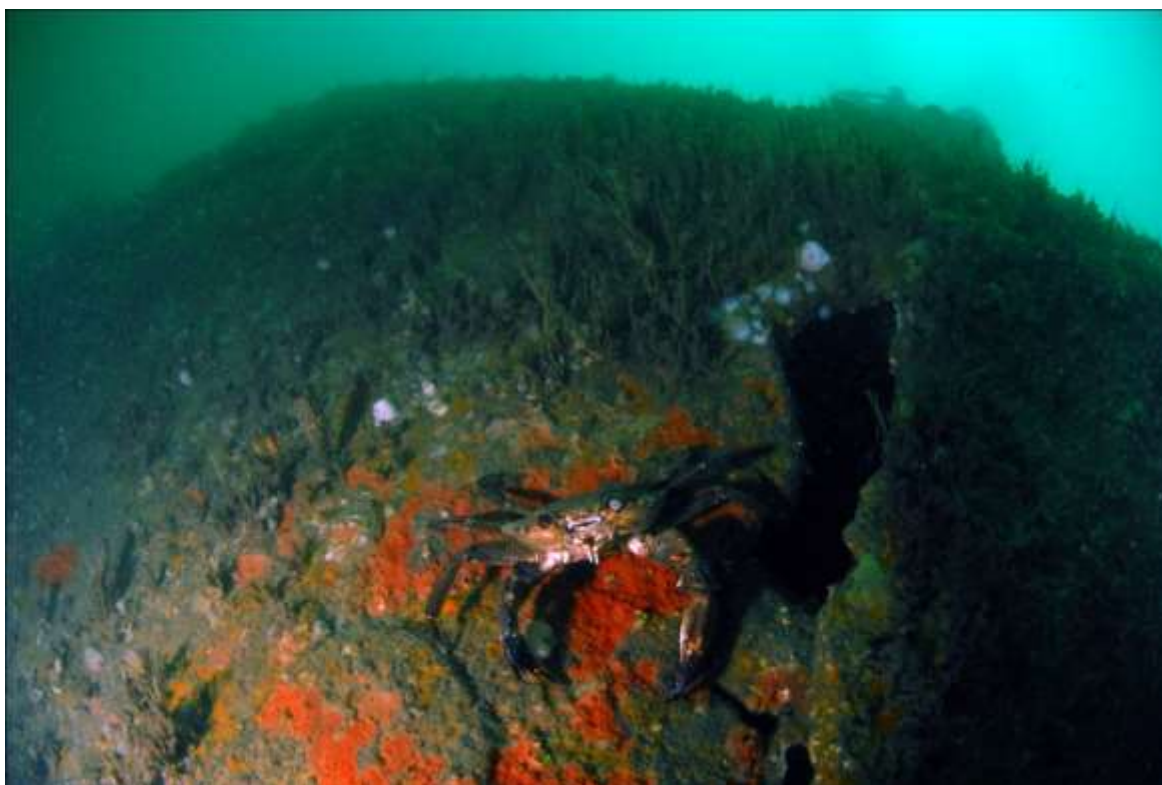
Figure 46 - the crack near the larger opening and velvet swimming crab.  
(Image Martin Davies)

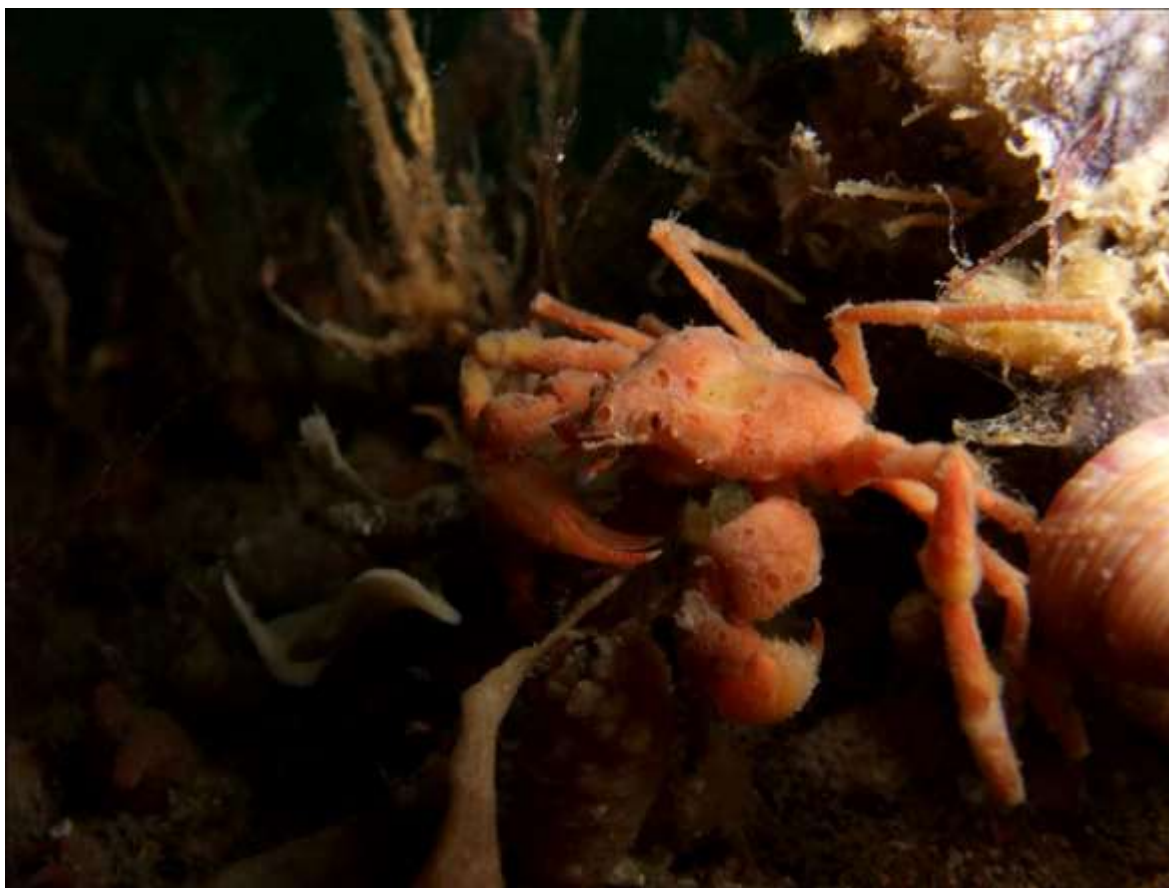
Two club members conducted a survey of marine life on the wreck in accordance with the MCS SeaSearch scheme. A copy of the survey form is at Annex B. The marine life recorded was typical of that found in the Hampshire to West Sussex coast and included a healthy population of small spider crabs (*Inachus*).

Figure 47 - *Inachus* spider crab on barge 20244. (Image Alison Mayor)

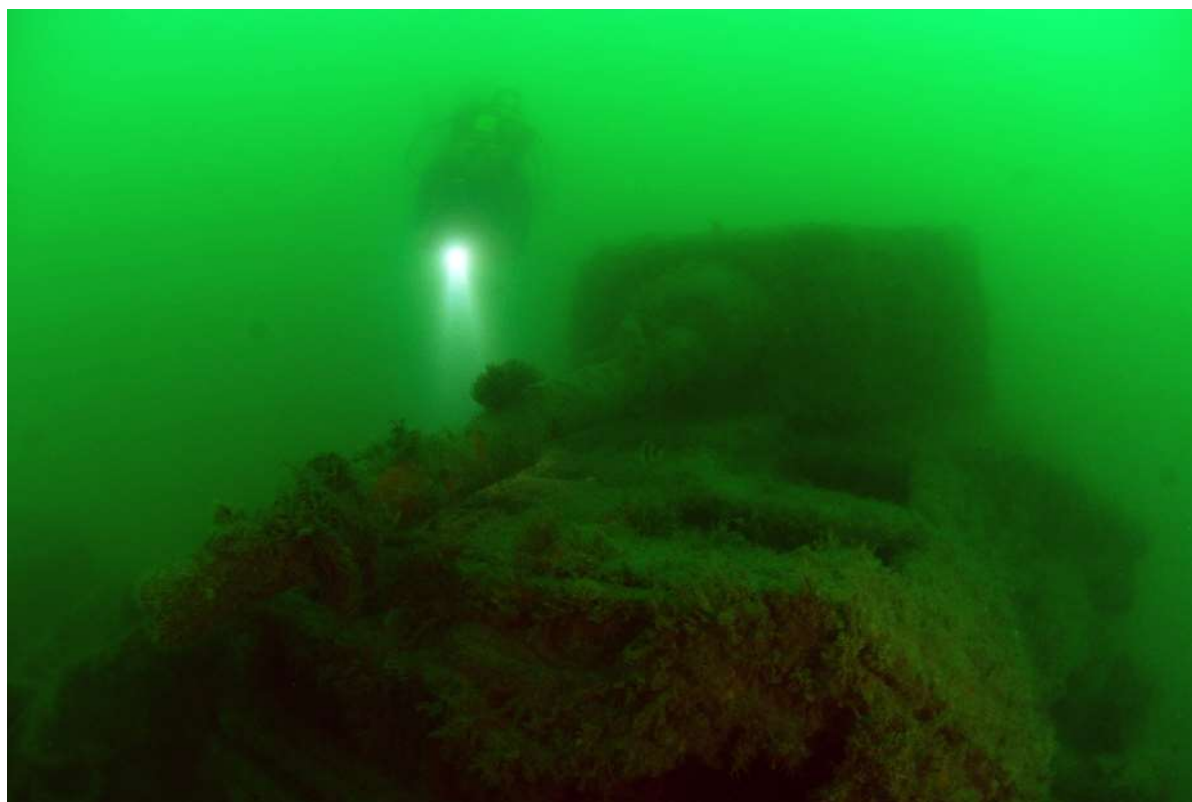
The tank wreck lies upright on a sandy bottom at a maximum depth 14m. The position is 50 44'.254N : 00 51' .973W. There are a number of wire circular fishing pots the ropes of which are wrapped around the tank.

The tank wreck is much smaller than the Centaur tanks found at the Tanks and Bulldozers site. The gun points forward and turret is open and it is possible to look inside.

Figure 49 Valentine Tank - Bracklesham Bay (Image Martin Davies).

The tank was confirmed by David Fletcher from the Tank Museum (Bovington) as a Valentine Tanks which was fitted with a 'skirt' assembly and small bronze propeller and was designed to 'swim' to shore. On a dive subsequent dive, from our club RIB and in poor visibility, we looked for signs of a propeller but with no success. If the propeller is still there it is likely to be buried slightly under the sand/shingle seabed.

We consulted the Historian at the Tank Museum (Bovington) and showed him images of the tank we had dived in Bracklesham Bay. David immediately confirmed it was that of Valentine Tank, and likely to be a 'DD' Duplex Drive version.
