## **NEPTUNE WRECKS PROJECT REPORT**

## Neptune Wrecks Project Report

### **Part 1 - Report Summary**

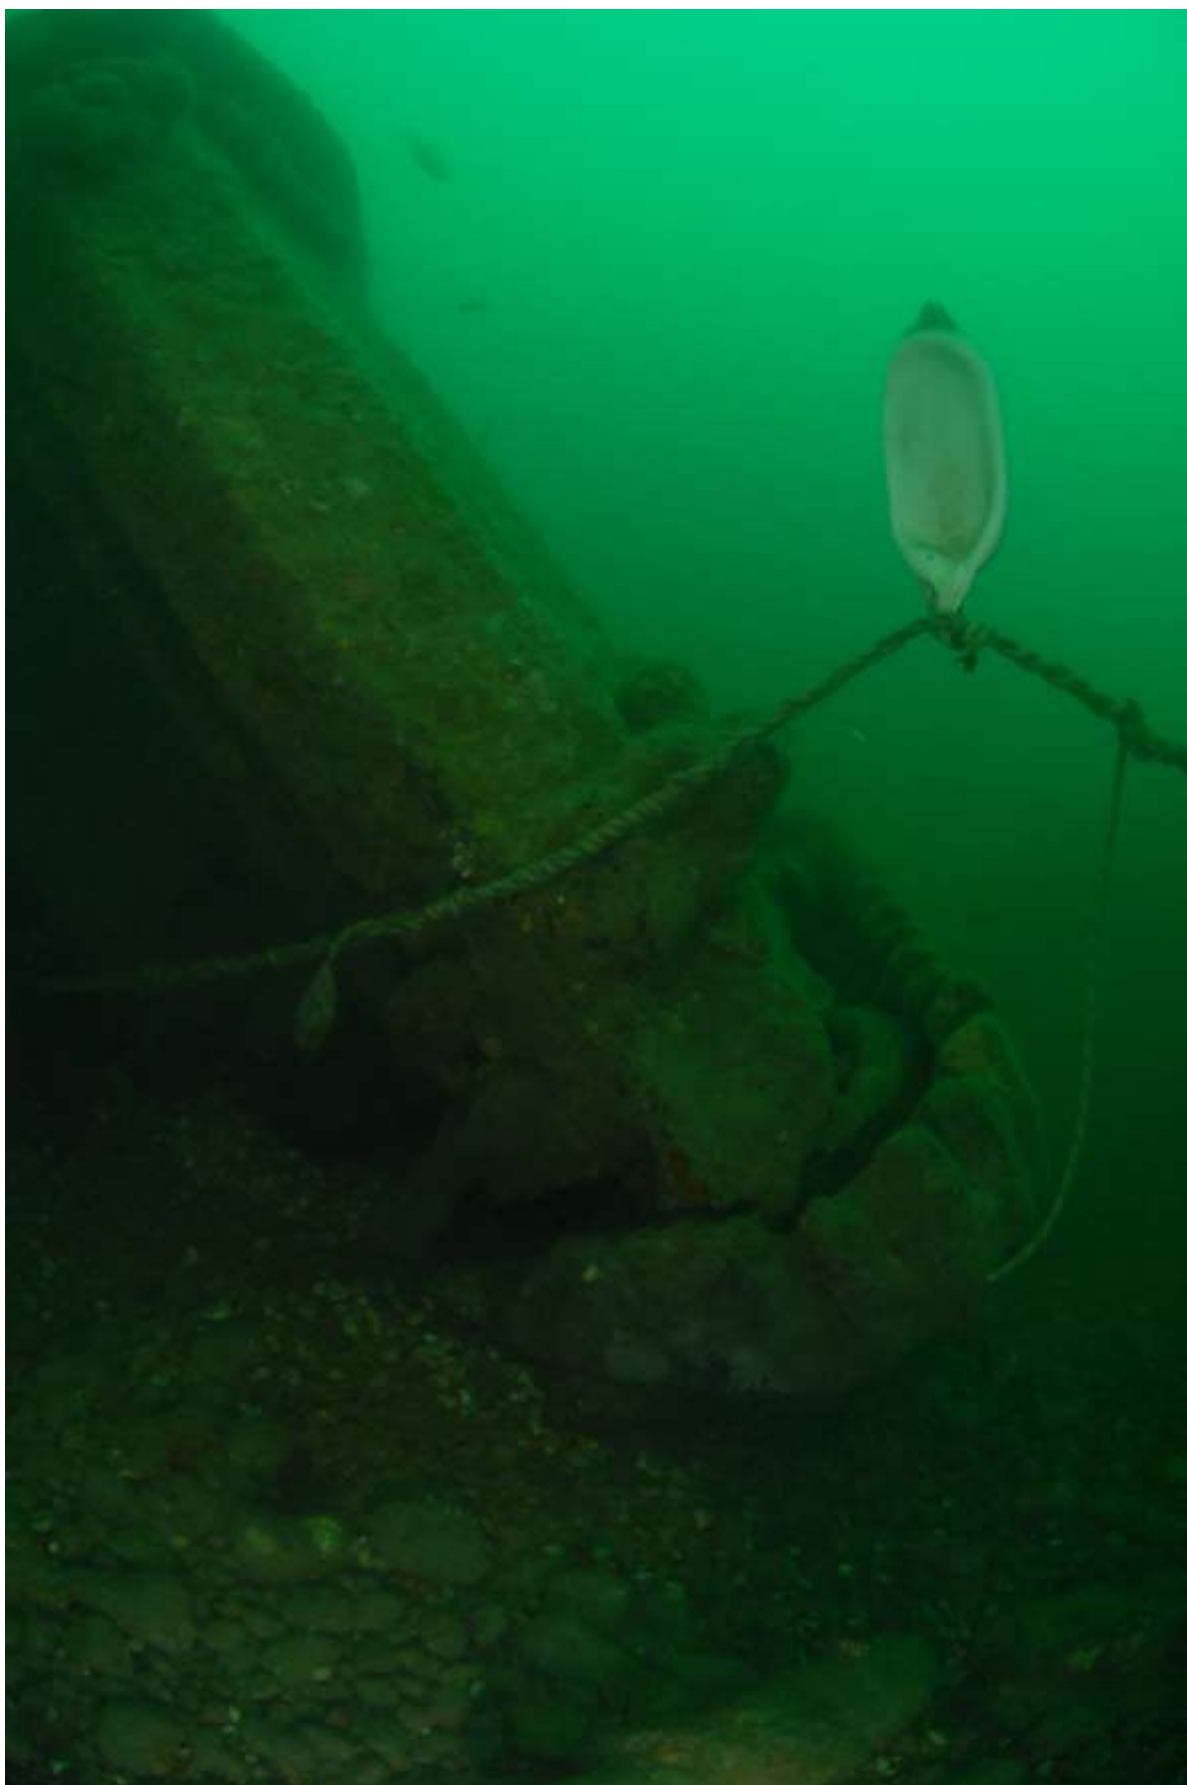
Figure 51 - Lines and ropes tangled around a Centaur. (Image Martin Davies)

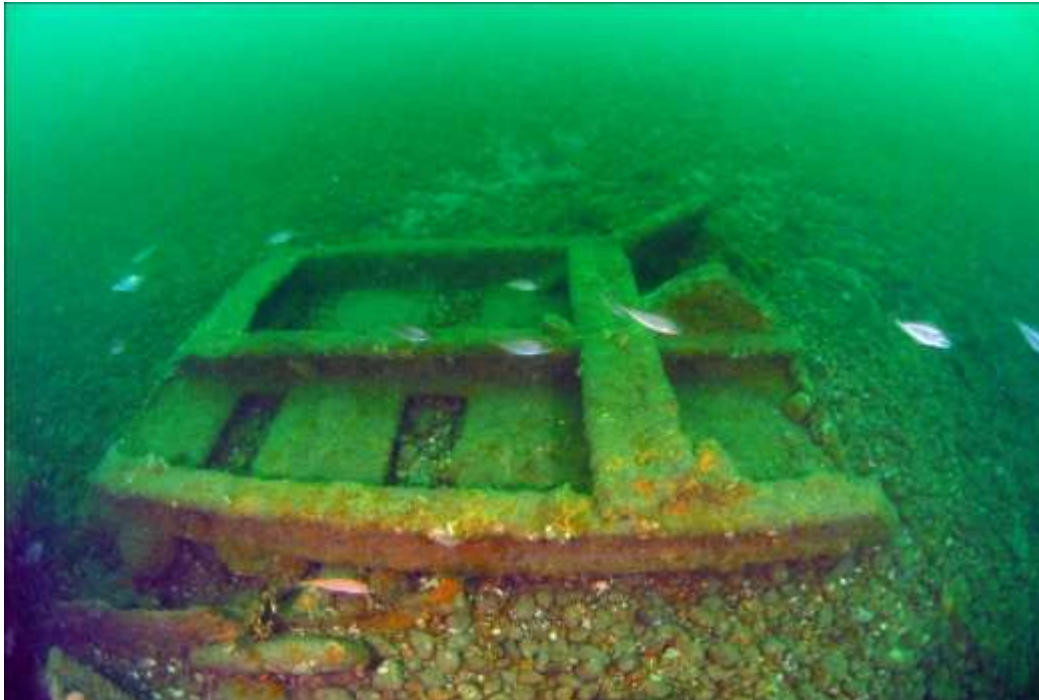
Figure 52 - Ramp extension from Landing Craft Tank Door? (Image Martin Davies)

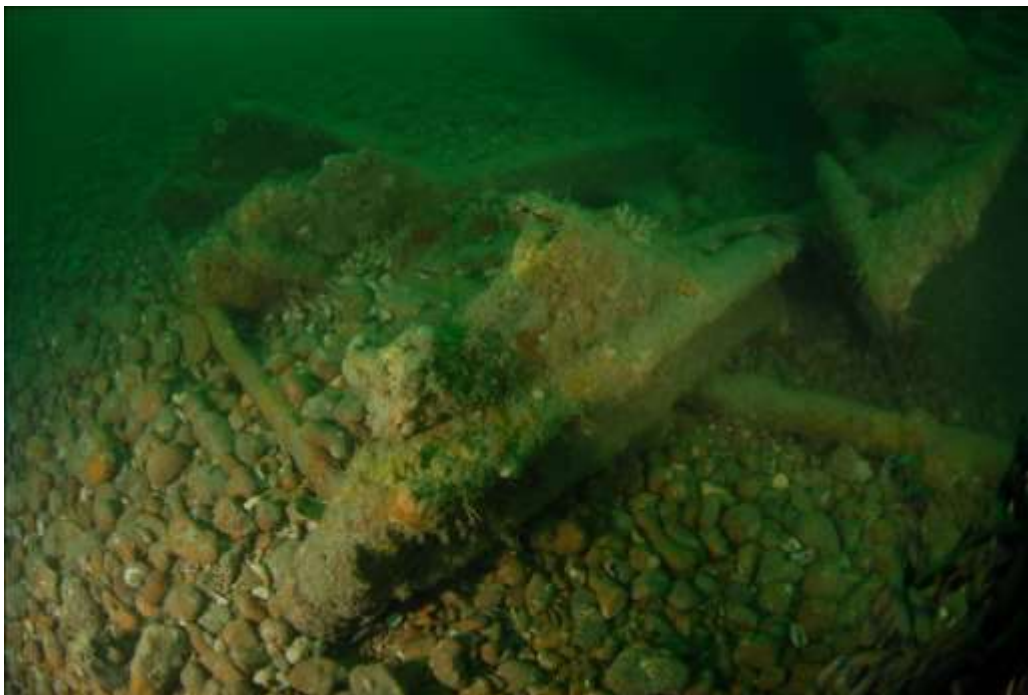
We had thought that 2 items found at the site might be waterproof ammunition sleds or 'porpoises' but the thing that puzzled us was that they were not full of HE ammunition. Further research of images of LCT (A)s would indicate that these items may be part of the ramp assembly from the door. There were 3 ramp sections and two appear to be at the Tanks & Bulldozers site.

Figure 53 - 2nd Ramp from Landing craft. (Image Martin Davies)

This image of LCT (A) 2075 taken after the storm of 19-22 June 1944 shows 3 ramp extensions to the bow door which are remarkably similar in shape/design to the items previously believed to be porpoises and it is the belief that they are ramps.

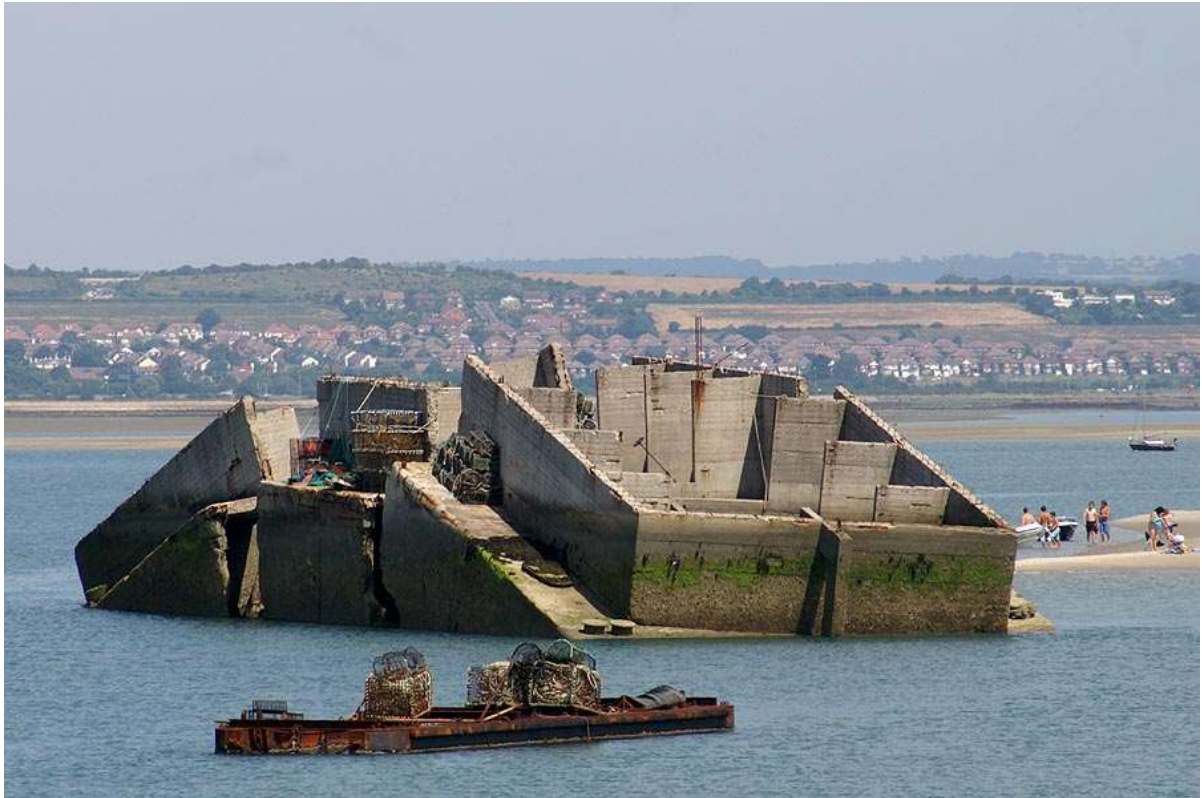
Figure 59 - Mulberry Harbour Unit at Langstone Harbour.

Many people will be unaware of the huge effort that went into constructing two floating harbours, each the size of Dover, which were assembled in a matter of days on the other side of the English Channel and which were critical to the success of Operation Overlord.

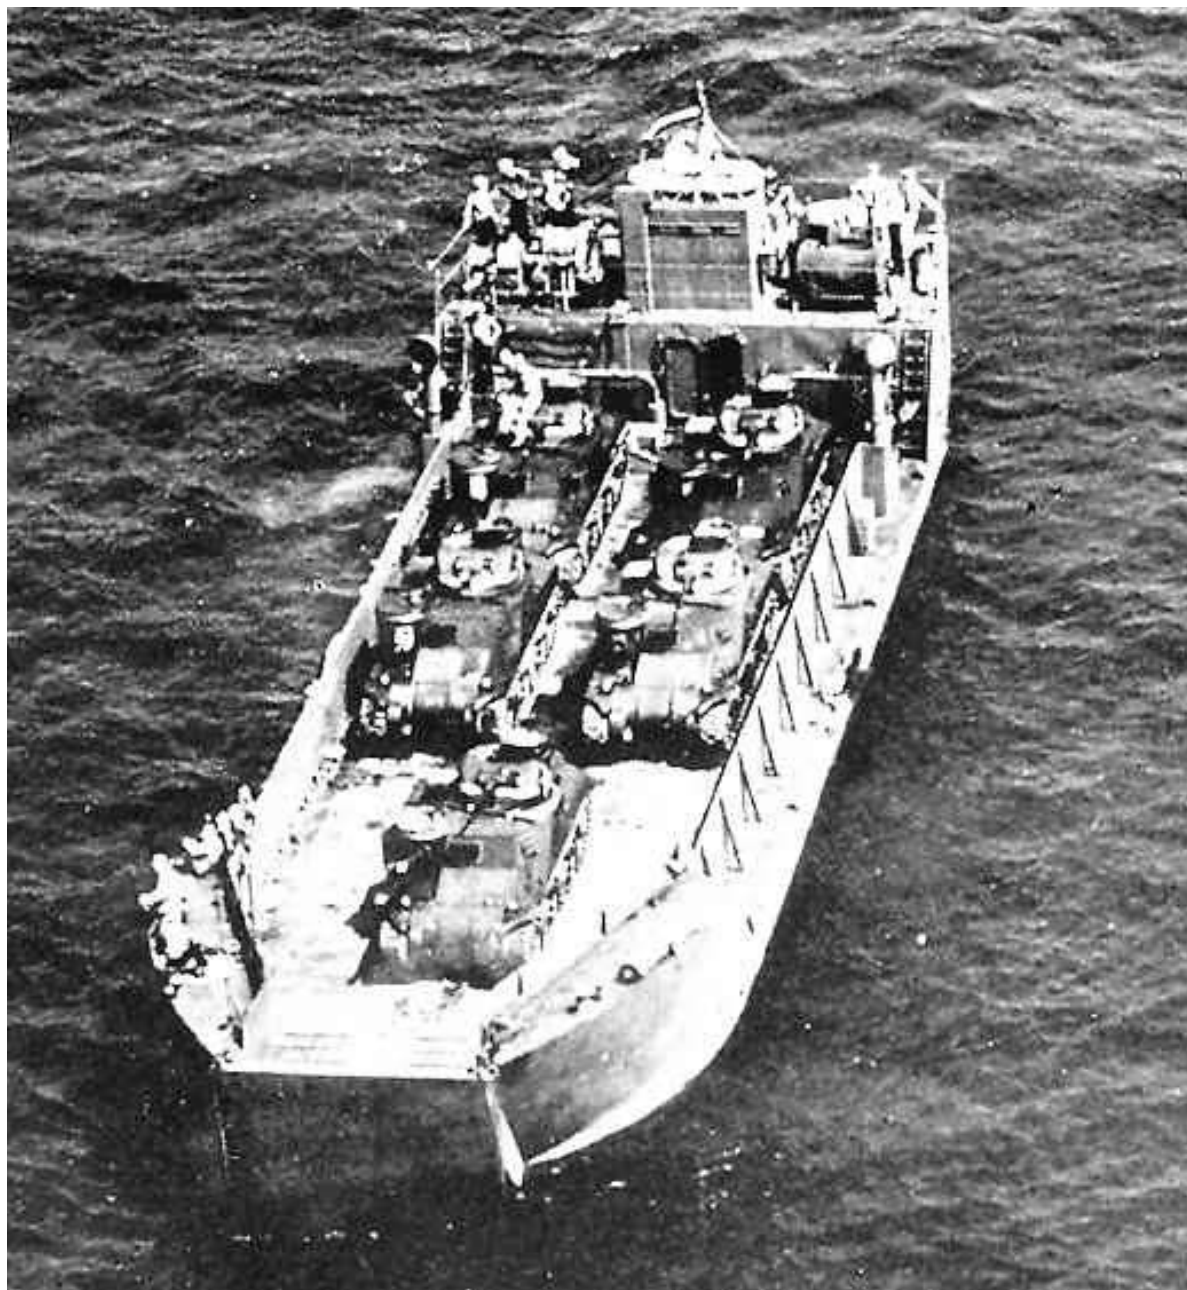
Figure 60 - US Landing Craft Tank Mk 5 (pre conversion) (IWM)

It is believed that 48<sup>3</sup> US built Mark V Landing Craft Tanks were converted for the role they were to play by providing 'Close Support' cover during the initial assault of the Normandy Beaches. 26 of the 48 were loaned back to the United States for the Invasion of Normandy – see Annex B for a fascinating account of the modifications made and of the role played by US LCT (A) 2124 by Lt Cdr Erwin Kaufmann USN

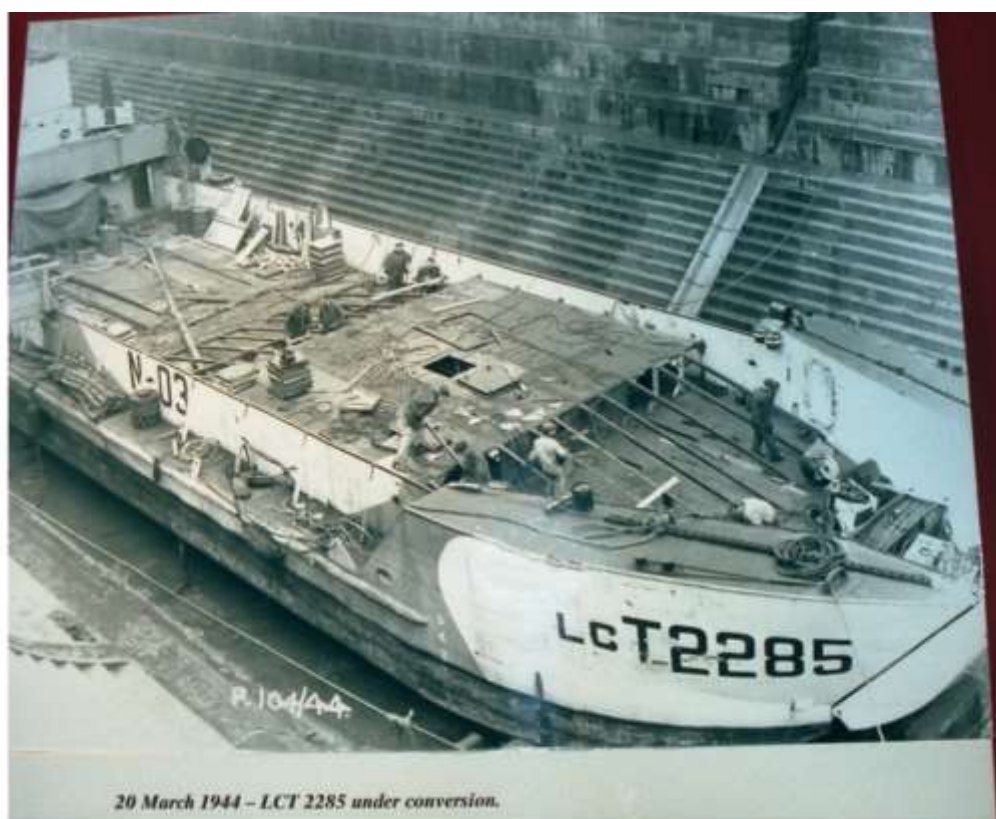
The conversion included the building of ramps on the tank deck to allow Centaur Tanks to fire over the bow on the approaches to the beach and additional 50 tons of armour plating, predominantly around the bridge area, to protect the personnel and craft in the first wave of the attack. In recognition of the modification the LCTs were renumbered to as a '2' in the front – and so LCT (Mk V) 428 became LCT (A) 2428.

Figure 61 - LCT 2285 under conversion to fit tank ramps.

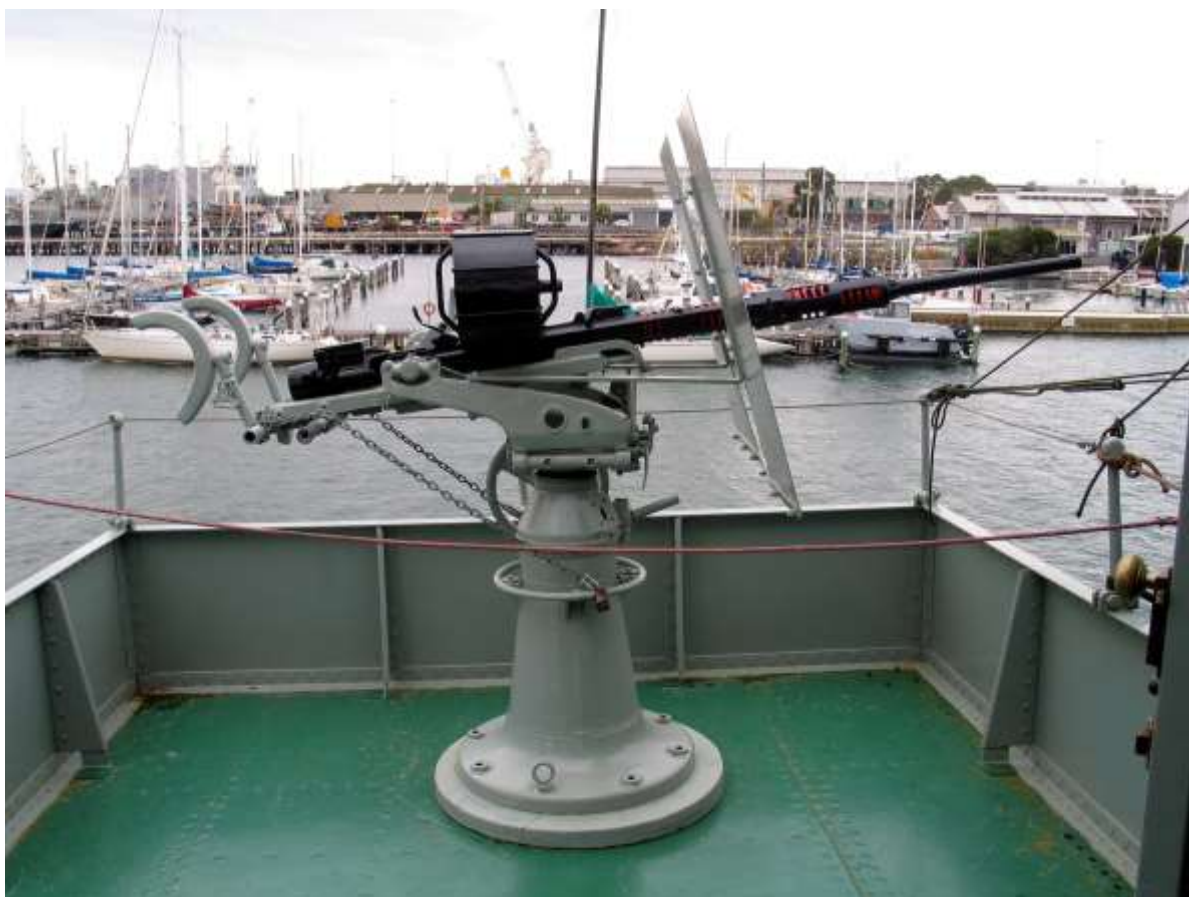
The shape and size of these guns are very similar to those found at the Landing Craft site 20004 (see Part 4).

Figure 67 - Oerlikon 20mm Anti-Aircraft gun.

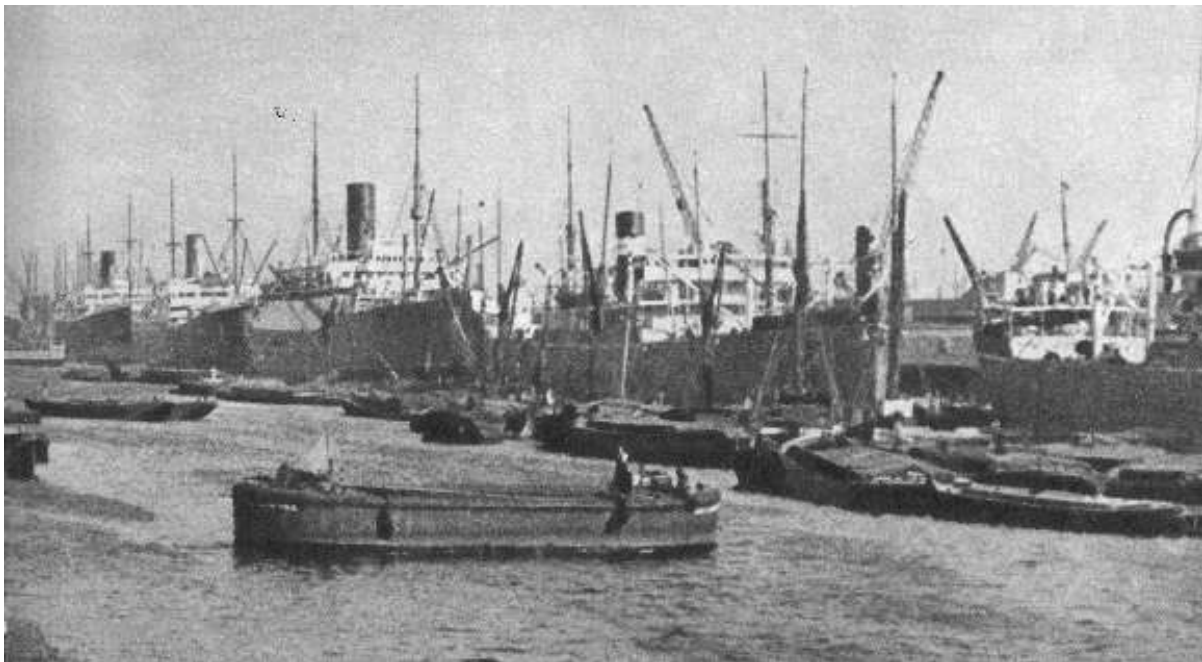
One of the lesser known but nevertheless essential element of Operation NEPTUNE was the role played by a thousand barges and vessels in supplying the invading forces with everything needed to support the Invading forces. The Royal Navy requisition 1,000 Thames barges and lighters and converted many to transport all types of supplies across the English Channel. Many of these barges had no form of propulsion or steerage and were normally towed across the river Thames in peacetime.

Figure 69 - Thames river barge or lighter.

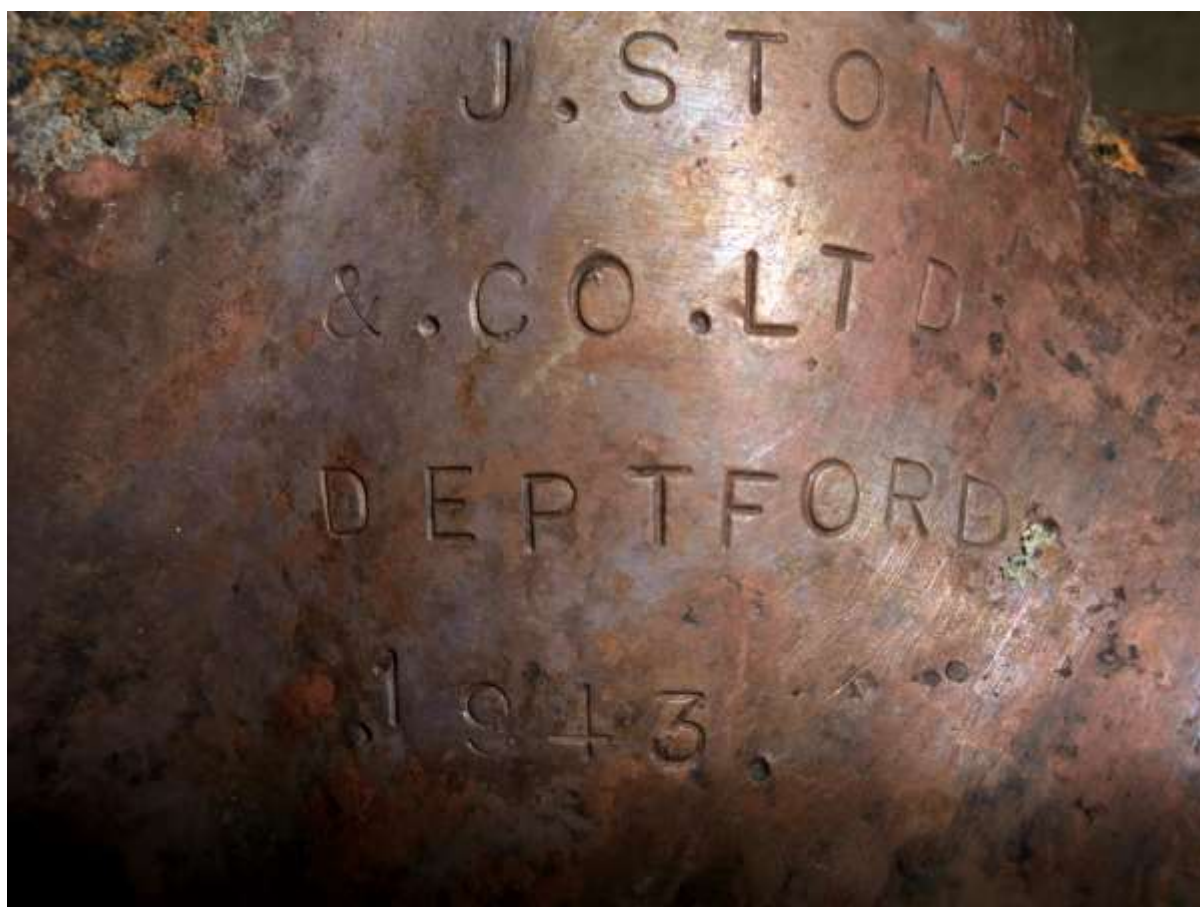
We carefully cleaned the 3 bladed propeller and revealed the makers' name – J Stone of Deptford' and the size pitch etc of the propeller. Importantly, there was also a date stamped onto the propeller of 1943. Each of the 3 blades is 15" from the centre and the propeller weighs 28kgs.

Figure 72 - Propeller maker "J Stone Deptford" 1943.

The propeller has a number "1804" on the edge of boss and details of the pitch etc. On the side as follows;

As mentioned in Part 4 we recovered a small bronze propeller from the site to aid research into dating the barge. The propeller was declared to the Receiver of Wreck in the form of a droit form reference 361/09. The purpose of recovery was to try to establish whether the propeller was part of a cargo or whether it was a spare for the vessel.

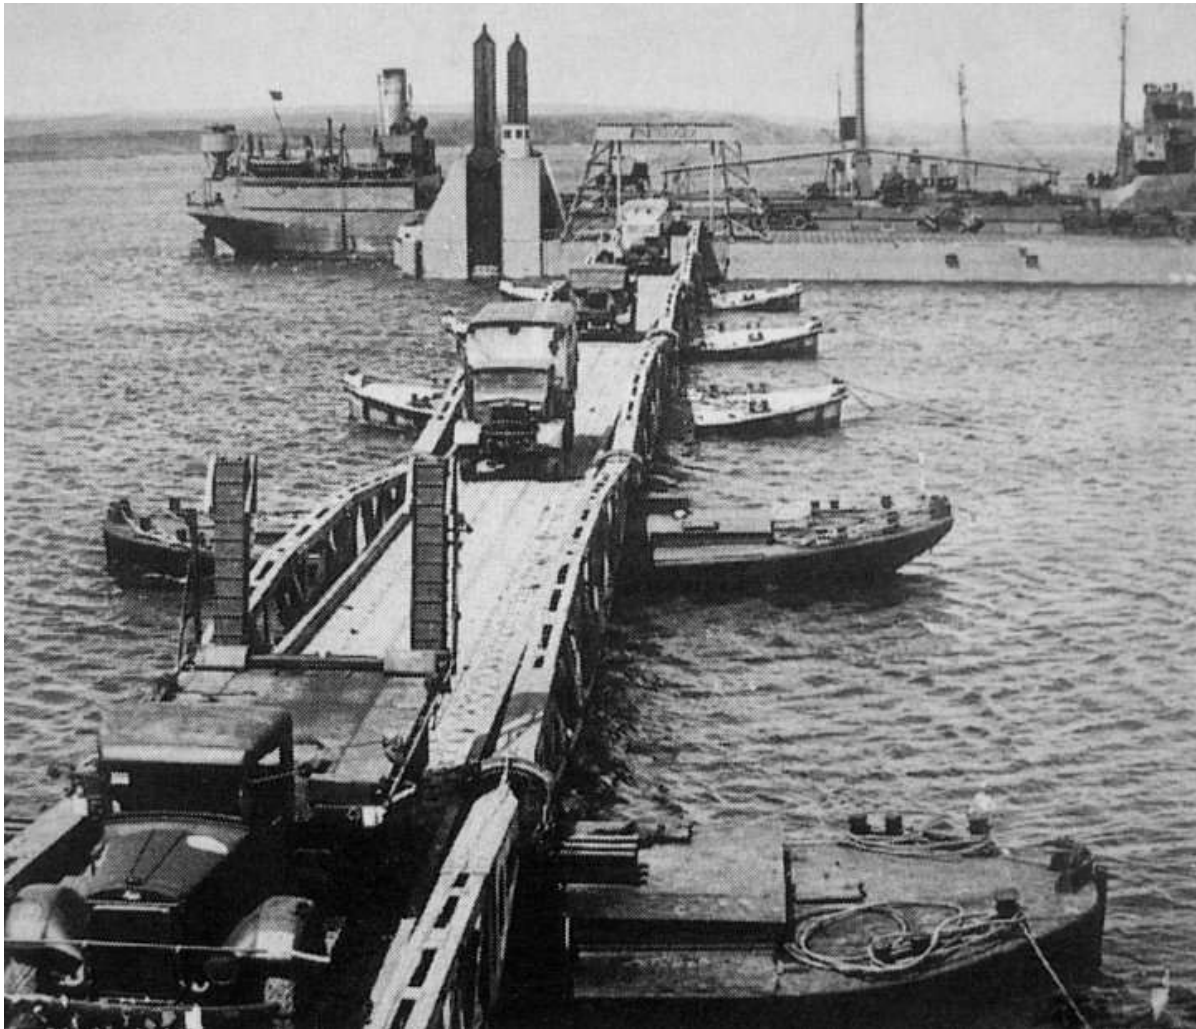
It was difficult to determine what this site may be. The steel 'vessel' had no propulsion and no hold. It was more like a pontoon but with angled corners. Having seen photographs of the Mulberry Harbour whale bridge sections some of the floating pontoons or 'beetles' looked a similar shape.

Figure 73 - Whale Bridge and supporting 'Beetles'.

Beetles were made of either steel or concrete depending on how close to the shore they were to be positioned.

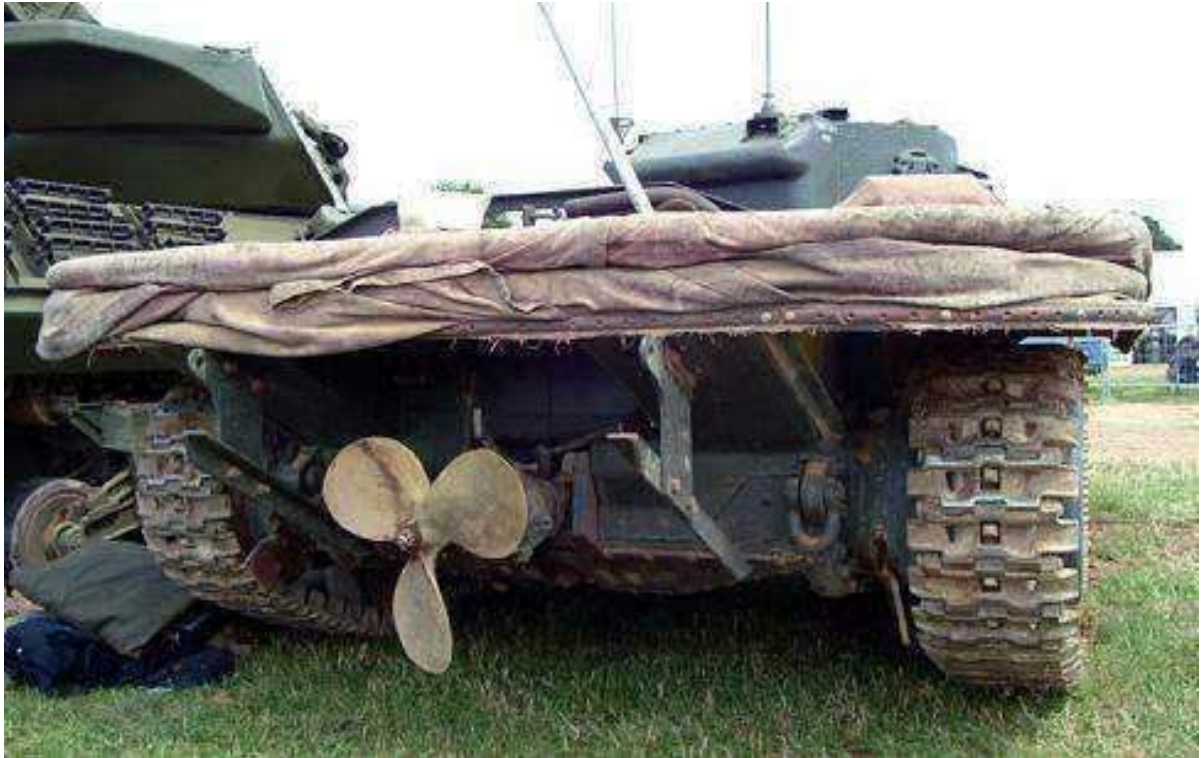
Figure 76 - Restored Valentine DD tank with propeller and canvas skirt.

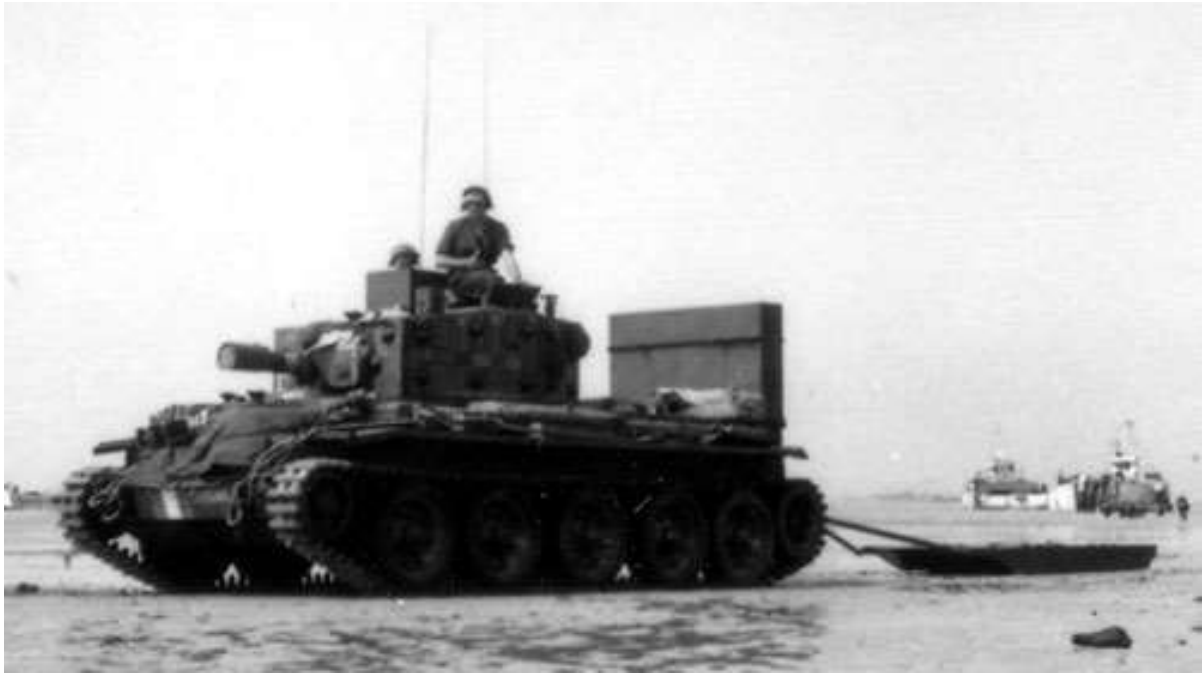
In our 2008 survey of the tanks and bulldozers site we recorded two items which we thought may be porpoise ammunition sleds. Porpoises were towed by Centaurs as a means of taking extra ammunition with them as they progressed inland at the front of the invading forces. Porpoises were waterproofed and could be towed across the beach to the shore. Once moving inland they tended to overhead on roads etc.

Figure 78- Centaur tanks towing a 'porpoise' ammunition sled.

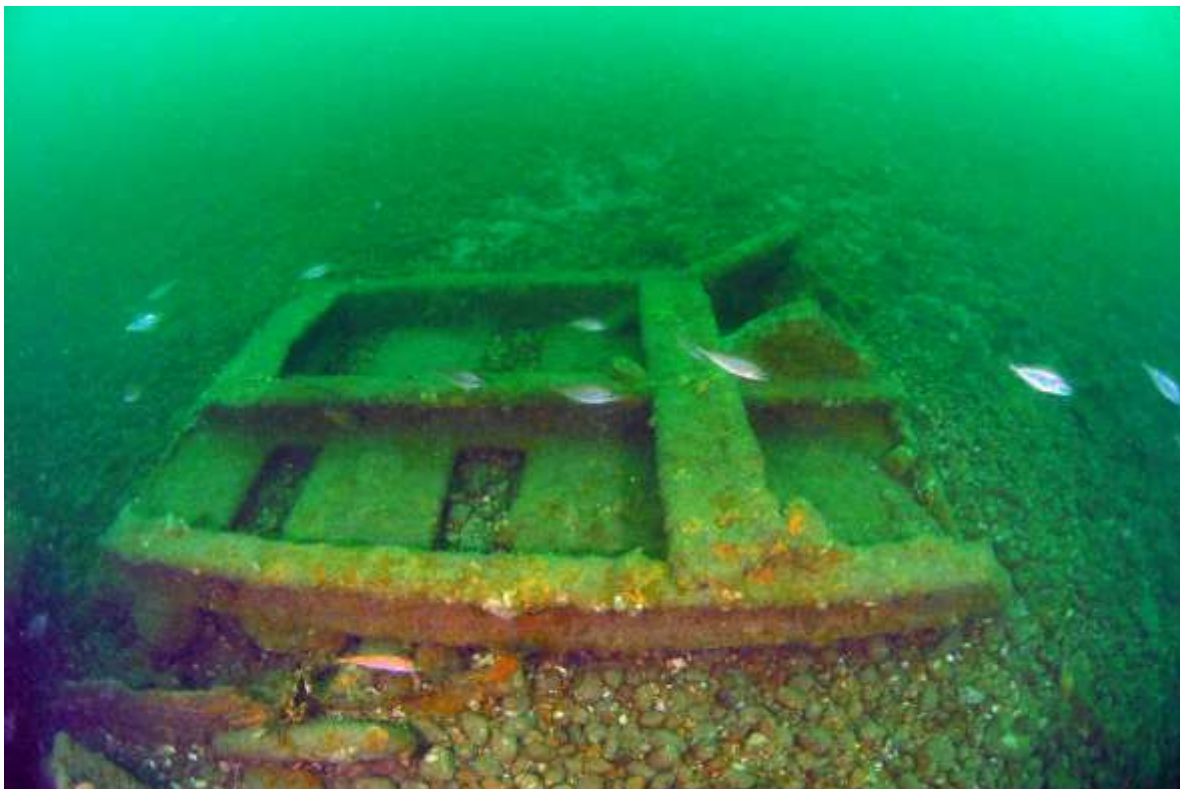
Figure 79 - Tanks & Bulldozers 'porpoise'?

Whilst the size and shape of these items closely resembled the porpoise, there was no ammunition present and we had expected to find some.

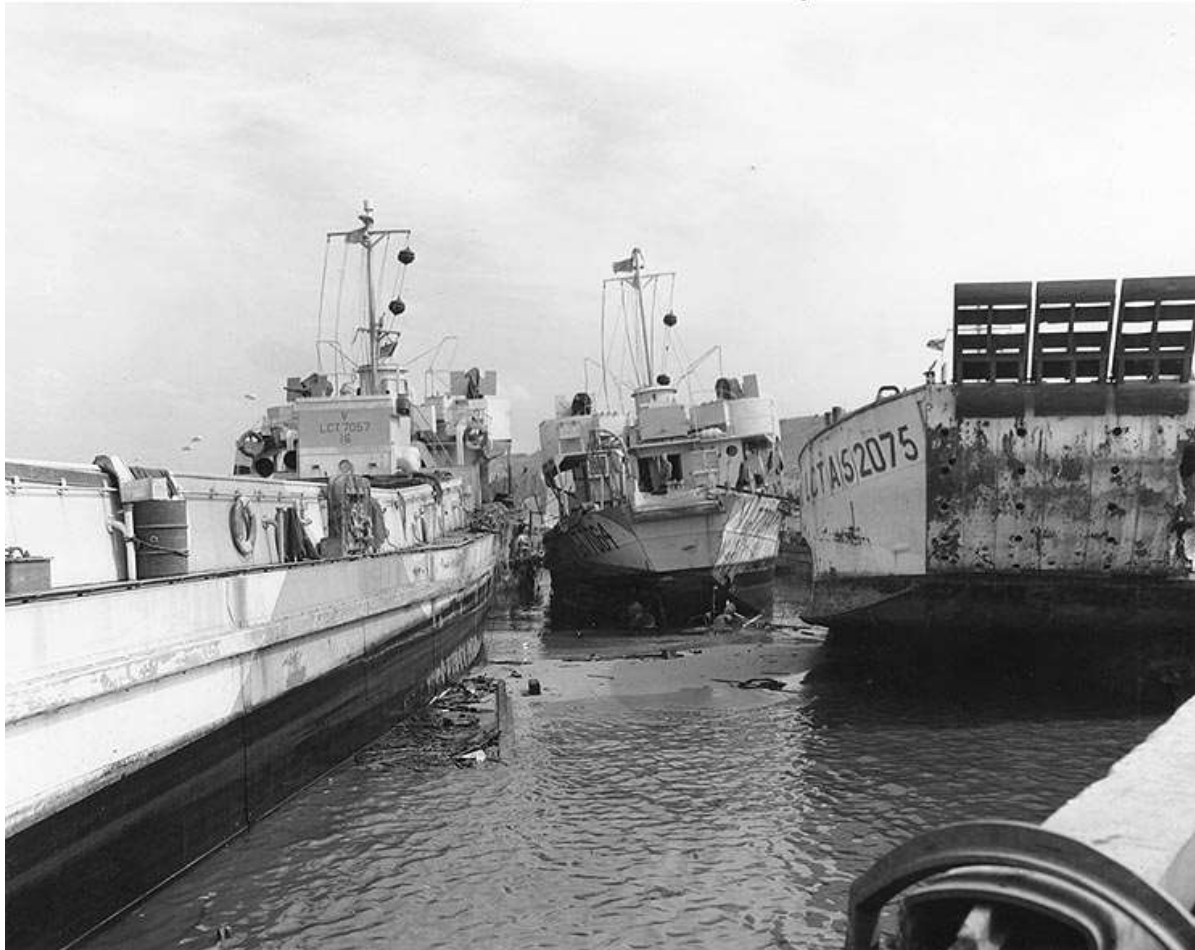
Photo # 80-G-286432 British LCTs 7057, 7064 and 2075 wrecked by the storm of 19-22 June 1944

Figure 80 - Ramp extensions on LCT(A) 2075.

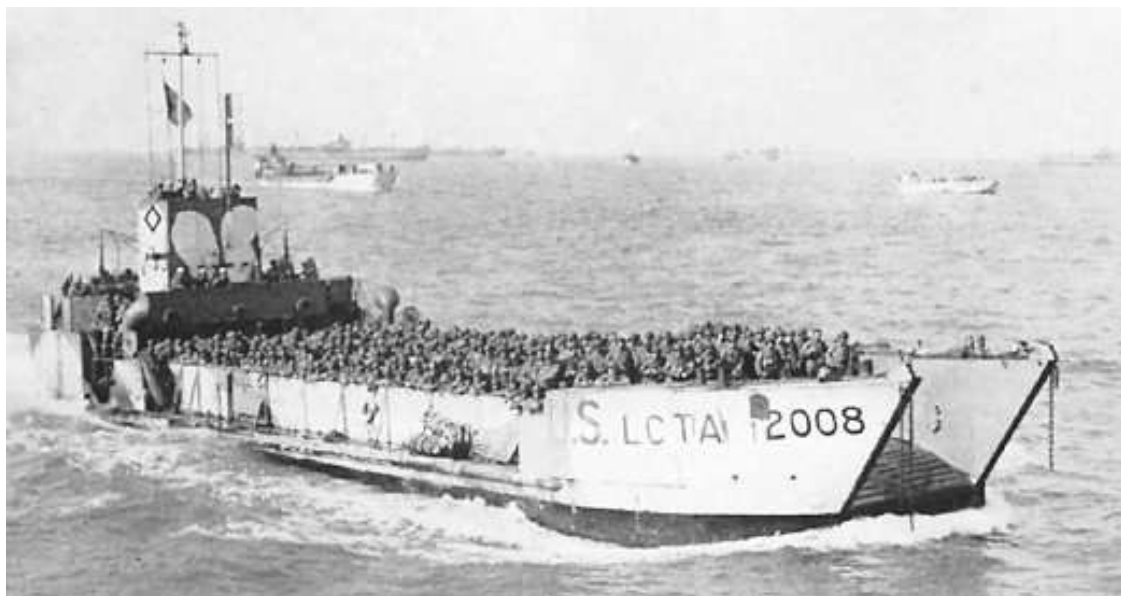
Figure 81 LCT 8/LCT (A) 2008 at Normandy, notice the missing bow ramp

Armor was added so these LCT (A)s could go into the beach at H Hour with firepower from two tanks. A wooden ramp of heavy timbers was built so the two tanks side by side up forward could fire going into the beach. The ramp raised them high enough so they could fire over the bow ramp. A last minute problem developed when ramp extenders were added that in an extended

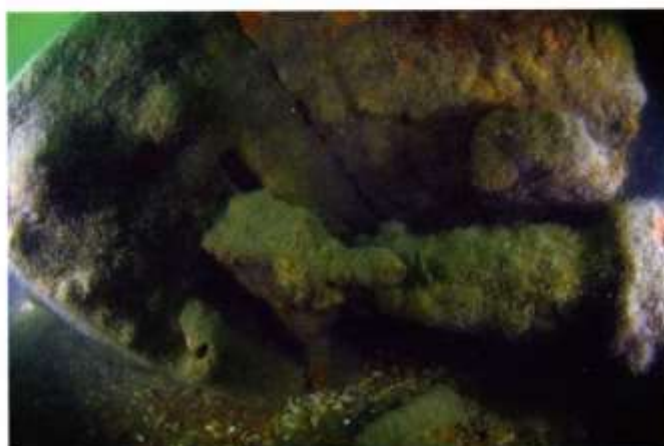
Caterpillar bulldozers, one of a series of modifications to different types of war equipment known as 'Hobart's Funnies'. This type of bulldozer was used by the British Army's 79th Armoured Division. Little is known about the modifications made and there are no known surviving bulldozers of this type.

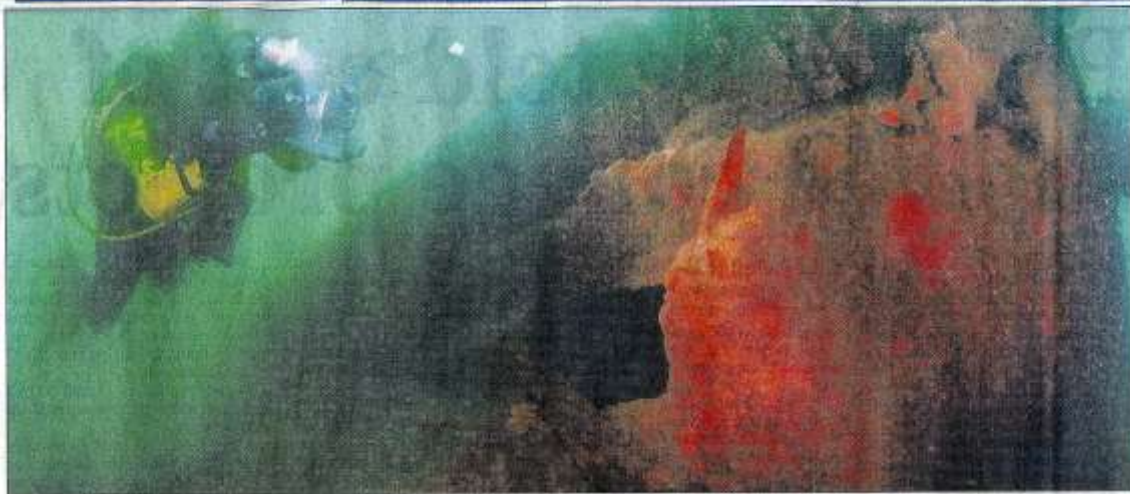
A diver explores the second world war tanks and bulldozers on the seabed at Bracklesham. PICTURE BY MARTIN DAVIES

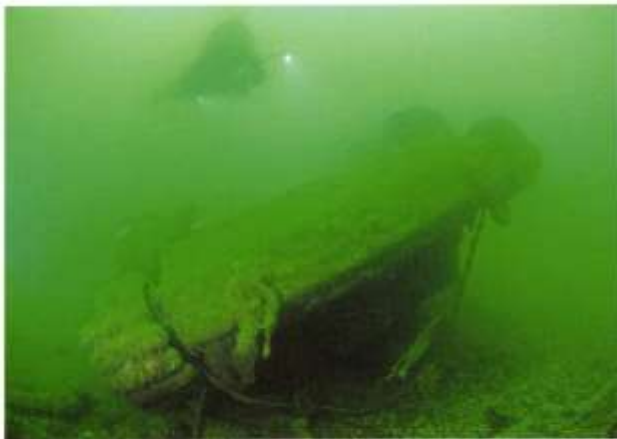
Tank A © Martin Davies

At the site one tank lies upside down, the other is on its right side at an angle of approx 45 degrees. Because of their armoured construction they are in excellent condition despite more than 65 years on the sea bed. The distinctive 12 inch round plate on the front of the tanks, a unique identifier for Centaurs, is clearly visible on both tanks. The bulldozers lie on their sides just three or four metres behind the tanks. One is complete with its magnificent huge blade standing almost three metres high. Sadly the blade of the other bulldozer has broken off but lies close by.

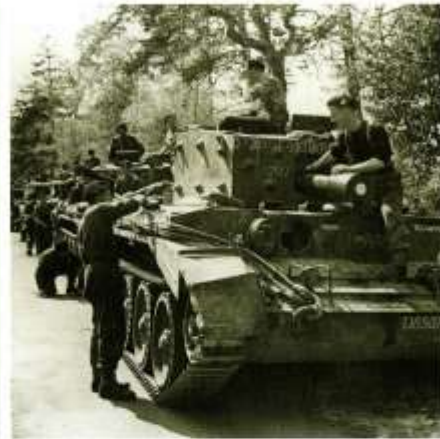
Centaur CS N, Hampshire © The Tank Museum

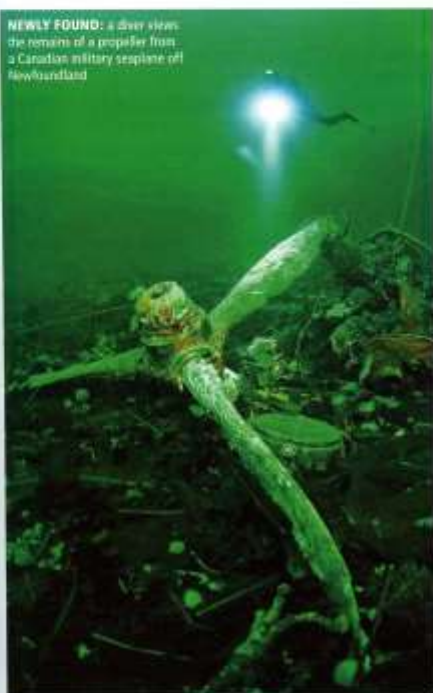
**NEWLY FOUND:** a diver views the remains of a propeller from a Canadian military seaplane off Newfoundland

Colin Fairhurst of Seaways Diving, also from Cornwall. They located an engine and propeller that had been missed by the original salvage – the fuselage is yet to be found.

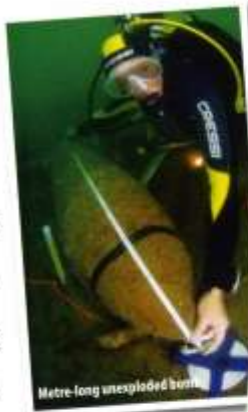
Metre-long unexploded bomb.

While working at the LCT site, the divers also found an unexploded bomb, more than a metre long.

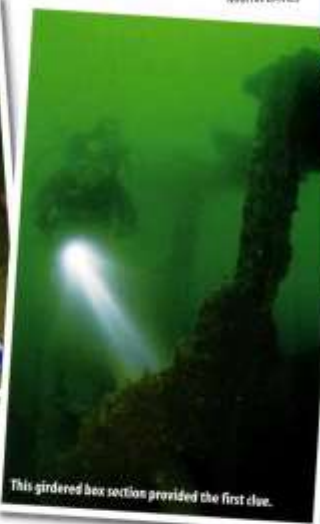
Little remained of the wreck's main structure except a girdered box section. This tallied with LCT design, in

which the hull was built in three parts connected by such sections. The section indicated that the hull had settled upside-down, as expected of a craft that sank after capsizing.

This girdered box section provided the first clue.

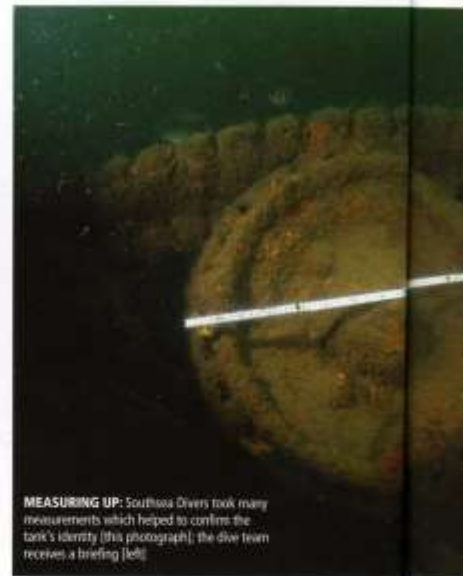
**MEASURING UP:** Southsea Divers took many measurements which helped to confirm the tank's identity (this photograph); the dive team receives a briefing (left)

On our initial dive, we established that the tanks were not the commonly used Shermans we had expected to find. They were definitely British, but with a shorter-barrelled, large-calibre gun. Experts at the Bovington Tank Museum subsequently identified them as Centaur CS IV tanks – only 80 of these vehicles had been

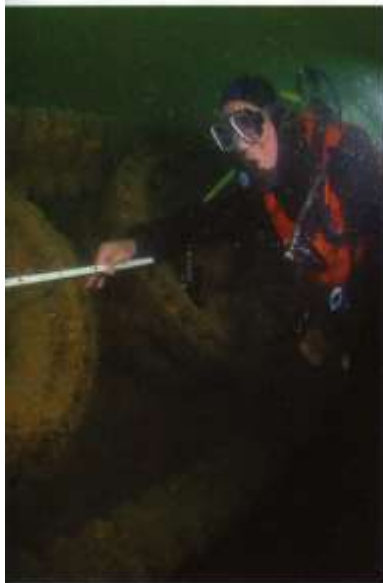
**RESTING PLACE:** Second World War Royal Marines prepare their tanks (left); the tanks' final resting place in Bracklesham Bay (below)

One tank lies upside down, while the other sits on its right side at a 45-degree angle. Thanks to their armoured construction, they are in excellent condition despite 64 years on the sea bed. Some track is missing on one tank, but they are

otherwise intact. Both tanks have a distinctive 30cm round plate on their front sides – a unique feature that identifies them conclusively as Centaurs. At the back of the tanks there are tow bars for pulling the porpoises – waterproof sleds designed to be dragged behind the tanks to carry the extra ammunition they needed for their missions.

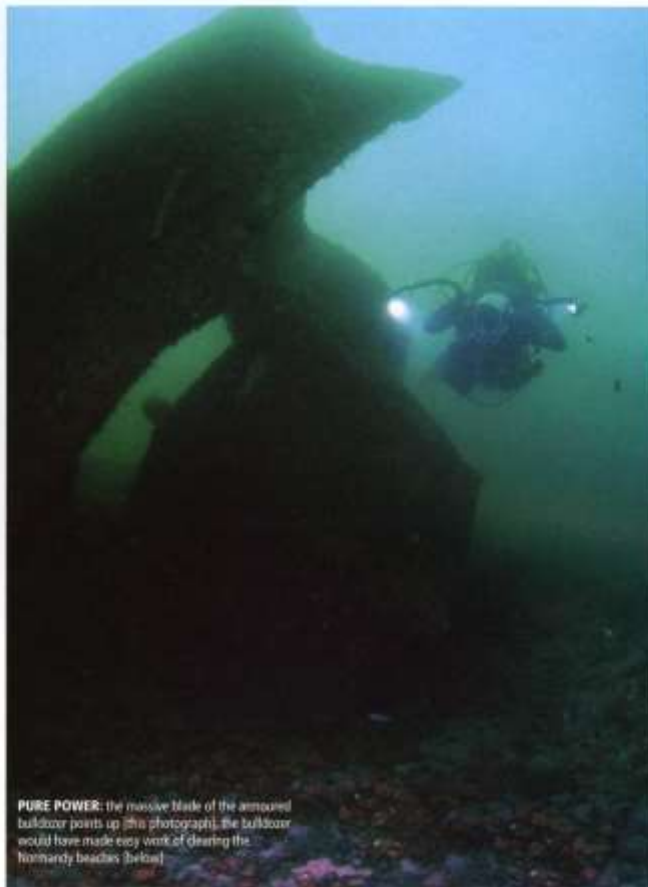
**PURE POWER:** the massive blade of the armoured bulldozer points up (this photograph), the bulldozer would have made easy work of clearing the Normandy beaches (below)

The two armoured bulldozers lie on their sides about 4m behind the tanks. They were intended for use on the landing beaches, to smash through German obstructions and push aside crippled tanks. One is completely intact, its five-ton plough standing 3m high. The plough of the other has broken off the second bulldozer, but lies nearby. These powerful machines had a winch on the back and huge hydraulic rams, which could have easily shifted practically any obstacle in its path. The driver's cab and the whole of the body of the bulldozer were covered in thick armour to protect against enemy fire.

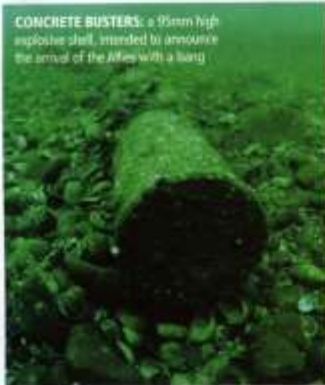
**CONCRETE BUSTERS:** a 95mm high explosive shell, intended to announce the arrival of the Allies with a bang

Ammunition. Care should be taken on the site. The Centaurs would have been supplied with 95mm High Explosive ammunition and if found on the site could prove to be unstable.

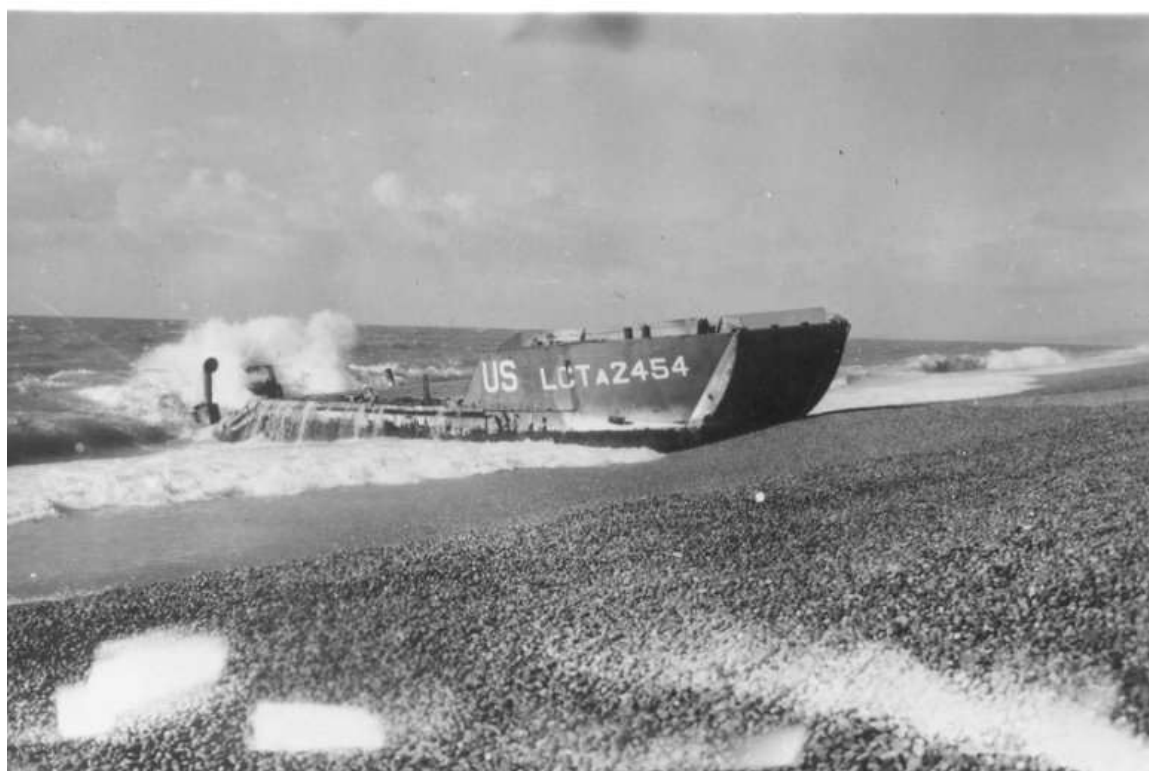
Figure 86 - LCT(A) 2454 wrecked at Chesil Beach 13 Oct 1944

Of the estimated 48 LCT(A)s modified specifically for their role in the first wave of the assault, none remain as floating vessels and only one other (LCT(A)2454) is recorded in the National Monuments register as a wreck site. LCT(A) 2454 is well broken up and lies, partly buried and in shallow water off Chesil Beach, Dorset.
