# USS LST-496 AND 523

Report of the investigation of WW2 wrecks reported to be USS LST-496  
and USS LST-523, Baie de Seine, Normandy, France

Southsea Sub-Aqua Club | BSAC Branch 0009  
May 2023

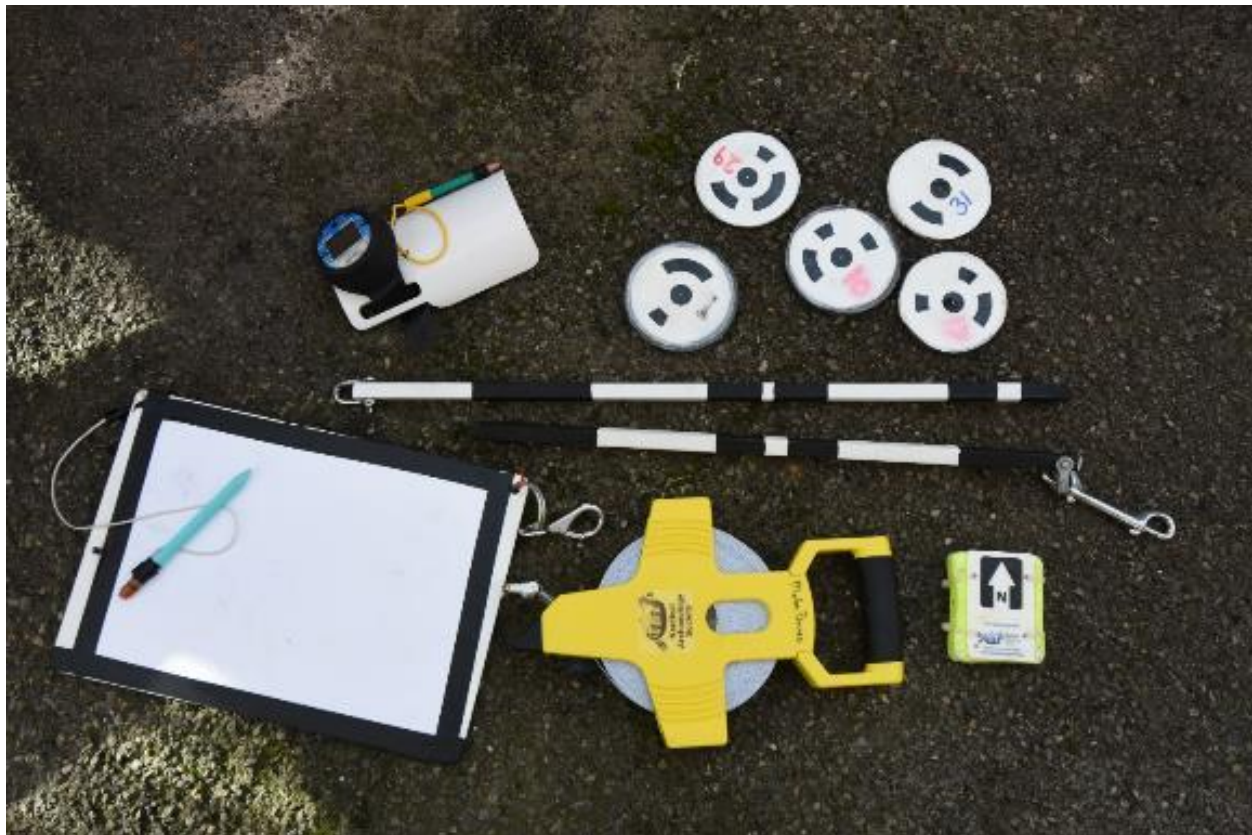
Figure 11. Typical survey equipment used for the project. (© Martin Davies)

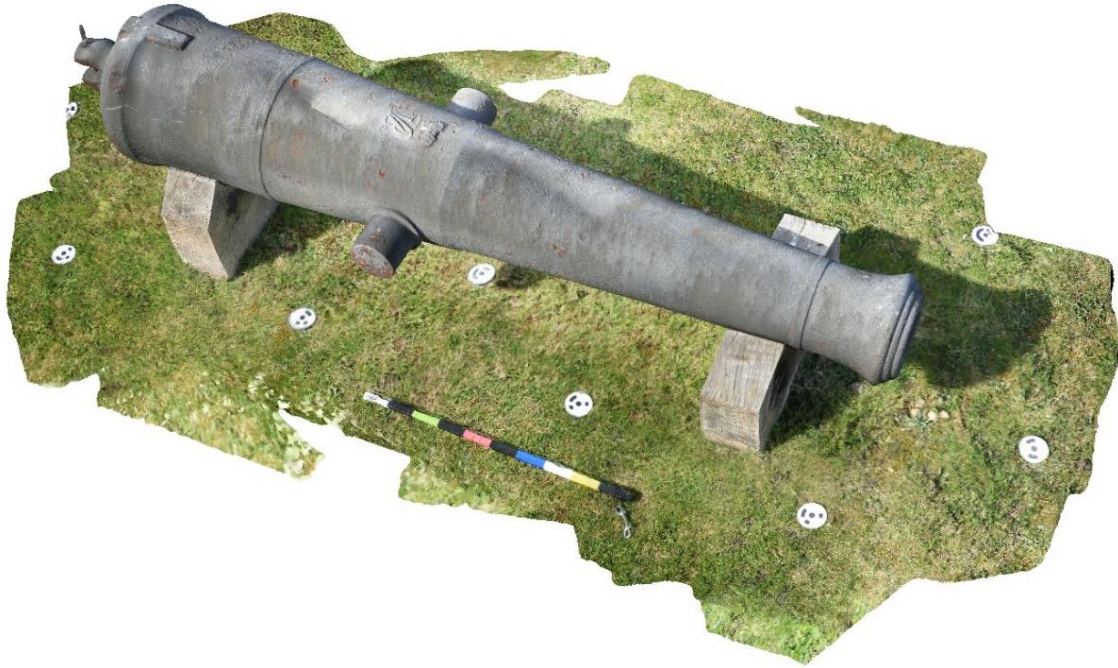
Additional survey equipment such as scale bars and circular ‘targets’ were used to assist the software to identify control points and assist in the creation of the image. Each target has a unique identification symbol irrespective of orientation.

Figure 12. Use of photogrammetry targets (© Martin Davies)

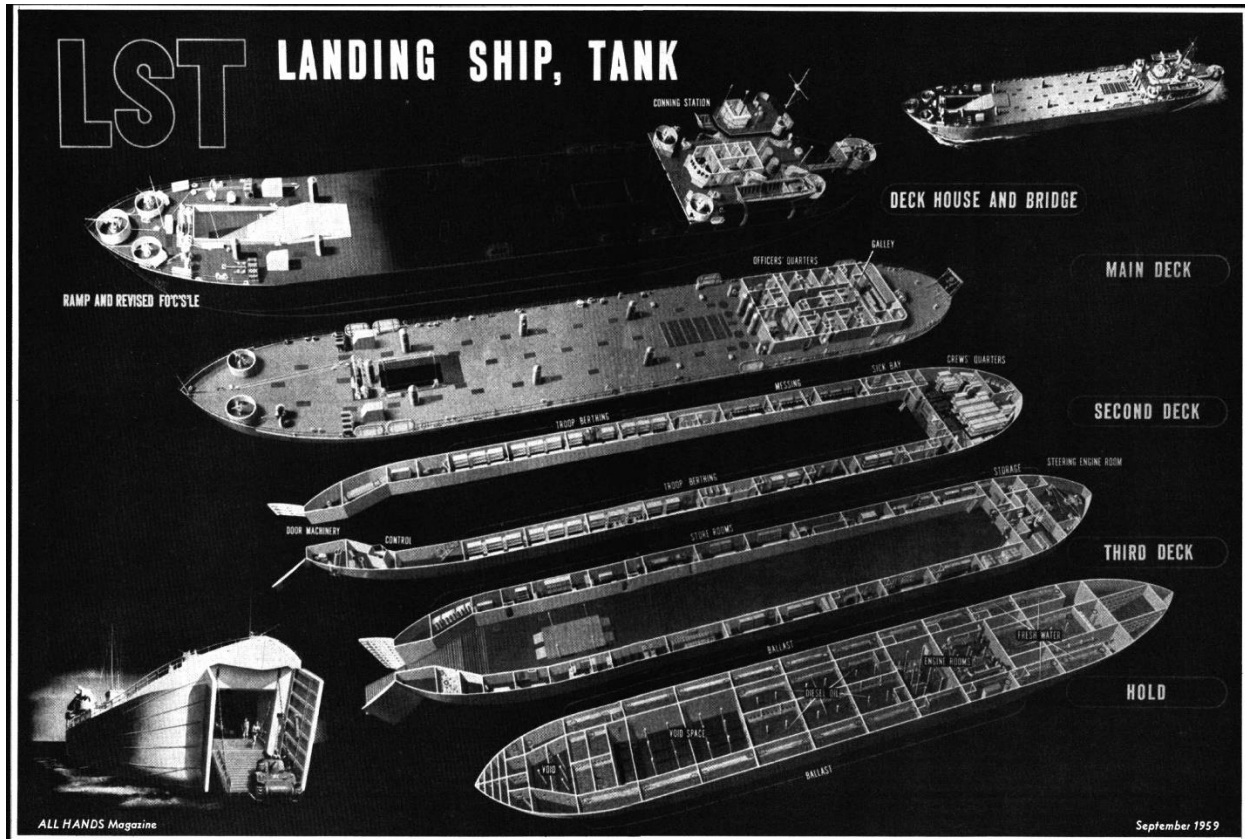
Figure 13 Technical drawing of a U.S. Navy World War II-tank landing ship ("LST")  
 (© US Navy All Hands Magazine DOD US PD)

All three LSTs (496, 499 and 523) were LST-491 class design. However, from LST-513, the elevator to transfer equipment between the tank deck and the main deck was replaced with a 12 by 32 ft (3.7 by 9.8m) ramp that was hinged at the main deck. This allowed vehicles to be driven directly from the main deck down to the tank deck and then across the bow ramp to the beach or causeway, speeding the process of disembarkation.<sup>24</sup>

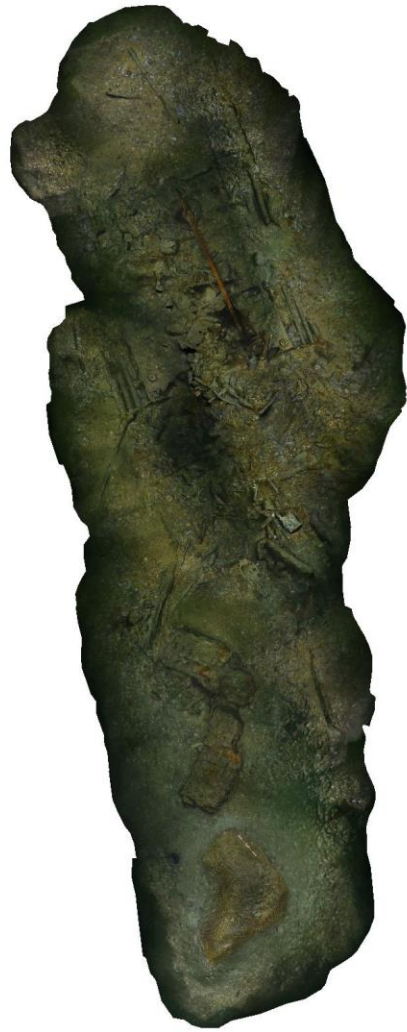
Figure 16 Comparison of photogrammetry to DRASSM multibeam of EA3232 (© Martin Davies and DRASSM)

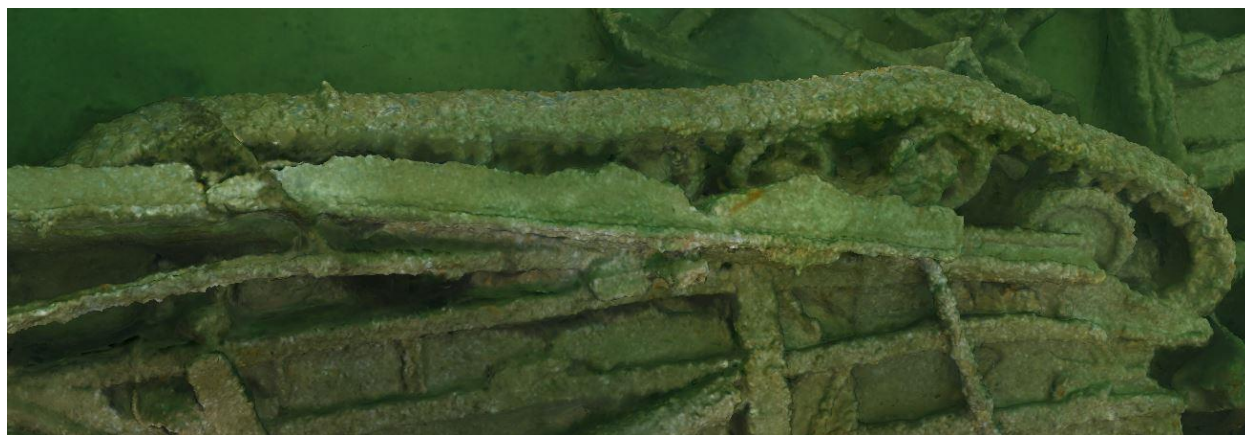
Figure 36 Tracks and wheel and suspension assembly of upside-down Sherman tank. (© Martin Davies)

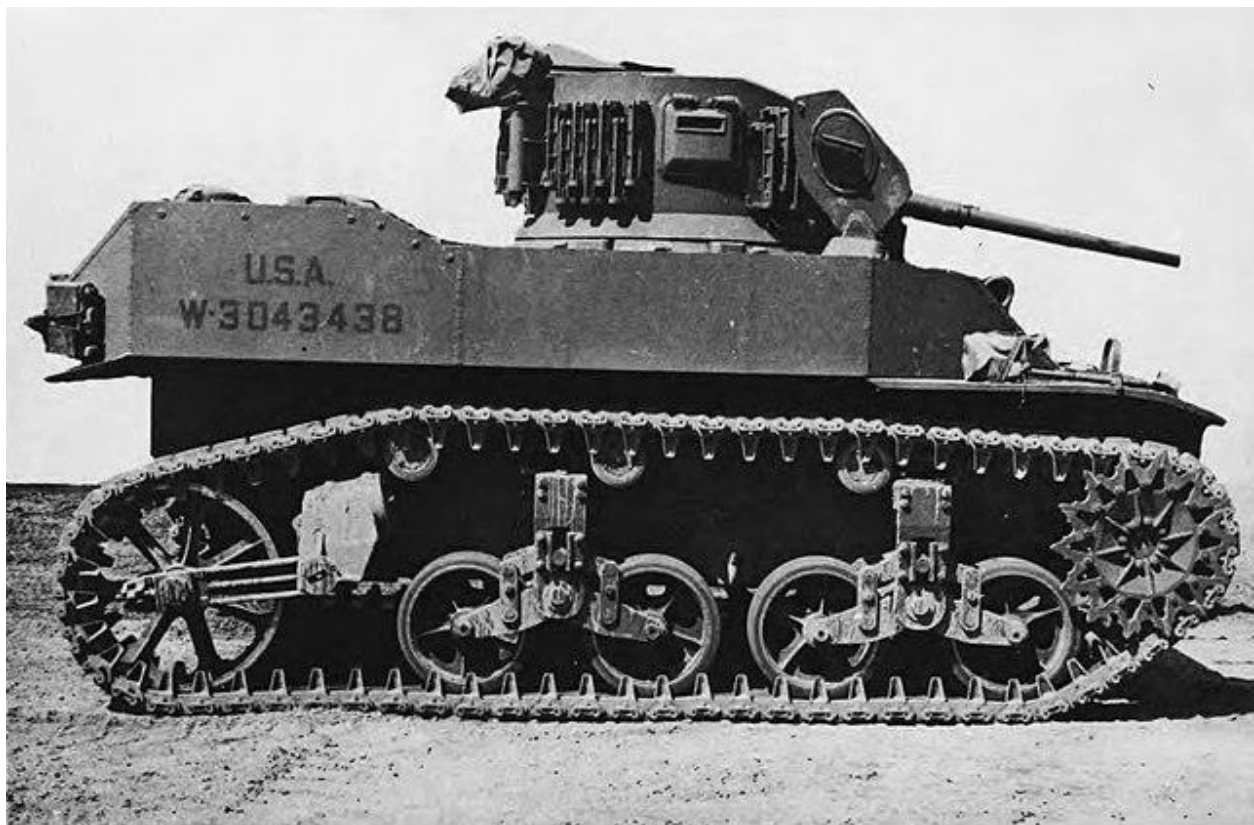
Figure 37 Stuart M5A1 tank (© US PD)

Figures 38 and 39 below are of Stuart tanks found on the wreck and are from photogrammetry models. Both tanks are upside down and the two pairs of suspension wheels are visible. Also clearly visible is the raised engine compartment that is indicative of a M5A1 version.

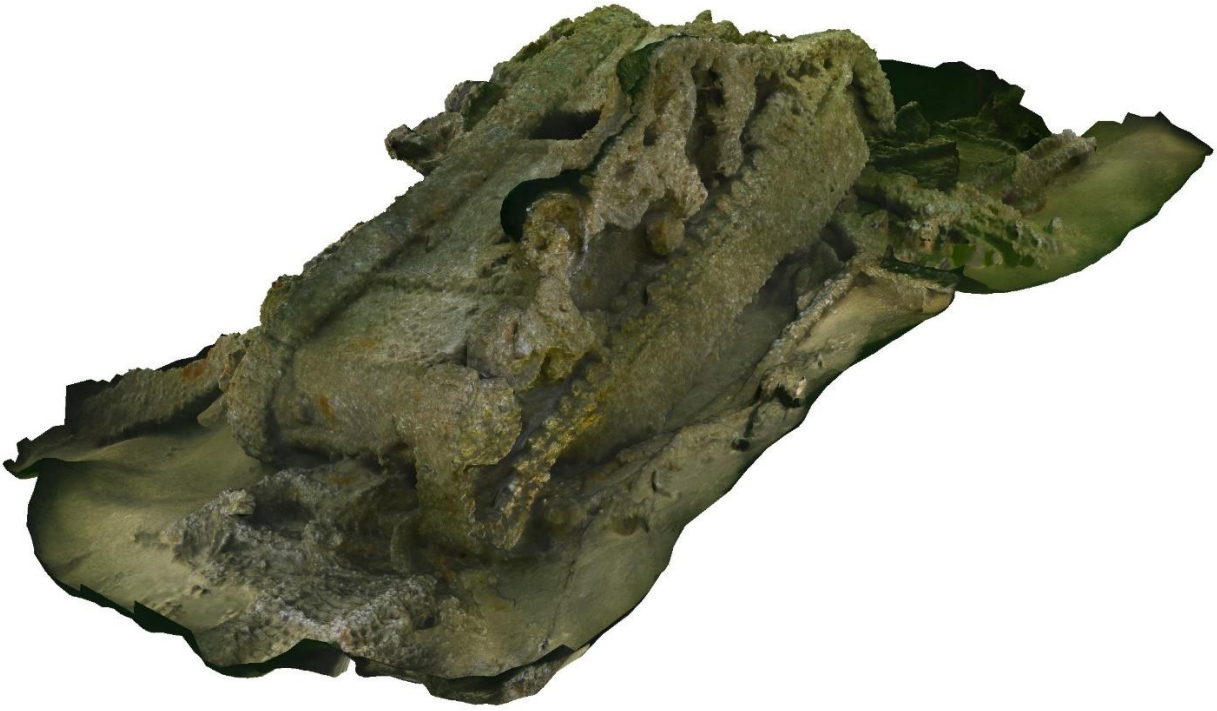
Figure 38 Front and right-hand side view of a Stuart M5A1 tank. Note the raised engine section which distinguishes it from a Stuart M3. (© Martin Davies)

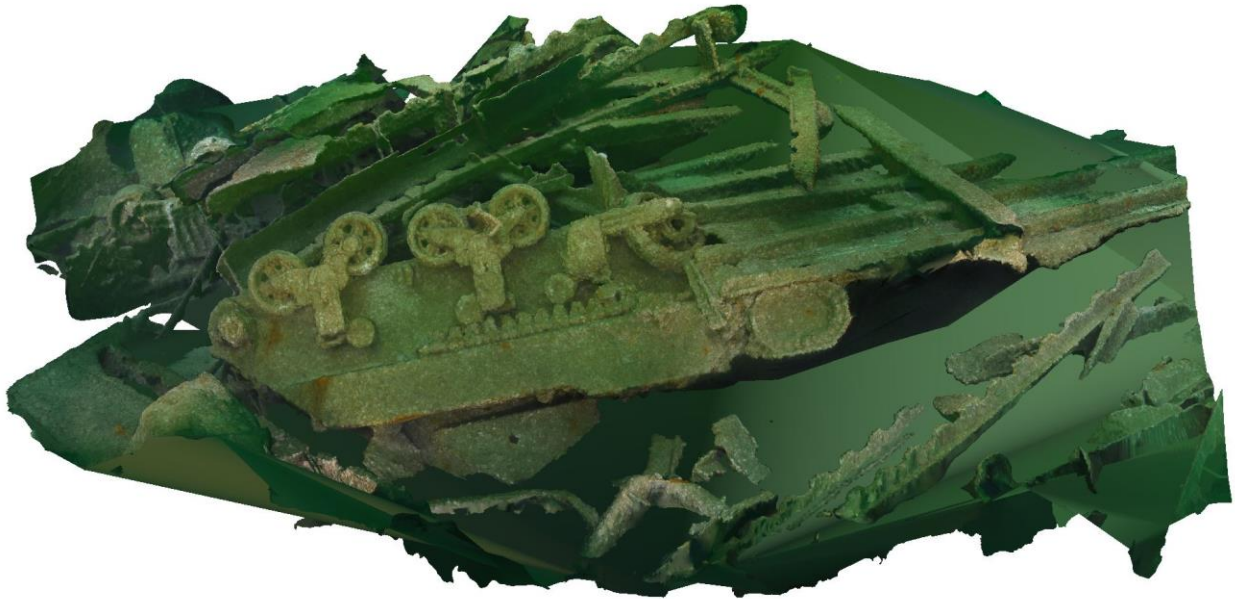
Figure 39 The second of the Stuart M5A1 tanks (© Martin Davies)

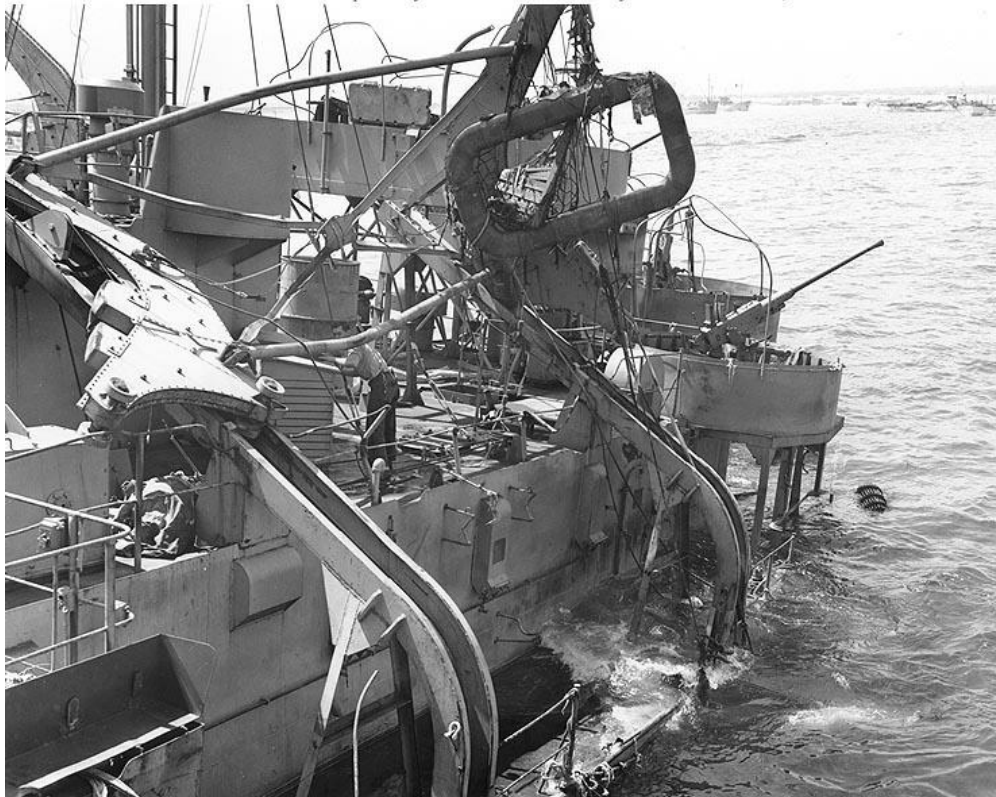
Photo # 80-G-253022 LST partially sunk off the Normandy invasion beaches, 15 June 1944

Figure 43 Stern of partially sunken LST Normandy 15th June 1944. (© US PD)
