Submarine A1 Licensee report 2015

Overview

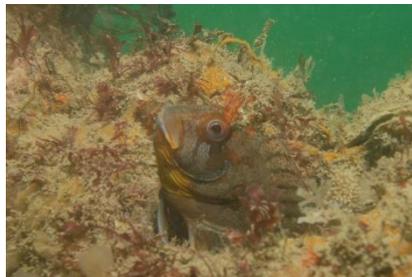
Figure 1 tompot blenny

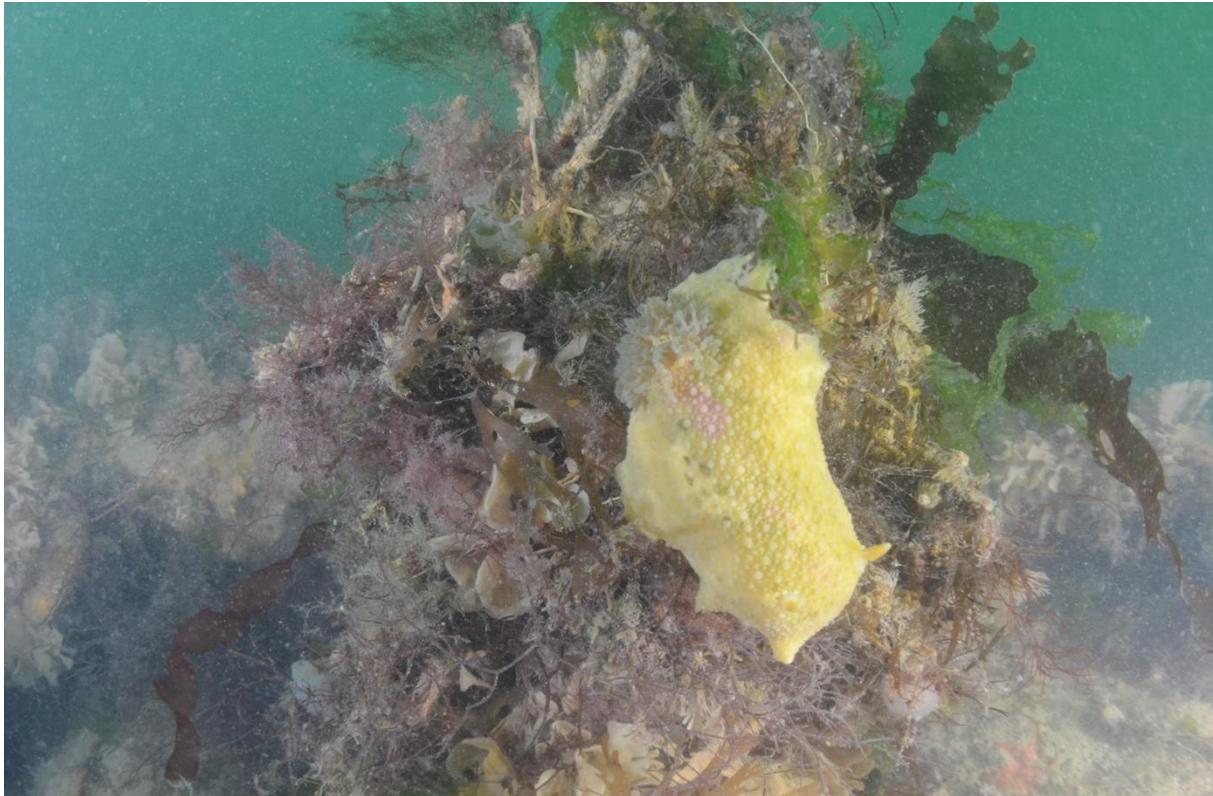
Figure 6 Sea Lemon nudibranch

A sea Lemon was observed at the stern, this is the largest nudibranch that we get in the UK and always good to see one. We also visited the area 8m beyond the stern to see the remains of what is thought to be a large navigation buoy; this appears to be a bit more exposed at the moment and is home to a lobster. The presence of the buoy will remain a mystery and while it could have been
