HM Submarine A1 Licensee Report 2012

by Martin Davies

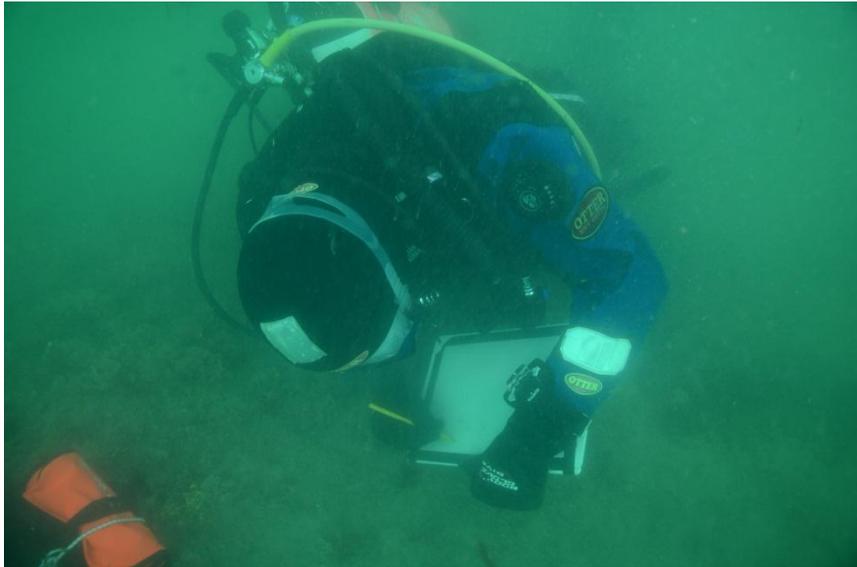
I visited the site again with members of Southsea BSAC, many thanks to Edward Rollins and Doug Carter for their assistance in taking some of the measurements while I was taking photographs. The measurements were of the crack in the conning tower which does appear to be growing from personal memory. From this date onward I intend to measure and monitoring the crack in the front of the conning tower and also a smaller one in the rear more carefully. See figures 4 to 6 for details.

The wreck of the A1 Submarine remains a stable and robust site for visiting divers to see, while she is showing signs of deterioration in many areas, the cracks in the conning tower being the most visible.

Figure 5 Width of crack is 8cm to 11cm
