TWO TUGS

Report of the investigation of WW2 wrecks reported to be HMRT SESAME
and USS PARTRIDGE, Baie de Seine, Normandy, France

Southsea Sub-Aqua Club | BSAC Branch 0009
December 2019

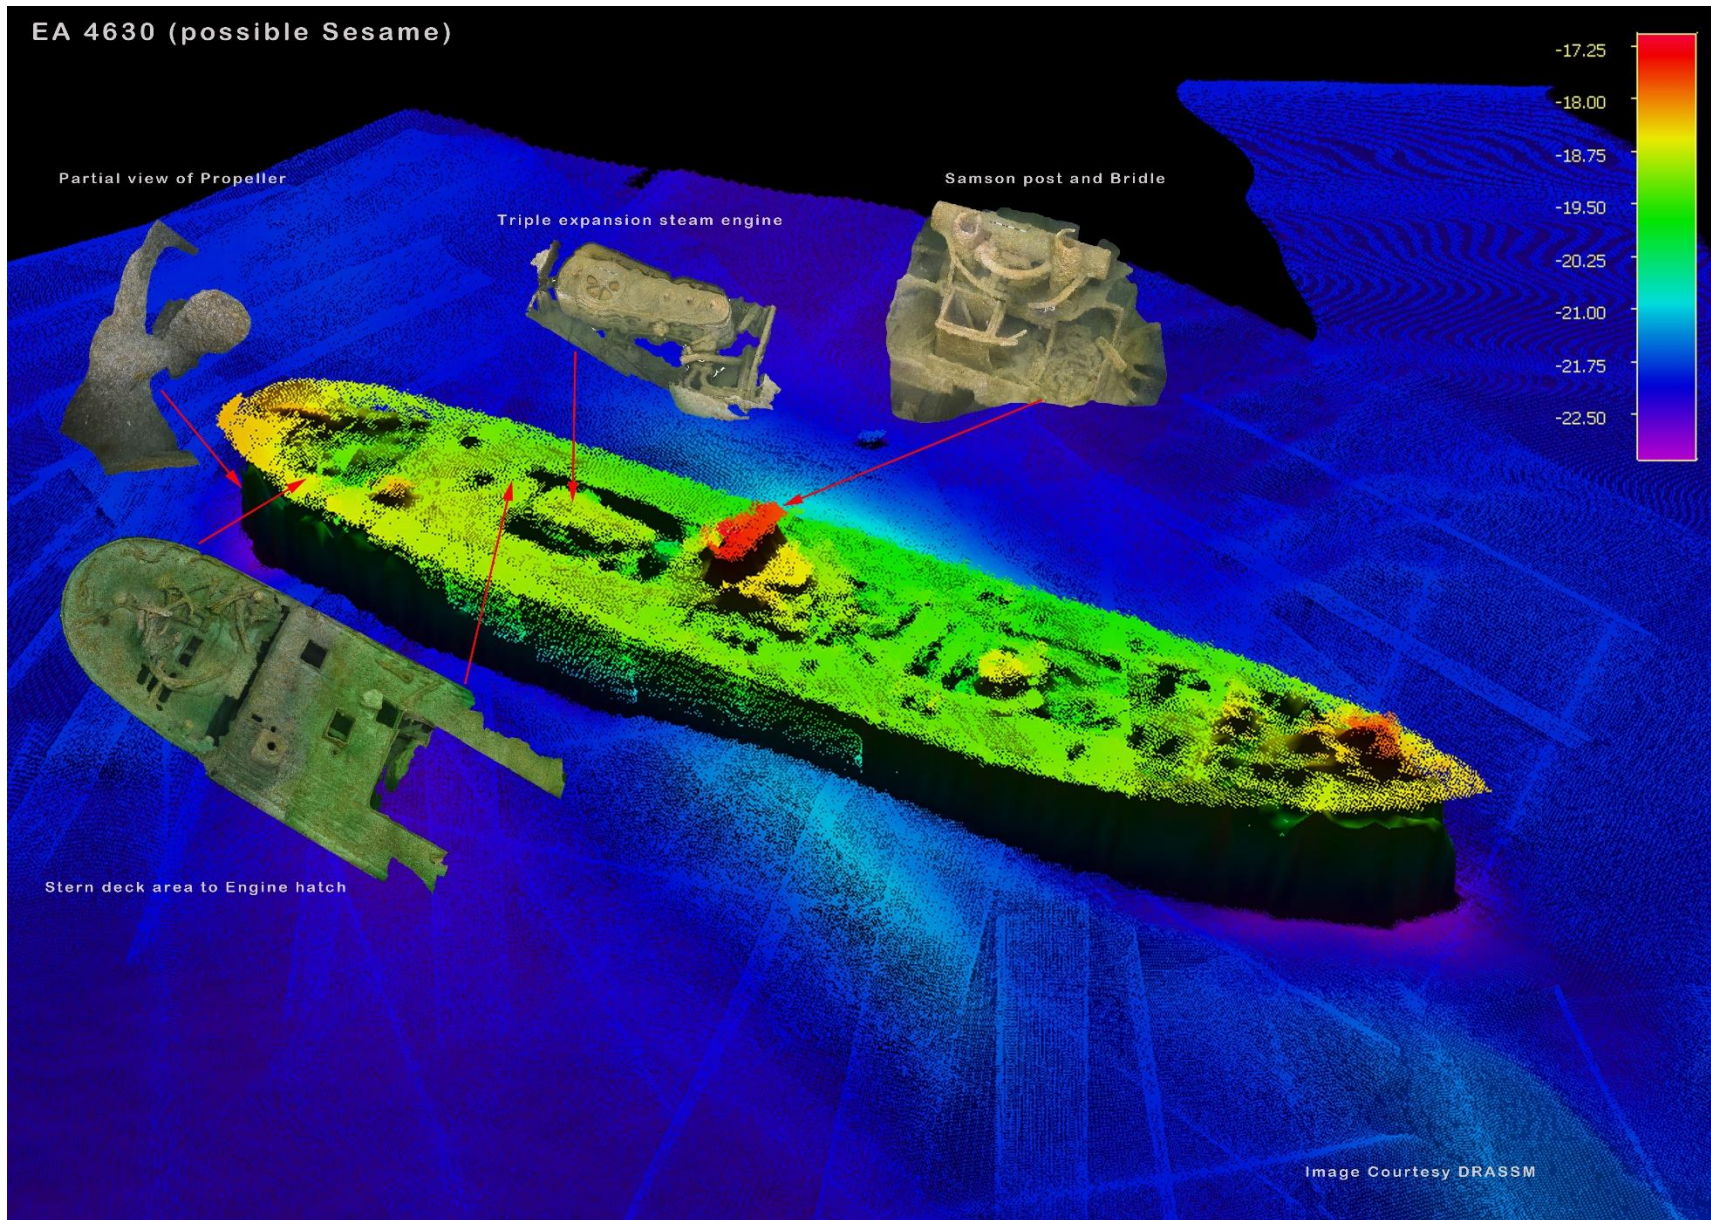
Figure 15 Multibeam image annotated with key features observed on the wreck. (© DRASSM and Martin Davies)

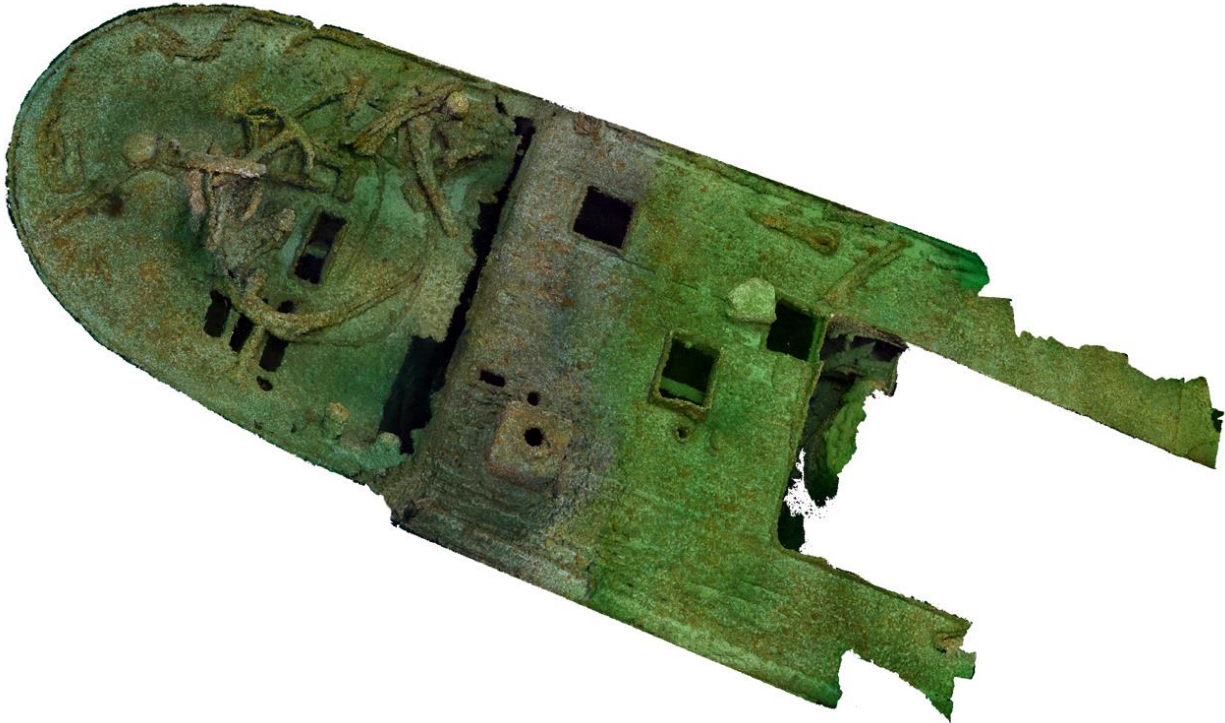
Further measurements and observations were recorded from the engine bay to the stern. It was noted that the wreck had a break in the structure, which was approximately 6m from the stern extending across the width of the deck (6.3m) and partially down the starboard side of the ship.

A photogrammetry model was also produced of the section between the engine and stern area of the wreck. This model clearly shows the break in the wreck structure and collapse of the deck.

Figure 18 EA4630 Image created from photogrammetry model – a plan view of the deck from the engine bay to the stern. Note steering quadrant and anchor. (© Martin Davies)

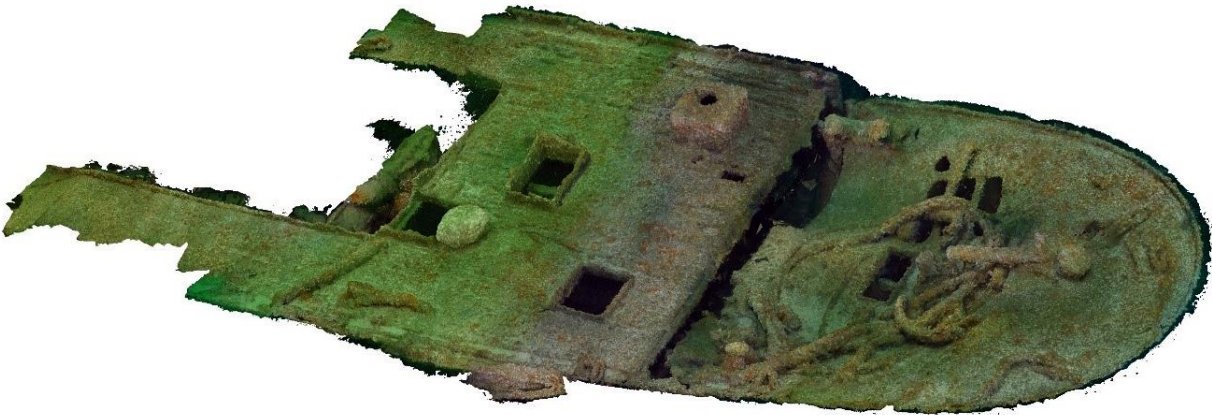
Figure 19 EA4630 Image created from photogrammetry model - stern from the port side showing the collapse of the deck area. (© Martin Davies)

The top of the rudder post and steering quadrant were observed together with an anchor and rope. The damage to the starboard side at the top of the hull was significant, but we could not determine whether this had occurred at the time of the sinking or afterwards. However, given the intact condition of the wreck elsewhere, and this being the only evidence of a breach in the hull's integrity, it may be that the damage was a contributory factor to the sinking.

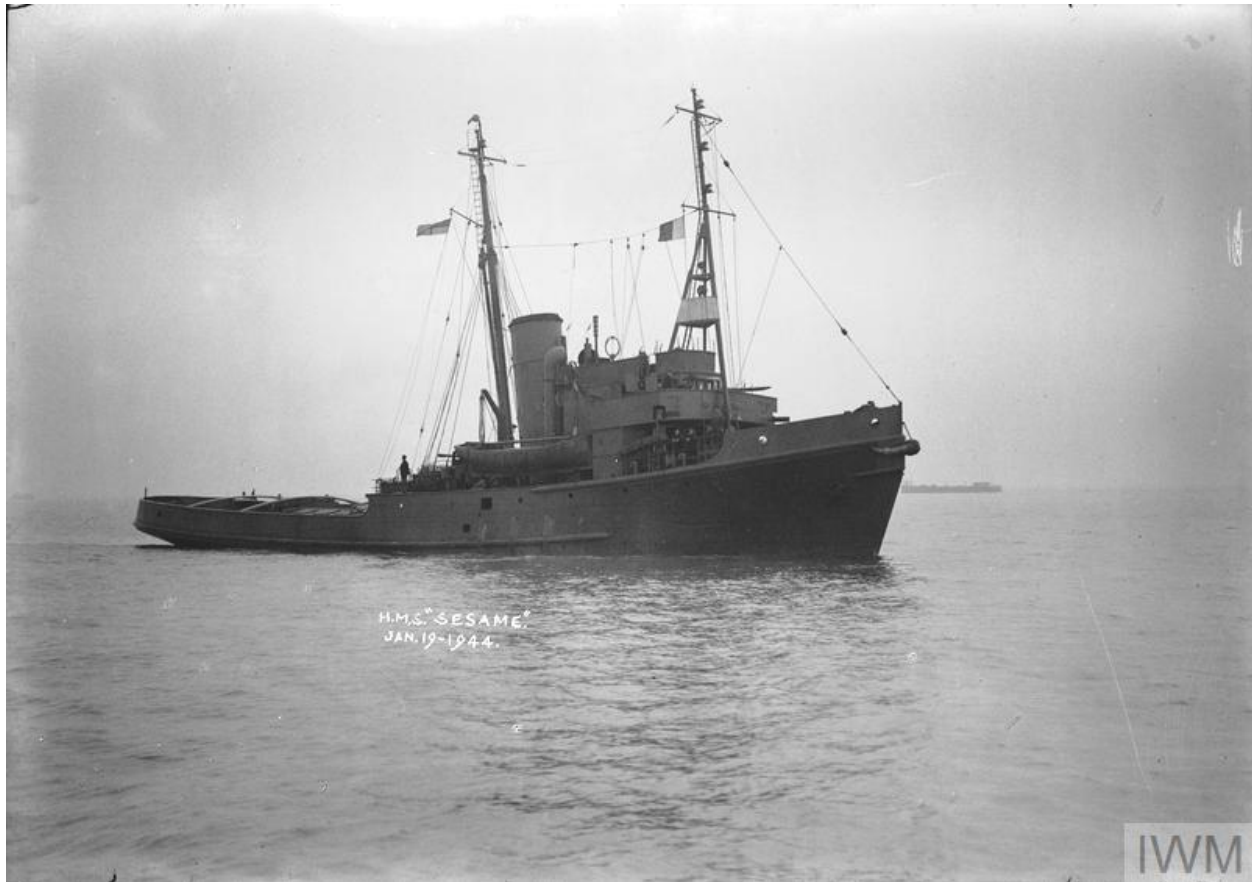
Figure 21 Photograph of HMRT SESAME January 1944. Note the stepped hull shape. (© IWM (FL 18913))

Observation 1 - The wreck is too small, both in length and width, to be that of HMRT SESAME.

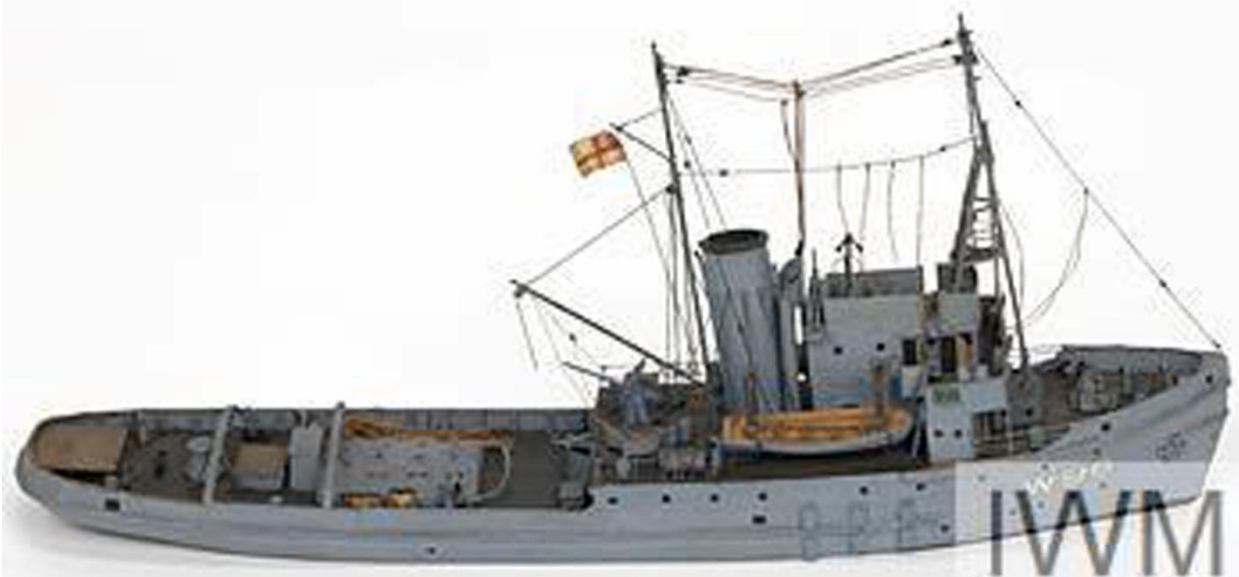
Having viewed the original construction drawing for Assurance Class tug HMRT ANTIC it was noted that this class of tug was fitted with a 'Monarch Patent tow hook' and the towing stanchion assembly was very different from that observed on the wreck. In addition the Assurance class tugs were fitted with a large capstan winch near the stern. No such winch was observed on the wreck.

Figure 25 Model of HMRT PROSPEROUS, and Assurance Class tug showing tow hook assembly (and stepped hull). (© IWM (MOD 575))

Observation 3 - The towing stanchion assembly on the wreck is not of a design that was present on Assurance Class tugs (such as HMRT SESAME).

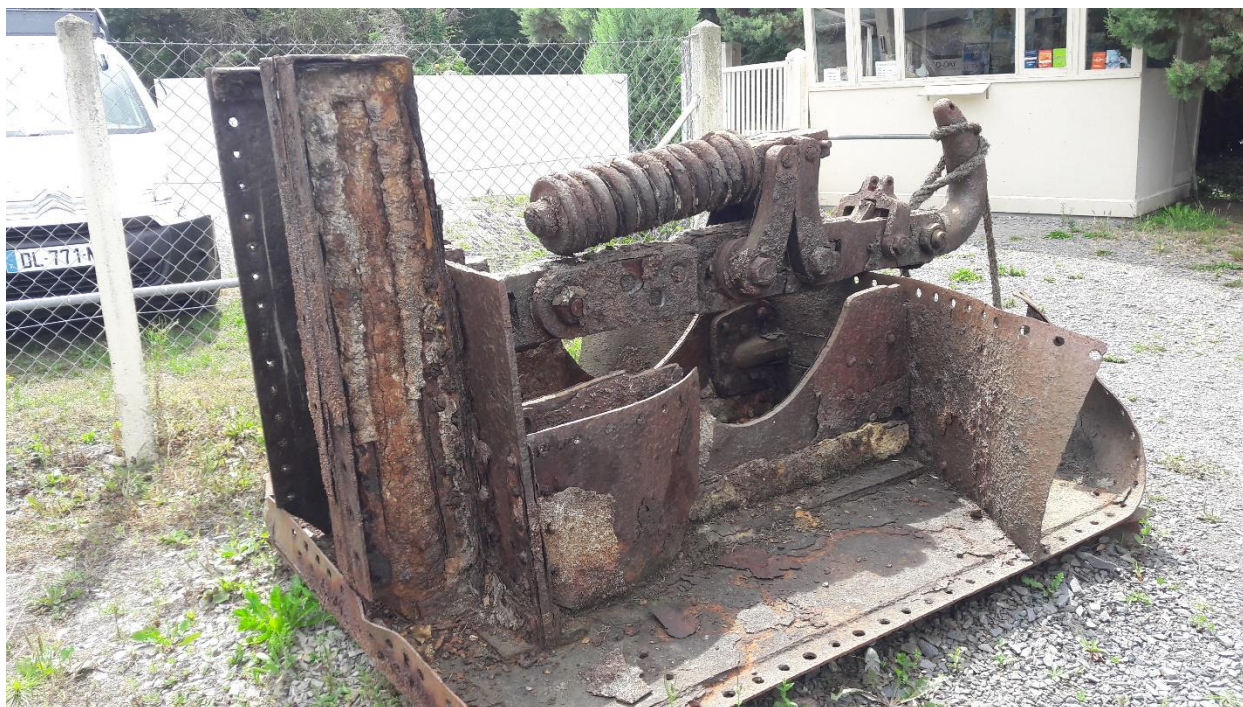
A tow hook was observed at the wreck museum at port-en-Bessin. The exhibit was not labelled and therefore the provenance of the tow hook cannot be established. However, it is likely to be from either HMRT SESAME or USS PARTRIDGE as both tugs had similar tow hook arrangements.

Figure 26 The tow hook exhibited at the wreck museum in Port-en-Bessin. (© Alison Mayor)

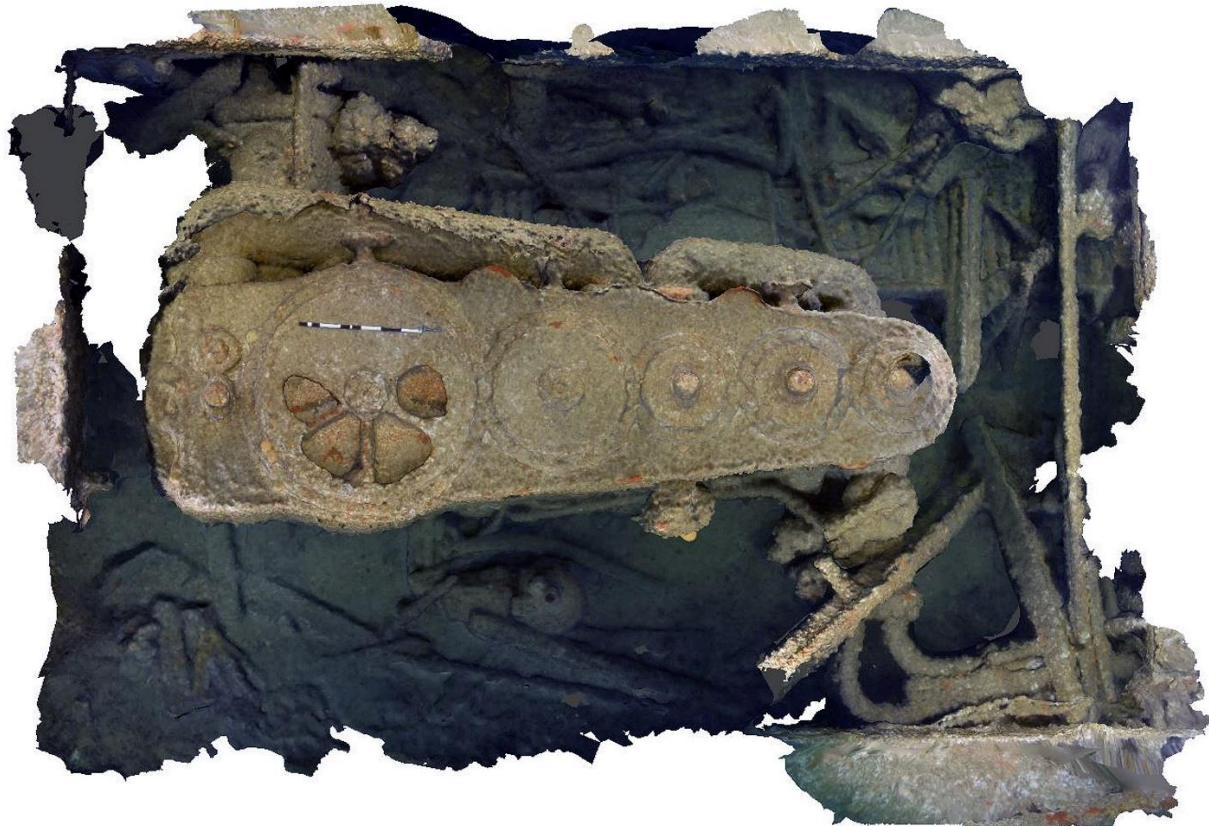
It is believed that the measurements 1 and 3 are of the steam expansion chambers. Measurement for 2, 4 and 5 represent the piston cylinder heads. Whilst the measurements of the largest cylinders are very similar, it is noted that there are some differences in the smaller measurements.

Figure 28 EA4360 Image of engine created from a photogrammetry model. (© Martin Davies)

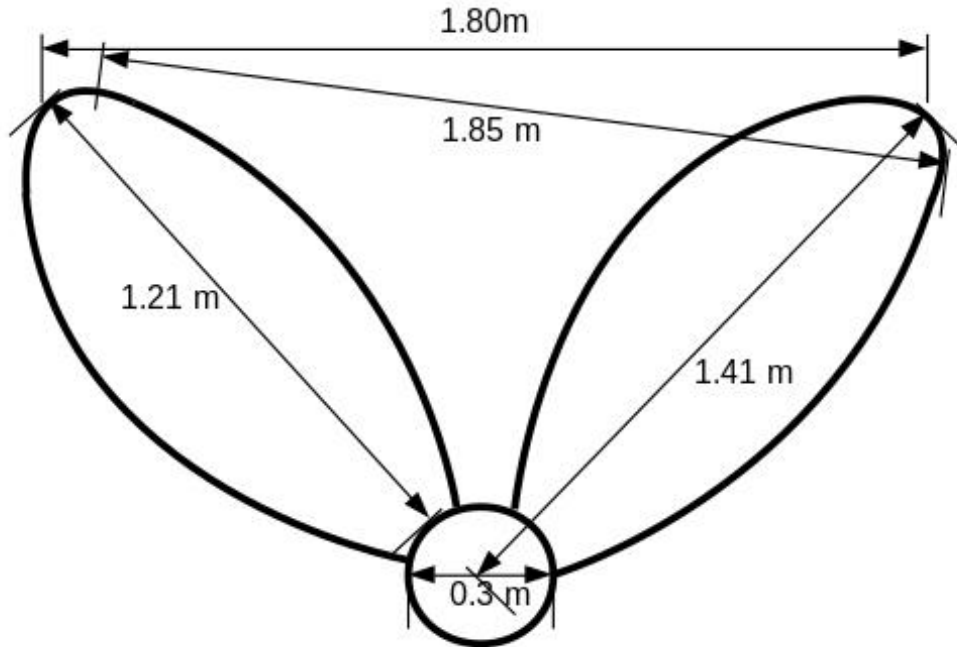
The iron propeller is in situ on the wreck, however one or more of the propeller blades is missing. The propeller was measured during the survey.

Two sets of measurements were taken and used to calculate whether the propeller originally had three or four blades. The lengths of the blades were measured as 1.36m and 1.41m. The distance between the tips of the blades was measured as 1.80m and 1.85m. This variation was due to the curve of the blades, the proximity of the rudder and the considerable marine growth on the propeller.

Figure 29 EA4360 propeller measurements. (© Jim Fuller)

It should be noted that it was not possible to measure between the tips of the blades exactly. A variation of less than 60mm between the tips would have yielded a more exact result of 90 degrees. If the propeller had been three bladed the distance between the tips would have been approximately 2.39m, i.e. more than 0.5m greater than the observed measurements. Thus the conclusion is that the propeller would have originally had four blades.

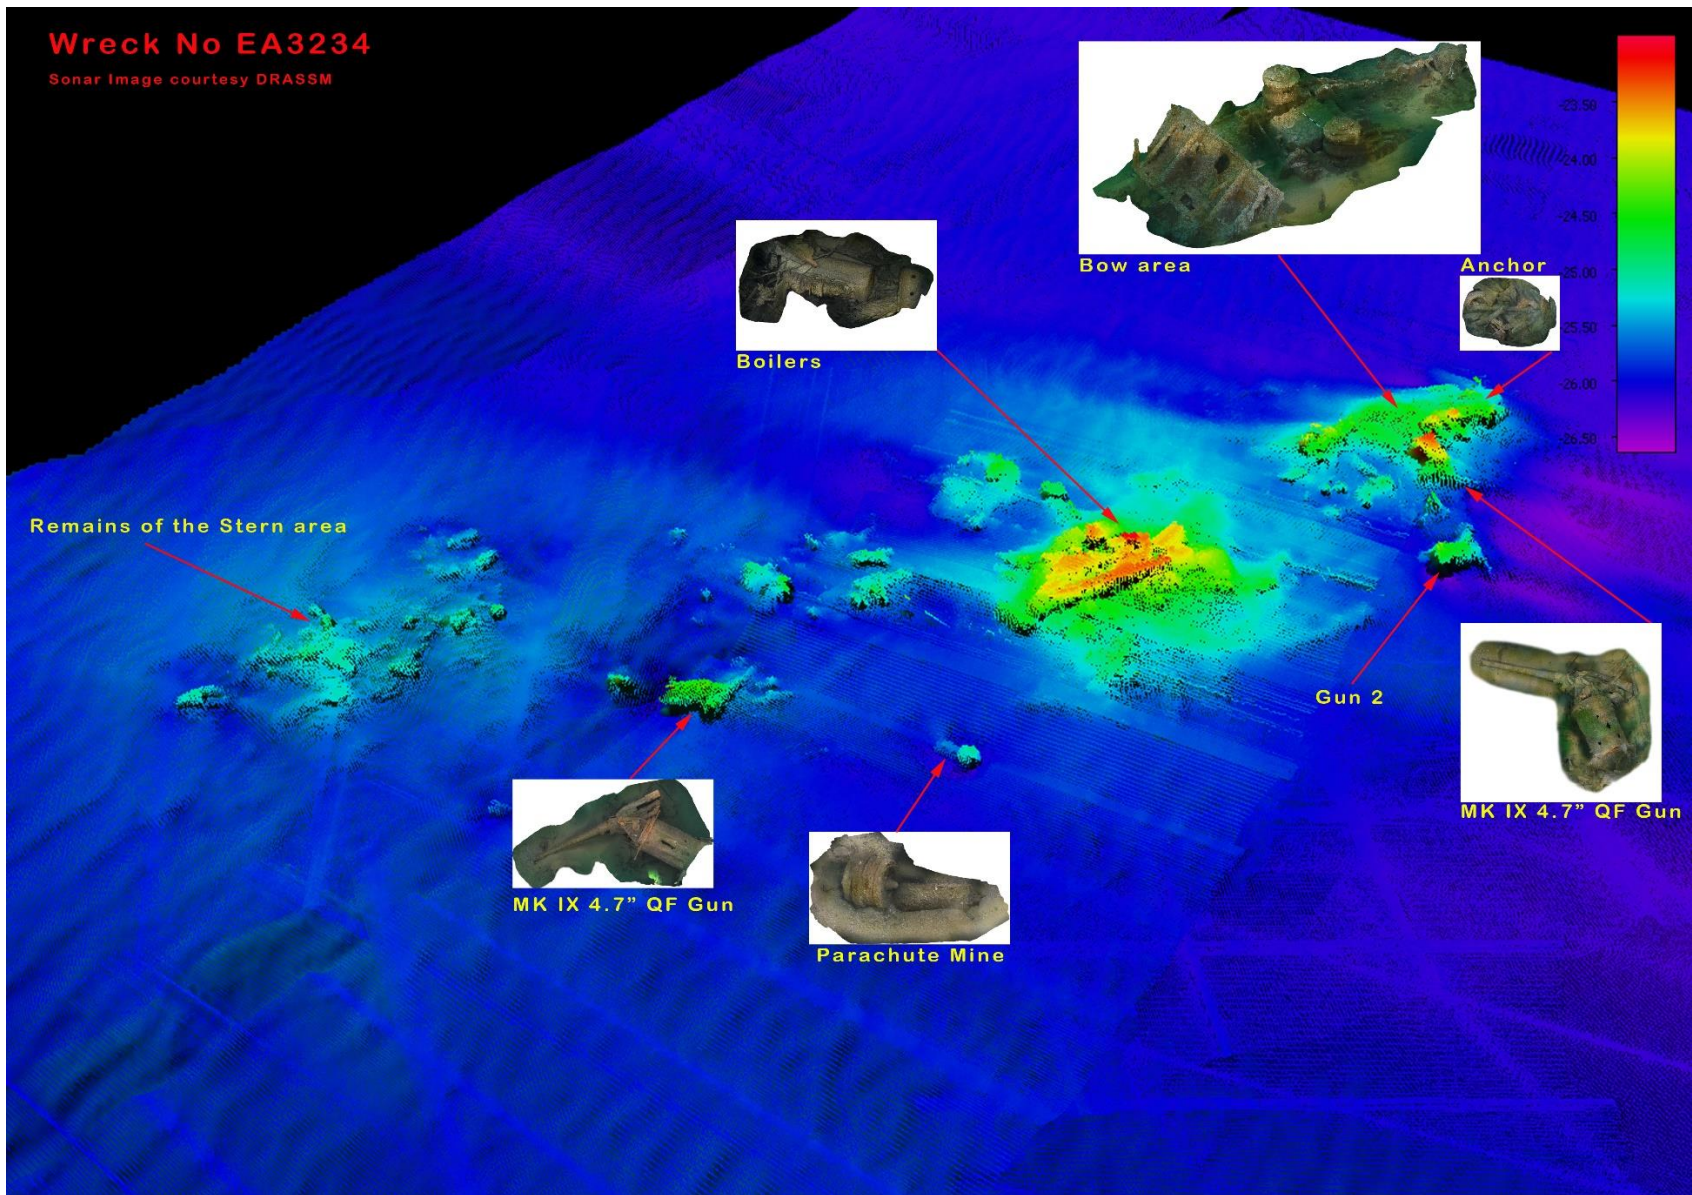
Figure 38 EA3234 DRASSM multibeam image showing location of key features. (© DRASSM)

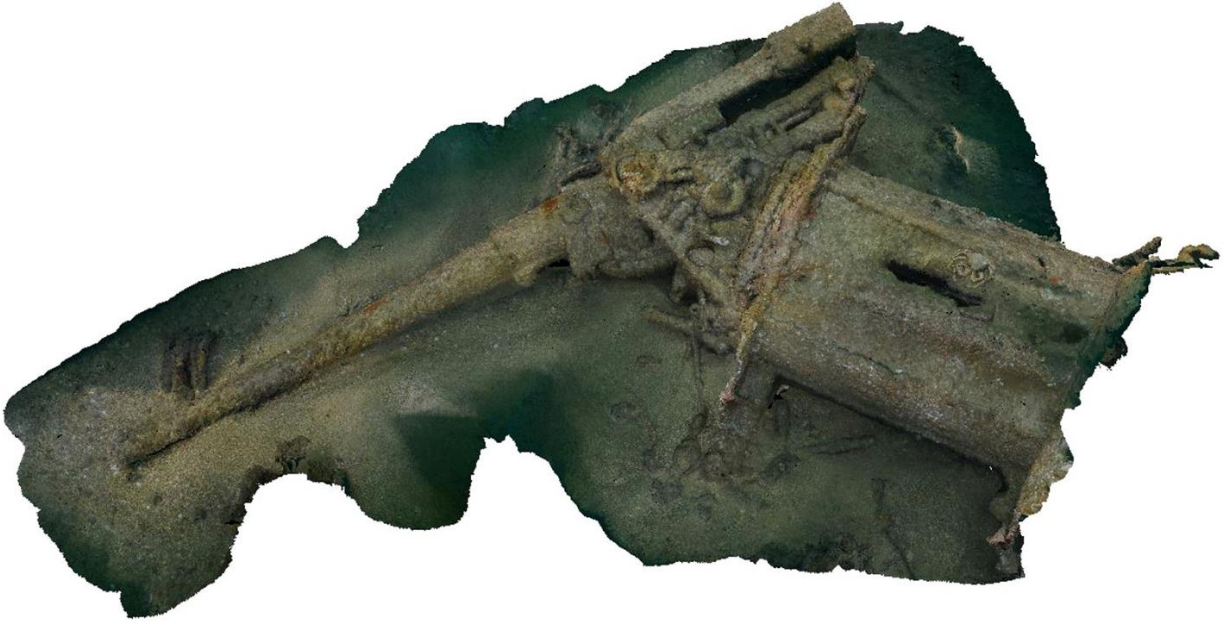
A total of three breach loading guns were found on the site; two guns behind the bow and one after the boiler section to the west.

Figure 45 EA3234 Plan view of Gun 3 (© Martin Davies)

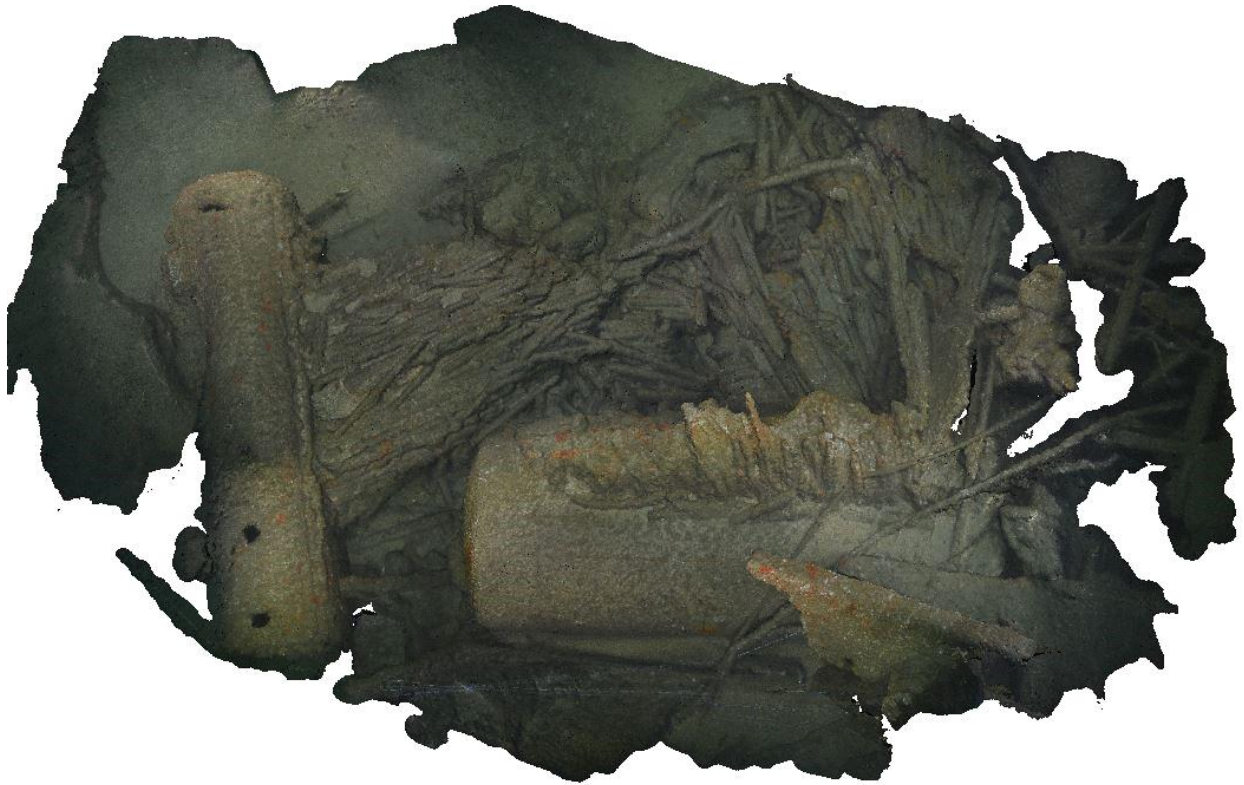
The highest part of the wreck is where the remains of the ship's steam boilers are located. We observed two cylinders surrounded by many lengths of broken pipes. The larger of the two cylinders had pipes extending vertically and the other, smaller cylinder, on its side, had pipes that extended horizontally. The boiler assemblage was very broken possibly as a result of salvage activity.

Figure 50 EA3234 Photogrammetry image of boiler debris - larger cylinder (steam drum) and smaller cylinder (water drum). (© Martin Davies)

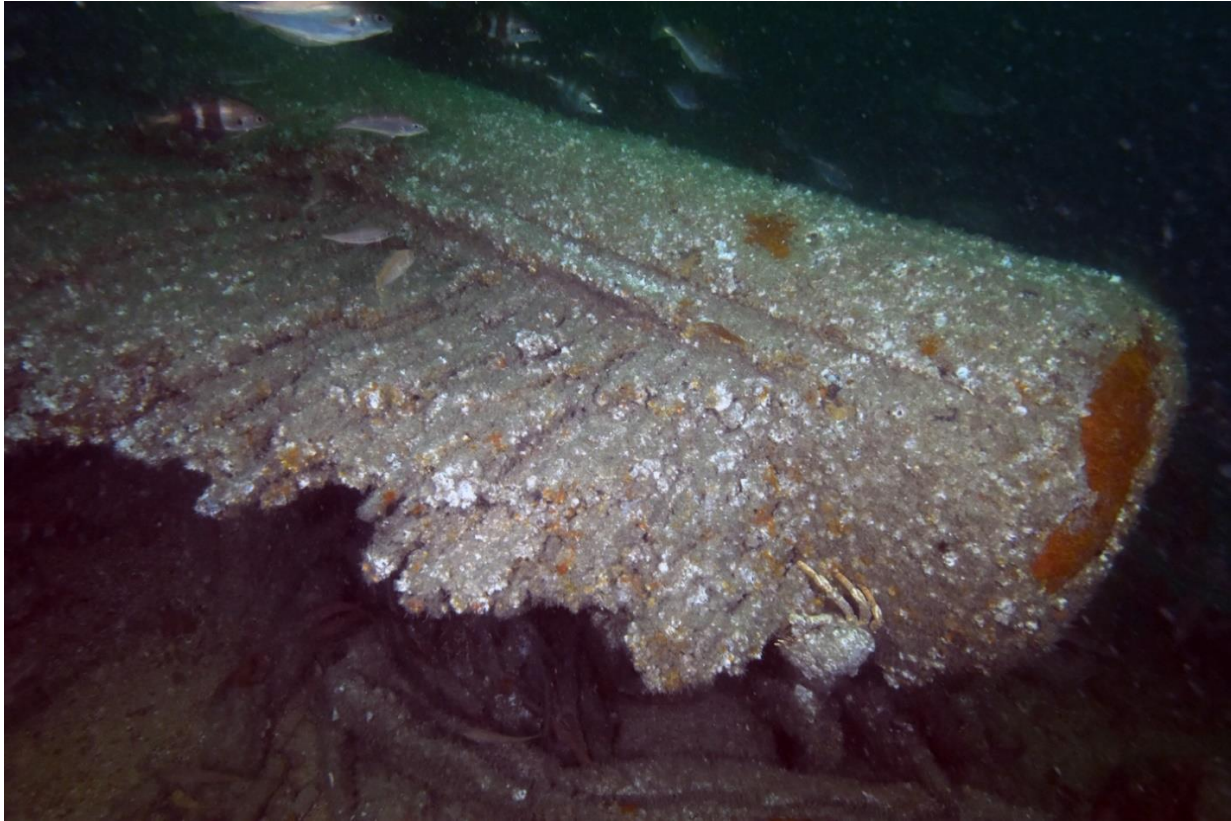
Figure 52 EA3234 the smaller boiler cylinder (water) with horizontal pipes. (© Martin Davies)

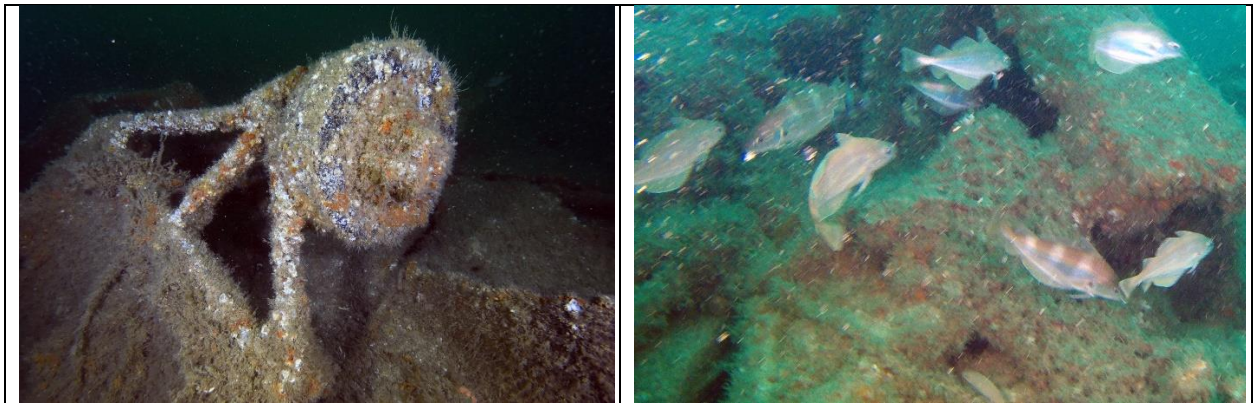
There was a substantial amount of trawler equipment present on the wreck, especially around the north west of the boiler area and gun 2.

Figure 59 EA3234 Trawl gear and netting (© Martin Davies) and (© Alison Bessell)

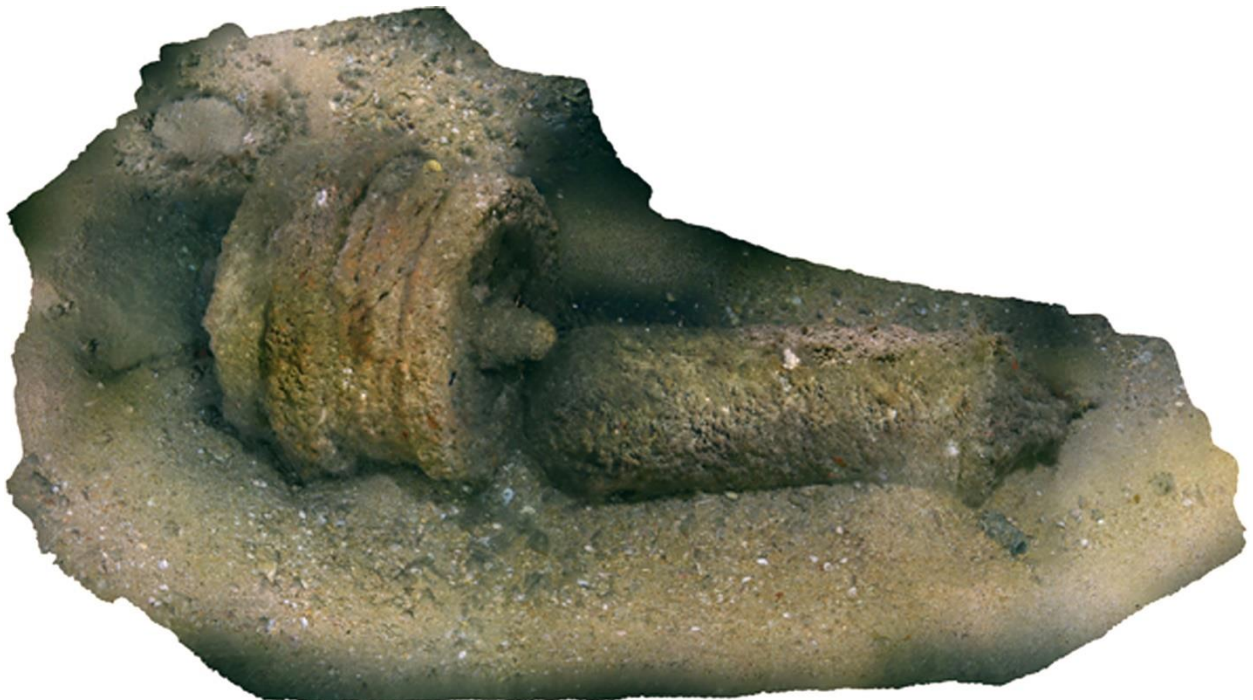
Towards the south west of the boilers we located two objects that were close together and our initial thought was that the two items were part of the same object. We considered it may be part of a turbine assembly.

Figure 60 EA3234 Mine like object (German Parachute Mine) and possible turbine assembly. (© Martin Davies)

Further investigation, some weeks later, and having visited the wreck museum at Port-en-Bessin, we realised that one of the objects may be a mine like object. The museum has a display of an inert German mine which closely resembled the artefact on the right hand side of the above image.

We alerted the presence of the mine like object to Semaphore Port-en-Bessin who notified the appropriate authorities.

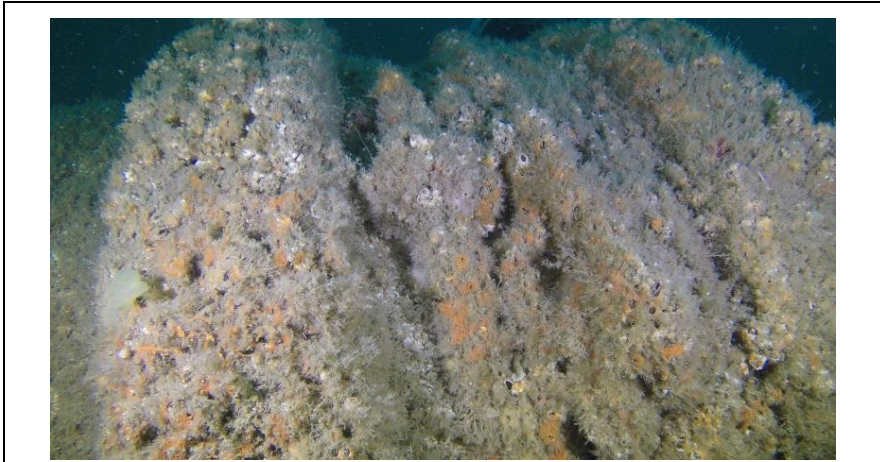
Figure 73: General faunal cover on EA3234 (USS PARTRIDGE).

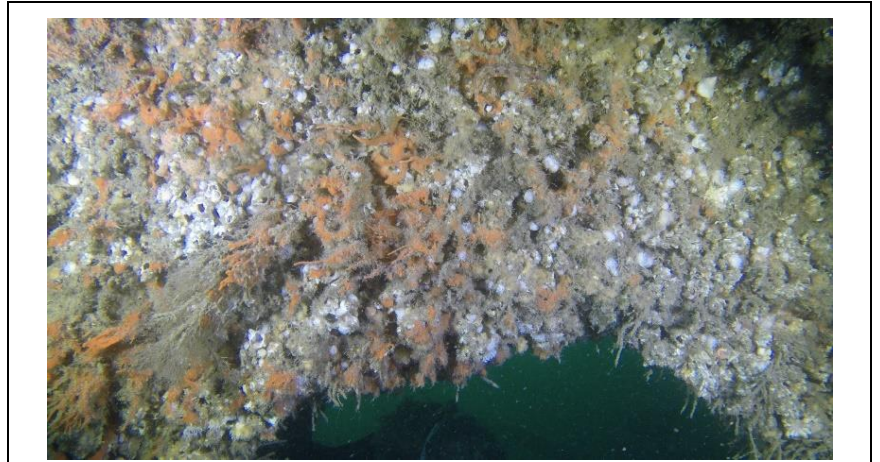
Figure 74: General faunal cover on EA4630 (HMRT SESAME).

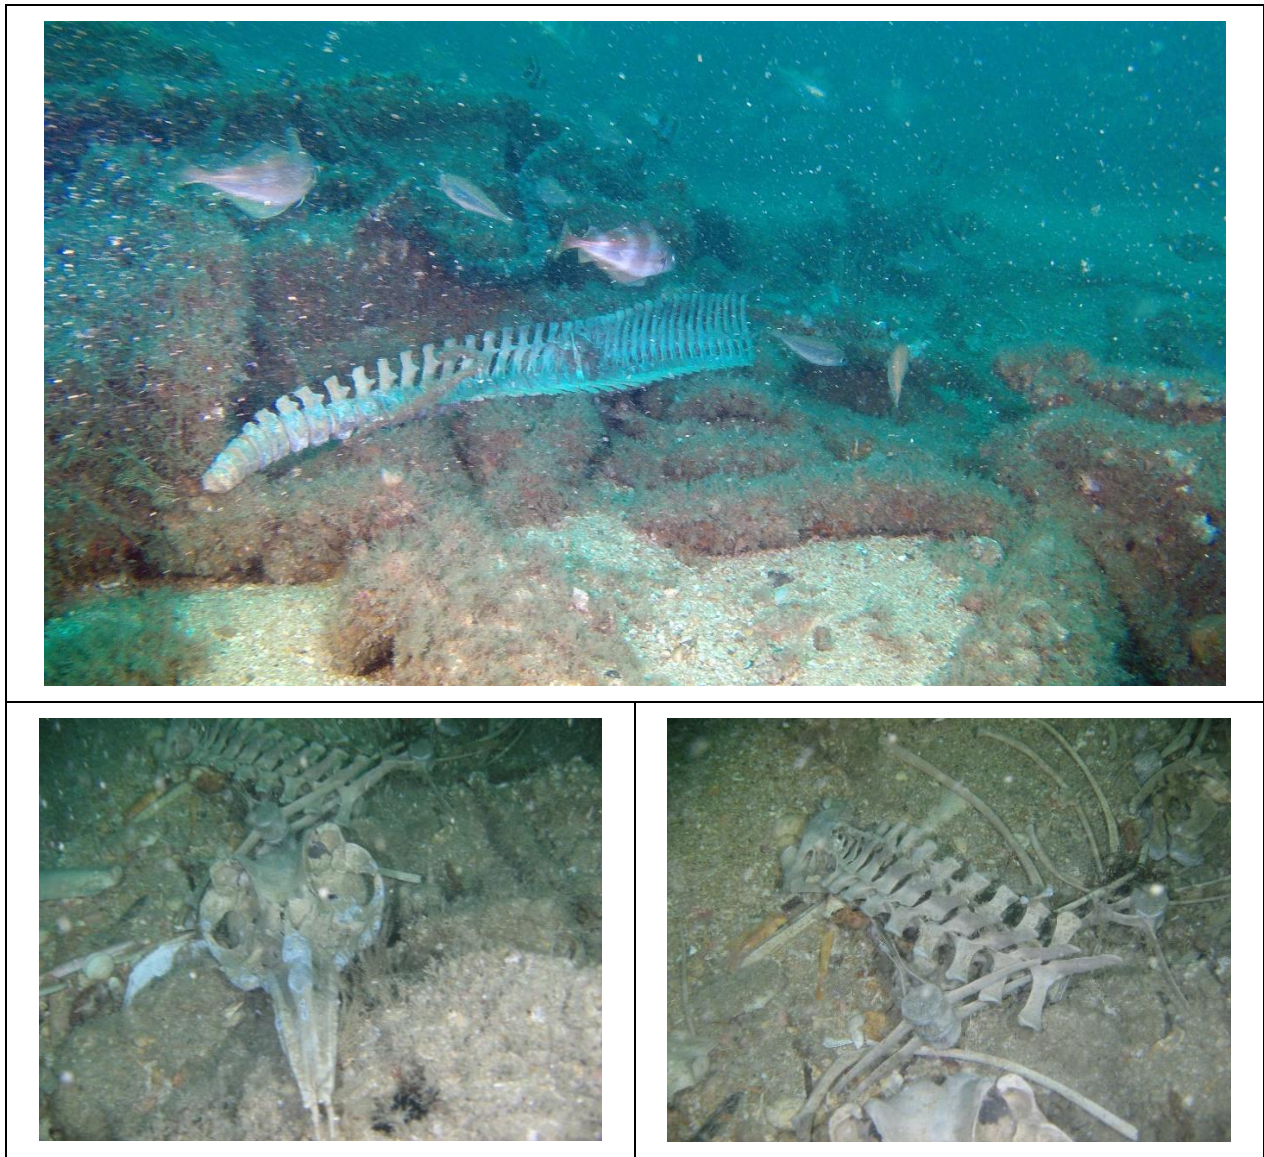
On the supposed wreck of the USS PARTRIDGE EA3234, an unusual sight was the skeleton of a marine mammal, believed to be a small dolphin. Towards the end of the survey, recent storms had started to disperse its remains.

Figure 85: Skeleton of small dolphin on the 'USS PARTRIDGE'

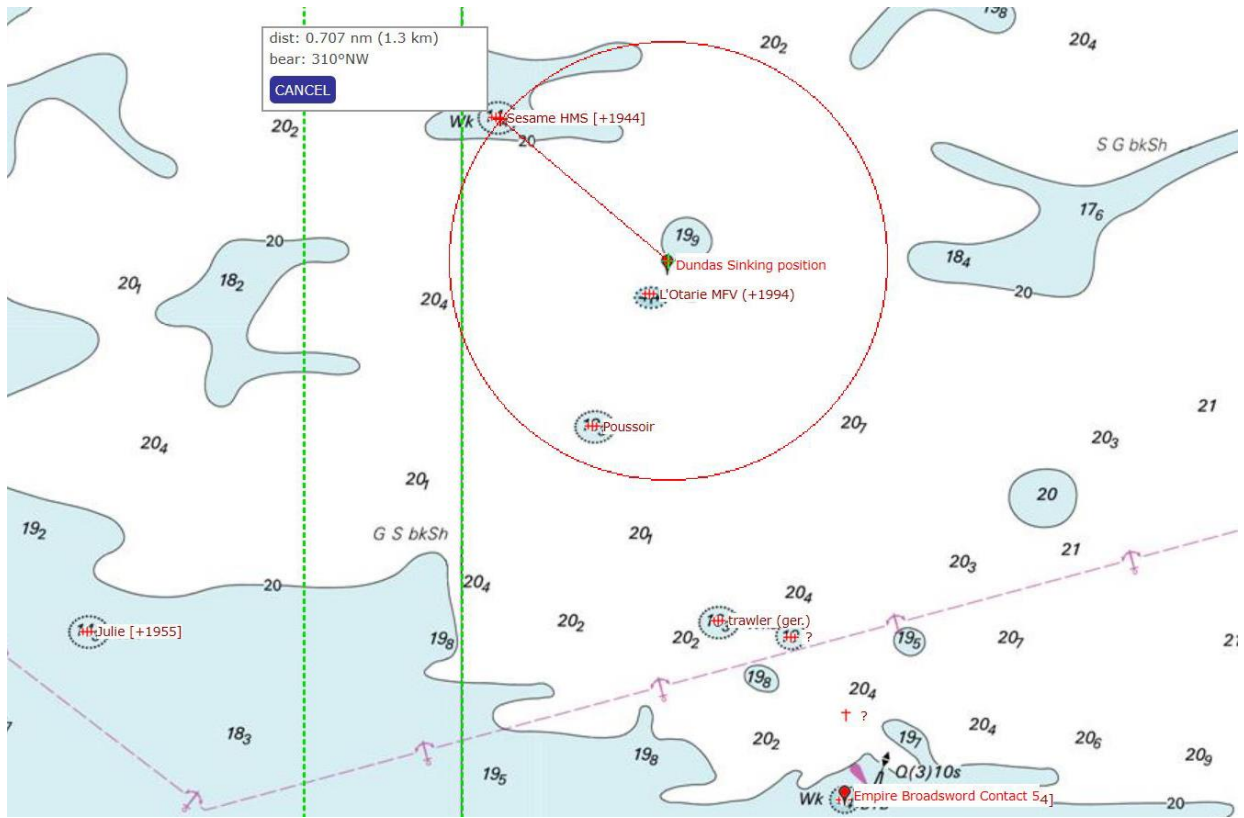
Figure 89 Extract of chart illustrating the position of wreck EA4360 in relation to reported position of HM Tug DUNDAS.

Observation 2. The position reported by USS BANNOCK of the wreck of HM Tug DUNDAS is approximately 0.7 Nm (1.3Km) from the wreck EA4360.

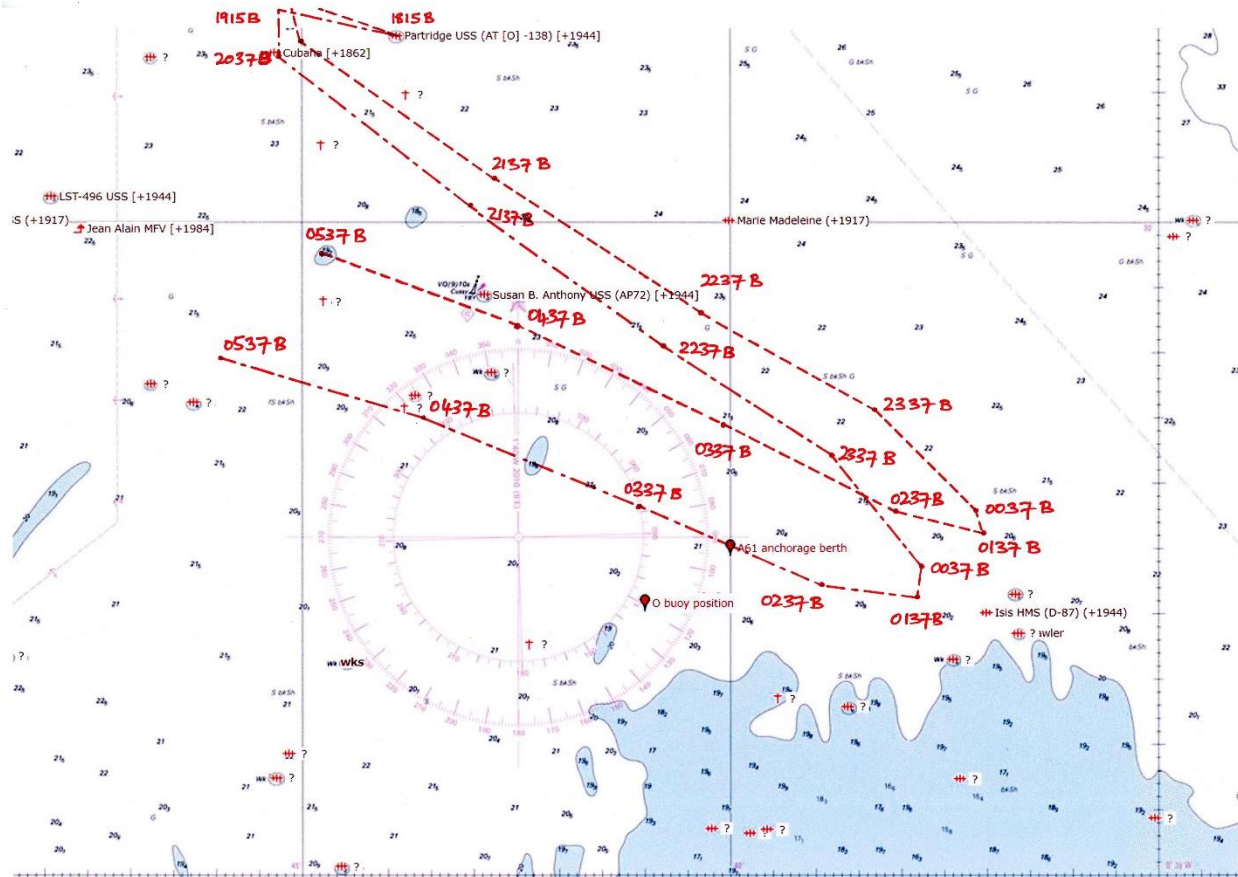
Figure 92 the estimated track of survivors from HMS ISIS survivors based on weather (wind) and tidal movement on 20th - 21st July 1944. (Tom Templeton)

Observation 5 the drifting pattern of survivors from HMS ISIS is consistent with the ship sinking at the location EA3234.

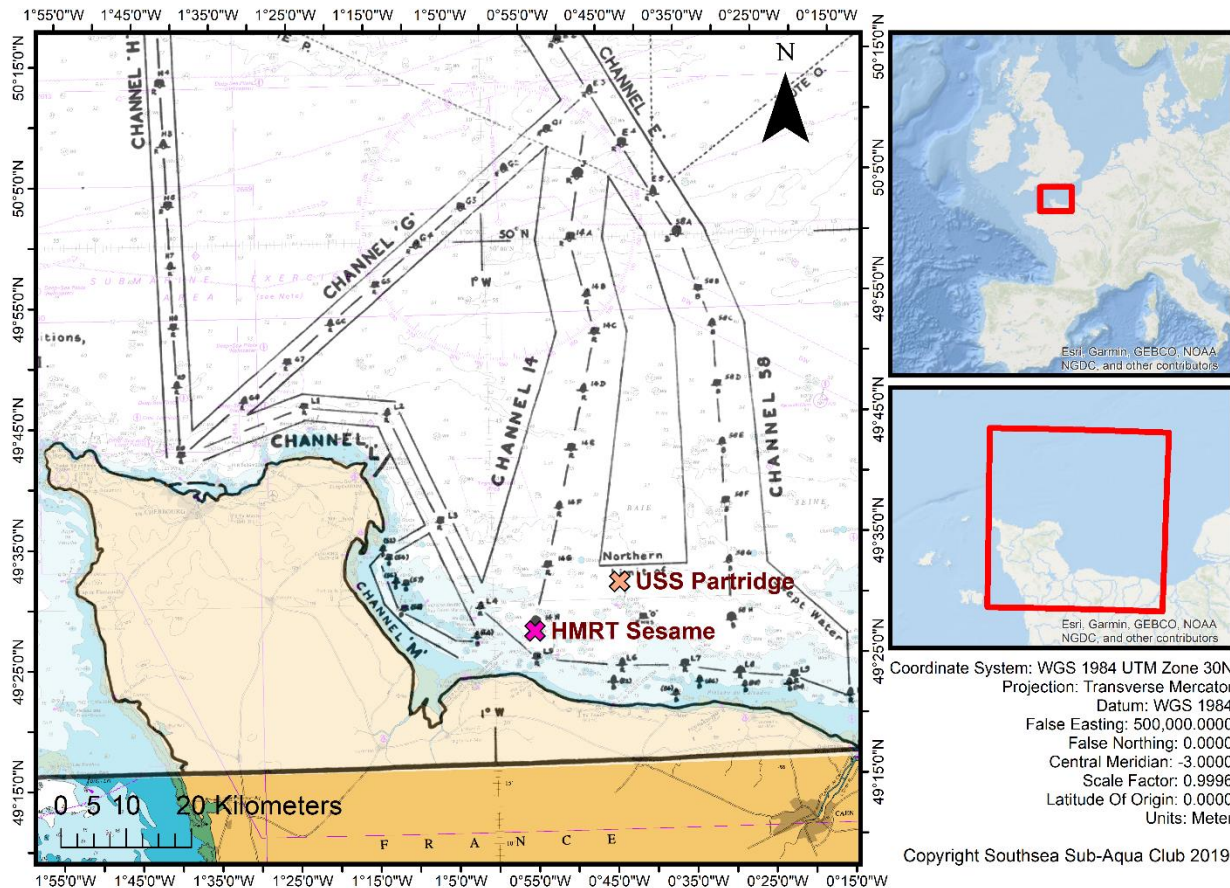
Figure 94 overlay image of swept channels and position of wrecks EA4360 (supposed SESAME) and EA3234 (supposed PARTRIDGE)

The above image illustrates the significant variation between the reported loss and the wreck sites.
