TWO TUGS

Report of the investigation of WW2 wrecks reported to be HMRT SESAME
and USS PARTRIDGE, Baie de Seine, Normandy, France

Southsea Sub-Aqua Club | BSAC Branch 0009
December 2019

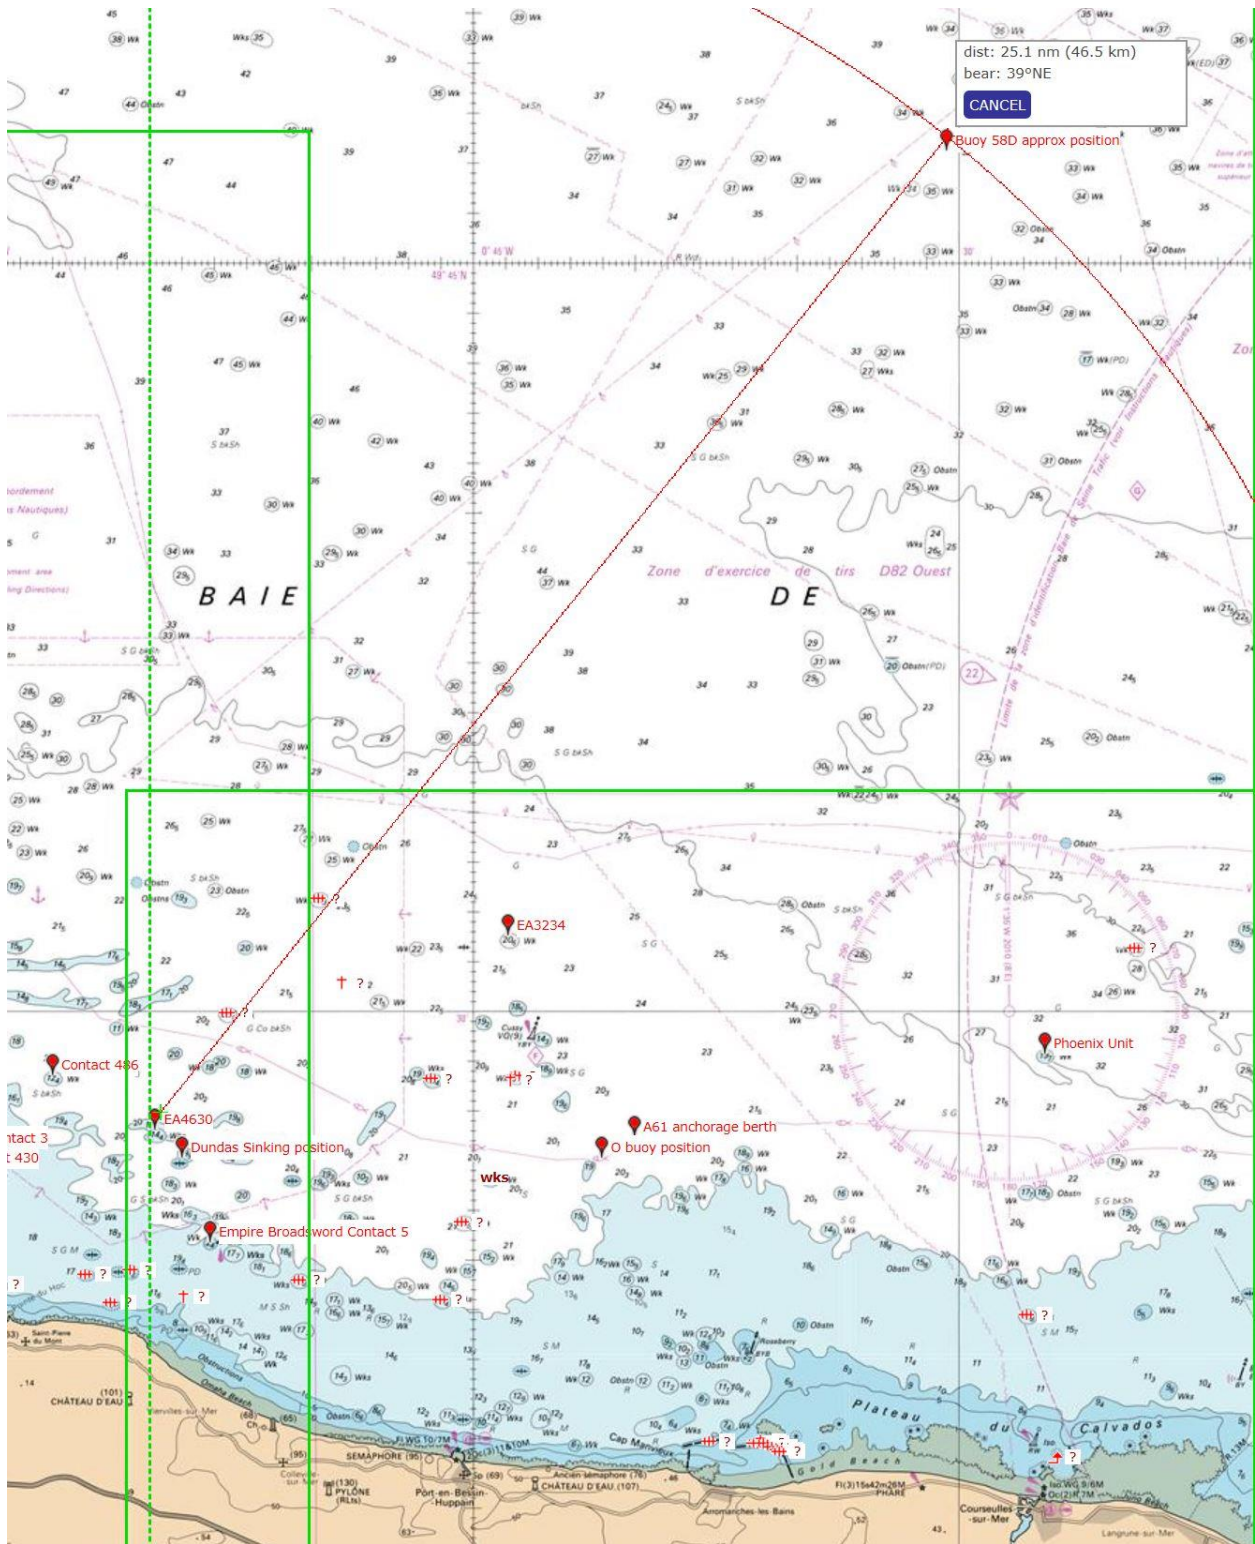
Figure 95 Position of EA4630 (supposed SESAME) from estimated position of '58D' buoy.

Site EA4360 (supposed SESAME) is 25.1Nm (46 km) distance from the estimated position of 58D buoy.

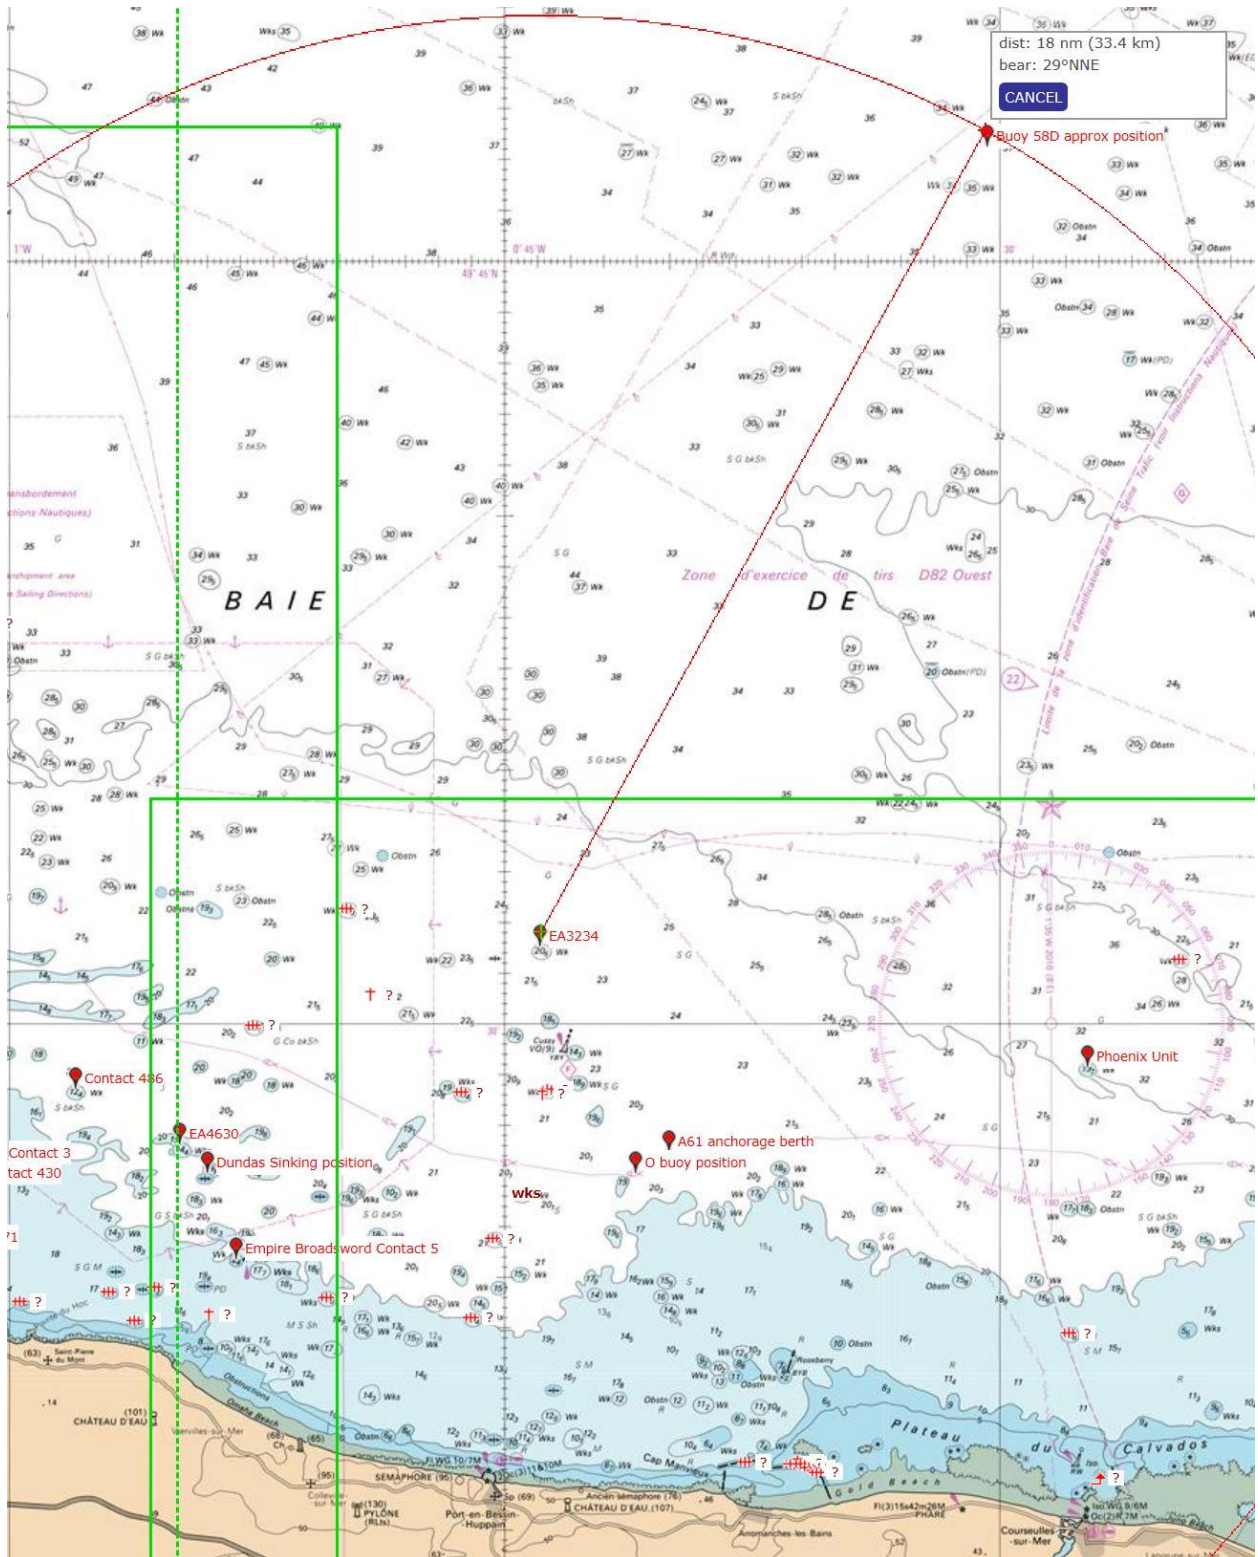
Figure 96 Extract from chart showing position of EA3234 (supposed PARTRIDGE) from the estimated position of 58D buoy. EA3234 (supposed PARTRIDGE) is 18Nm (33.4km) distance from 58D buoy.

Observation 7 the position of the wrecks EA4360 and EA3234 are too far from the reported loss of HMRT SESAME and USS PARTRIDGE; being in the vicinity of 58D buoy.

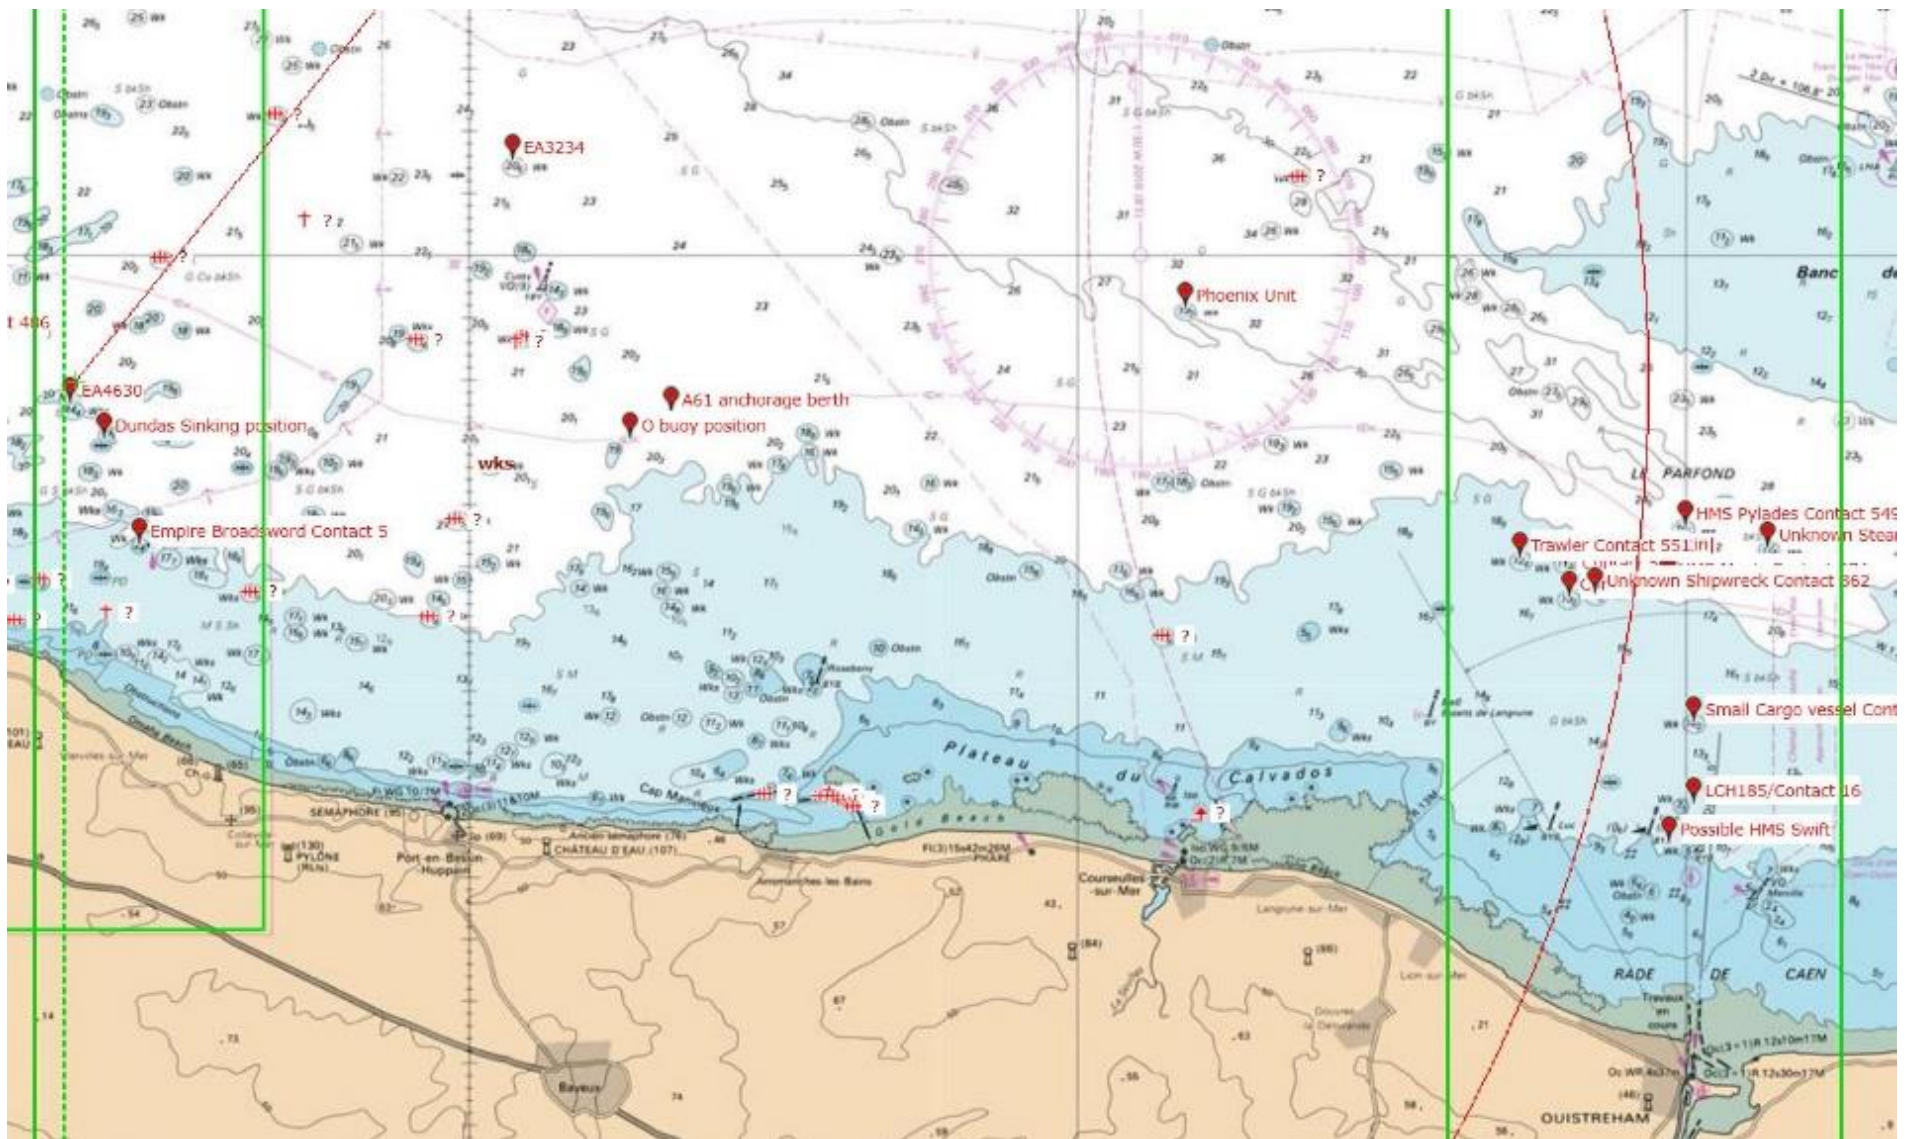
Figure 97 Extract from SHOM Chart showing wrecks EA4360, EA3234, O Buoy, A61 Anchorage, HM Tug DUNDAS and HMS SWIFT reported loss positions.

The positions of the wrecks, buoys, anchorages and the reported position of the loss of SESAME, PARTRIDGE, DUNDAS and ISIS are noted on the following extract of the SHOM chart.
